Durability of GFRP Bars Extracted from Bridges with 15 to 20 Years of Service Life

June 1, 2019

DURABILITY OF GFRP BARS EXTRACTED FROM BRIDGES WITH 15 TO 20 YEARS OF SERVICE LIFE

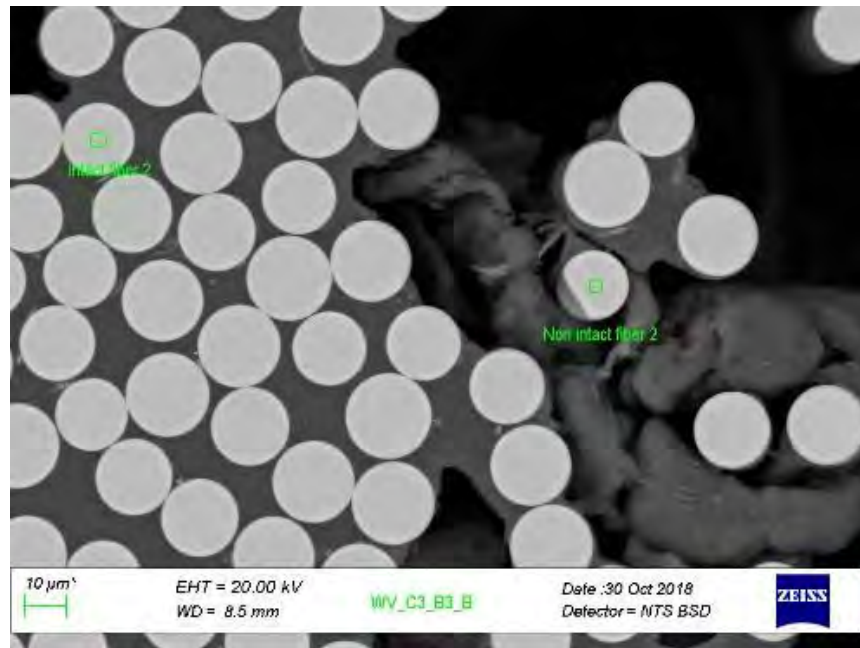
The results of each bridge are presented in Appendix V. *Fig. 49* shows an SEM image without any deteriorated fibers, while *Fig. 50* shows an SEM image with fibers possibly deteriorated by concrete exposure.

Fig. 49–Sample from McKinleyville Bridge – no fibers negatively affected by concrete

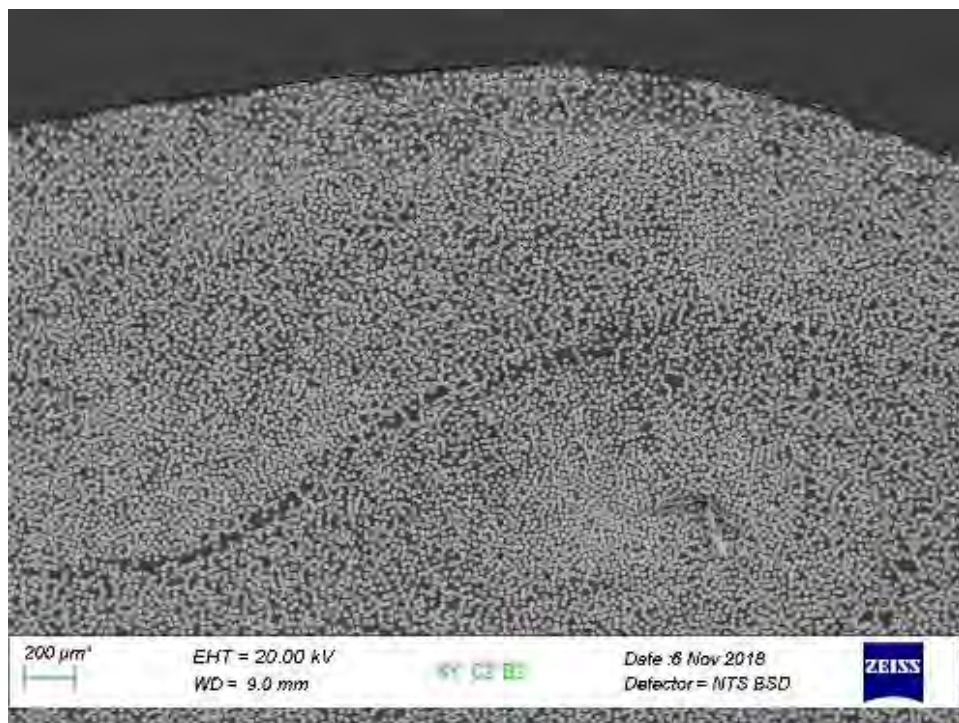
Fig. 99. KY_C2_B2

SEM imaging for *Roger's Creek Bridge* was performed at Owens Corning. The fibers from *Roger's Creek Bridge* showed some evidence of being negatively affected by concrete exposure. Of the few negatively affected, they were located on the exterior or near large cracks. The number of affected fibers is expected to be similar or less than the Cuyahoga or Gills Creek samples. The SEM imaging of each bar is shown in Fig. 99 through Fig. 109.
