# **Durability of GFRP Bars Extracted from Bridges with 15 to 20 Years of Service Life** June 1, 2019

# DURABILITY OF GFRP BARS EXTRACTED FROM BRIDGES WITH 15 TO 20 YEARS OF SERVICE LIFE

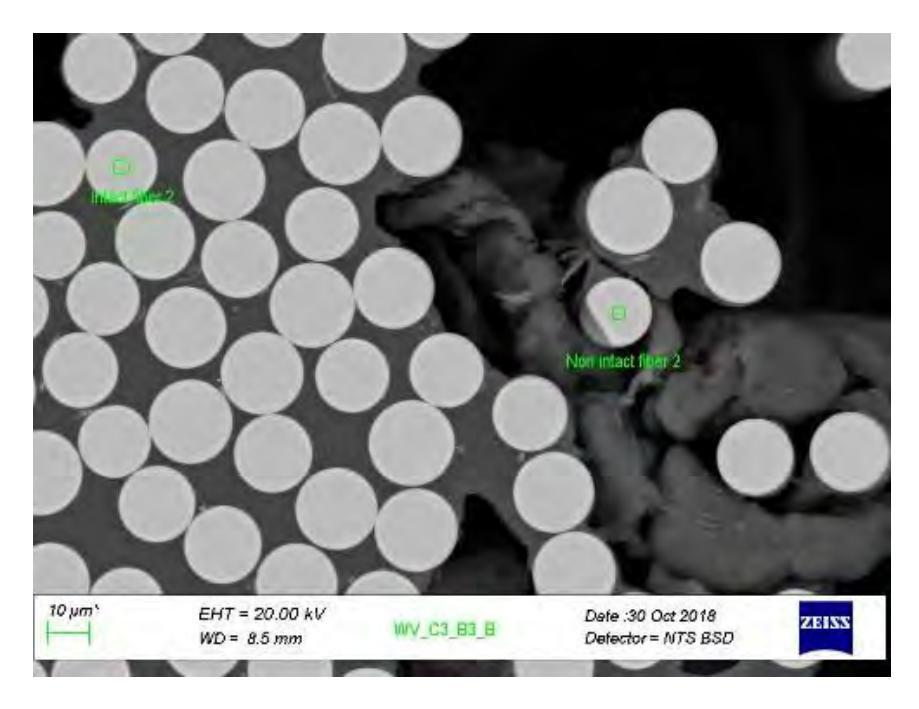
*Fig.* 49–Sample from McKinleyville Bridge – no fibers negatively affected by concrete

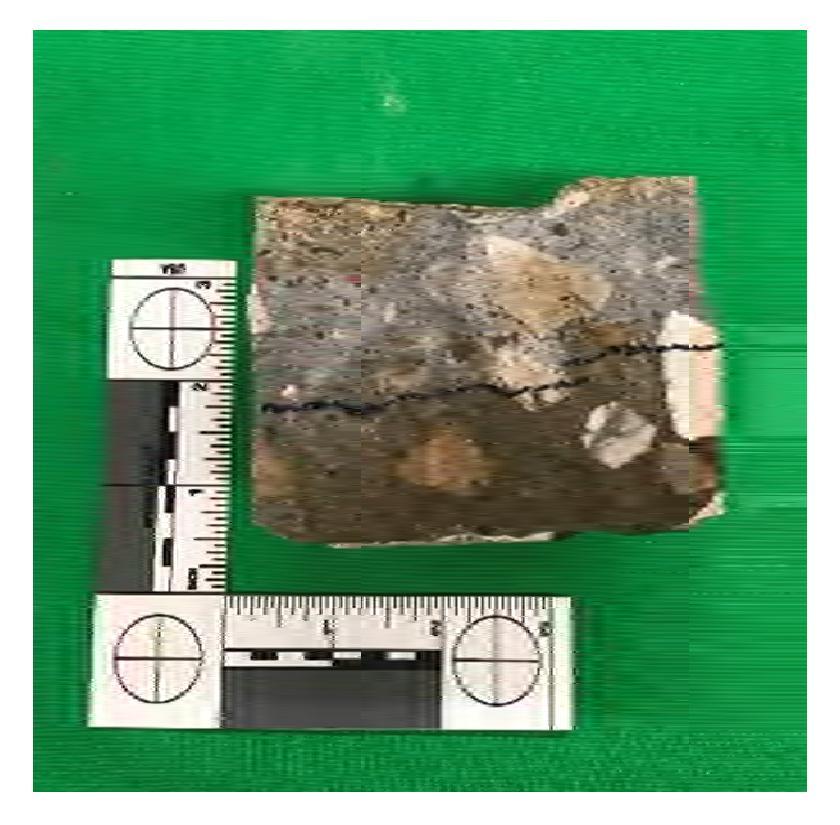
*Fig.* 55 shows the worst case scenario, where the chloride penetration was approximately 2.5 in. (64 mm) and *Fig.* 56 shows the best-case scenario, where no visual chloride penetration was observed. The test results of the individual bridges are reported in Appendix IV.

Fig. 55-Cuyahoga Bridge sample with visual chloride penetration

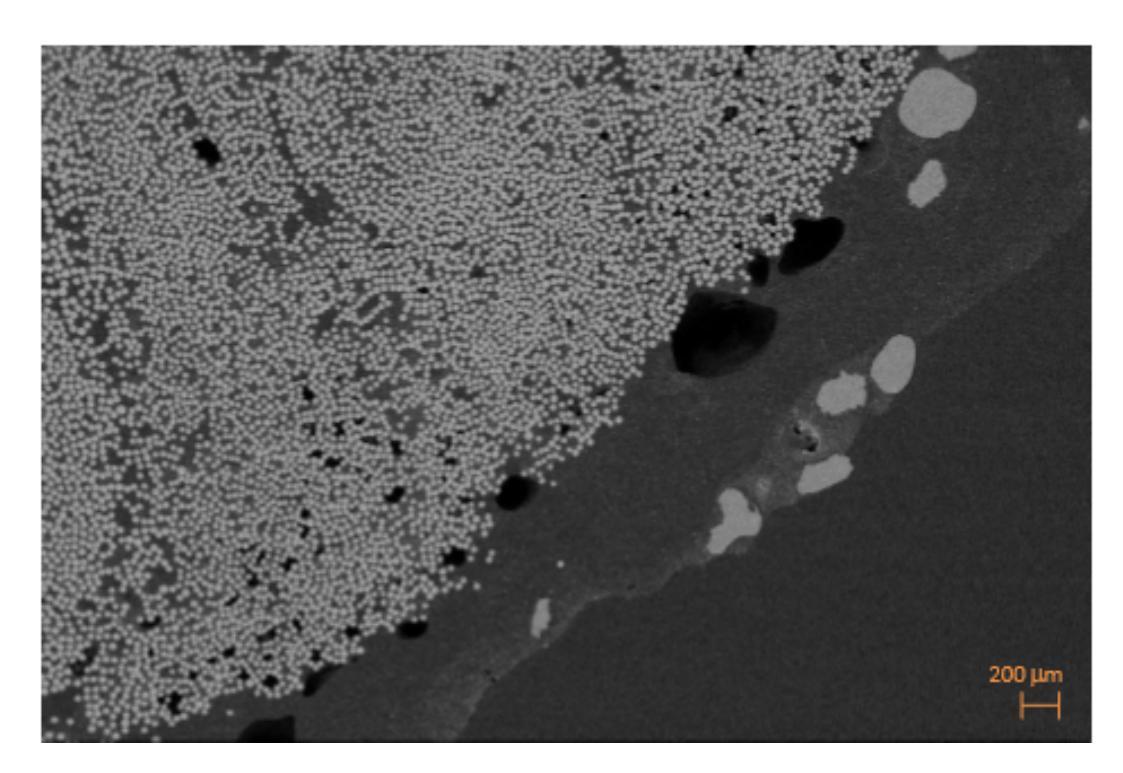
Fig. 32: OH2\_C5\_B2

SEM imaging for *Cuyahoga Bridge* was performed at Owens Corning. GFRP rebar extracted from Cuyahoga bridges show some damage on 0.05 to 0.12 % of the glass fibers. This is much less than expected or predicted by accelerated test methods, and has a negligible impact on mechanical properties. The affected fibers were typically on the outer edge of the rebar. The results of each bar is shown in Fig. 32 through Fig. 35.

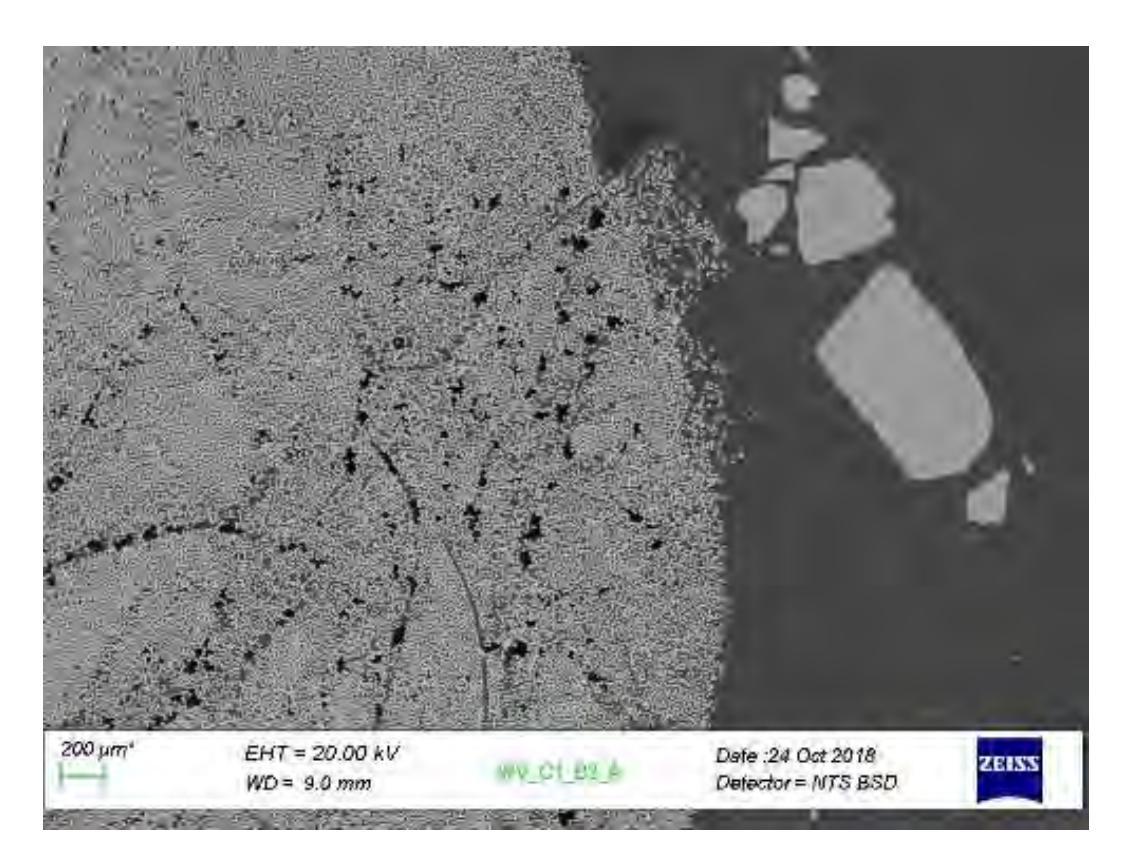
*Fig. 36. WV\_C1\_B2A*

SEM imaging for *McKinleyville Bridge* was performed at Owens Corning. Nearly no negatively affected fibers were observed on the interior or exterior of in-service rebar. The few negatively affected fibers appear to have physical damage from specimen preparation as they are near resin voids. The SEM images of each bar is shown in Fig. 36 through Fig. 80.

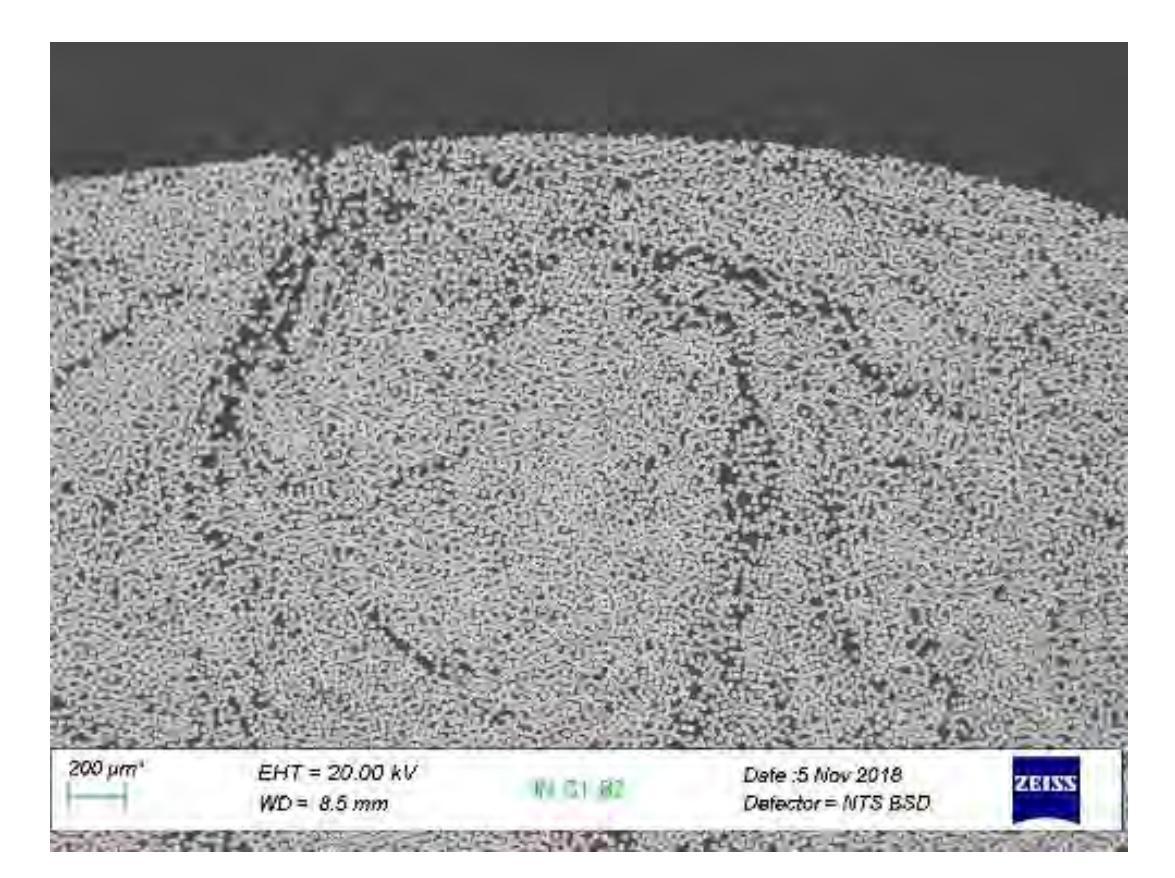
Fig. 81. IN\_C1\_B2

In the bars from Thayer Road Bridge, the physical damage was likely from the manufacturing process as the fiber damage is isolated to perimeter fibers and appears to be a partial fiber.

SEM imaging for *Thayer Road Bridge* was performed at Owens Corning. A few negatively affected fibers were observed but appeared to be isolated on the outer perimeter of in-service rebar. The affected fibers only indicated physical damage, likely from manufacturing process. Extrapolated damage was not visible in this sample. Swirls observed in optical microscopy can be seen in low magnification images and are related to resin rich areas. The SEM imaging of each bar is shown in Fig. 81 through Fig. 98.

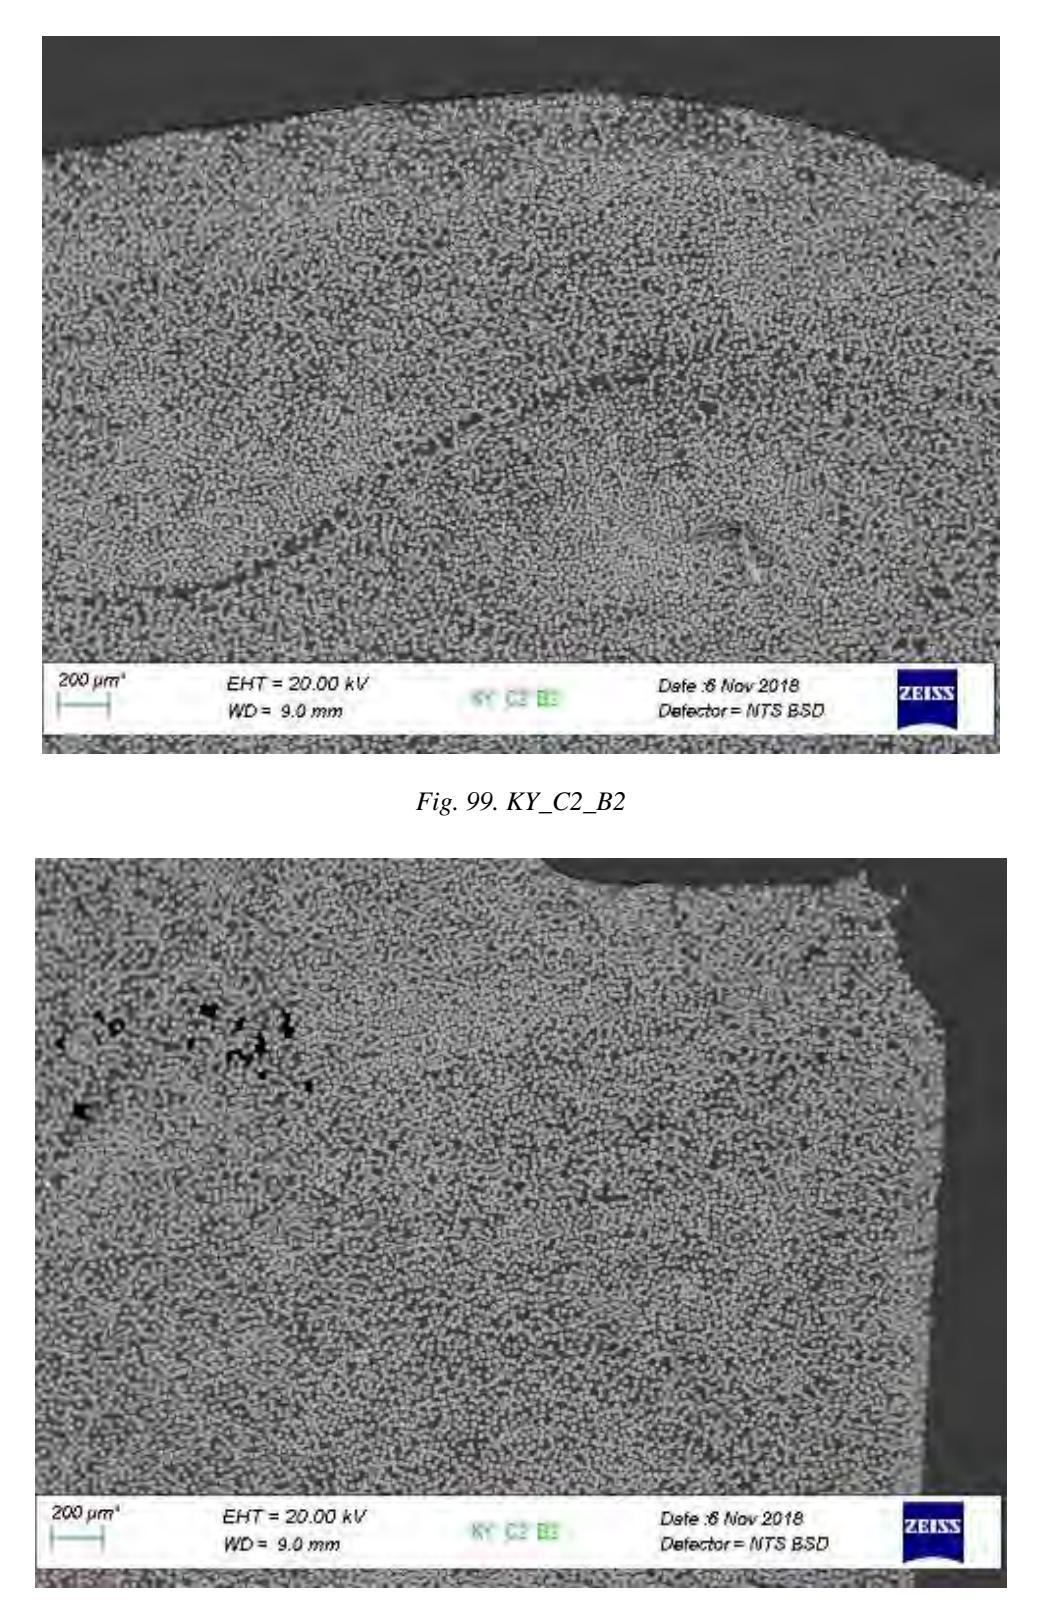
Fig. 100. KY\_C2\_B2

SEM imaging for *Roger's Creek Bridge* was performed at Owens Corning. The fibers from *Roger's Creek Bridge* showed some evidence of being negatively affected by concrete exposure. Of the few negatively affected, they were located on the exterior or near large cracks. The number of affected fibers is expected to be similar or less than the Cuyahoga or Gills Creek samples. The SEM imaging of each bar is shown in Fig. 99 through Fig. 109.

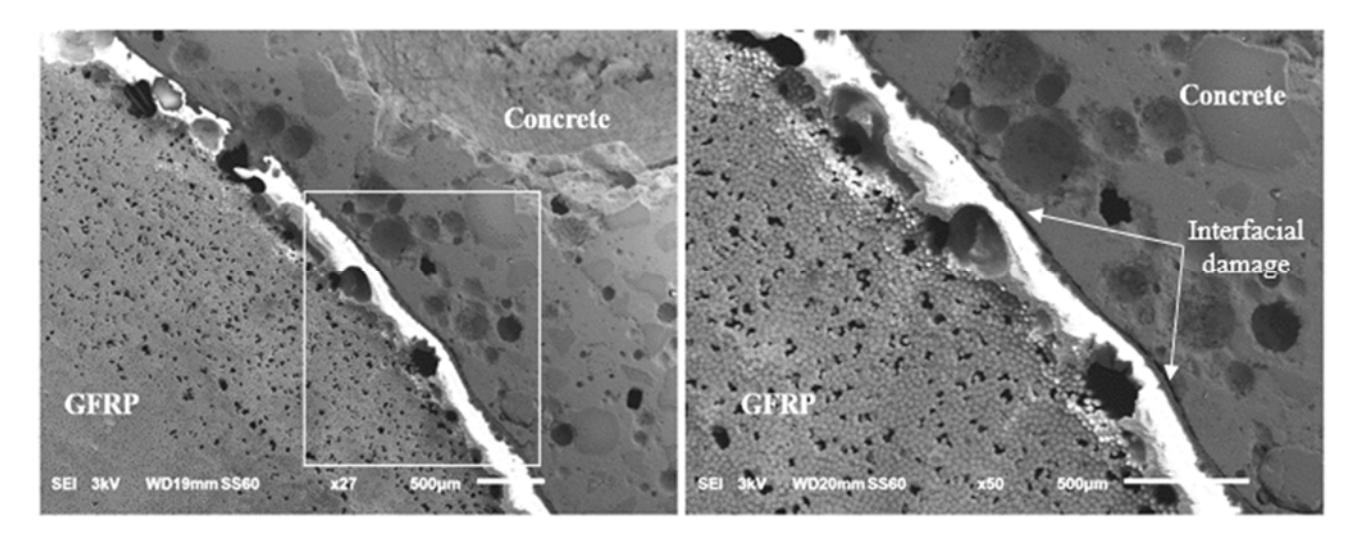
GFRP-to-concrete interfacial bond appeared to be maintained properly and no sign of bond degradation nor loss of contact was observed as presented in Fig. 112. As documented by others (Aftab A. Mufti et al., 2007), the visible interfacial damage was the result of sample preparation and drying in the SEM chamber.

Fig. 112. SEM images of concrete-GFRP interface at magnifications of 27x (left) 50x (right)

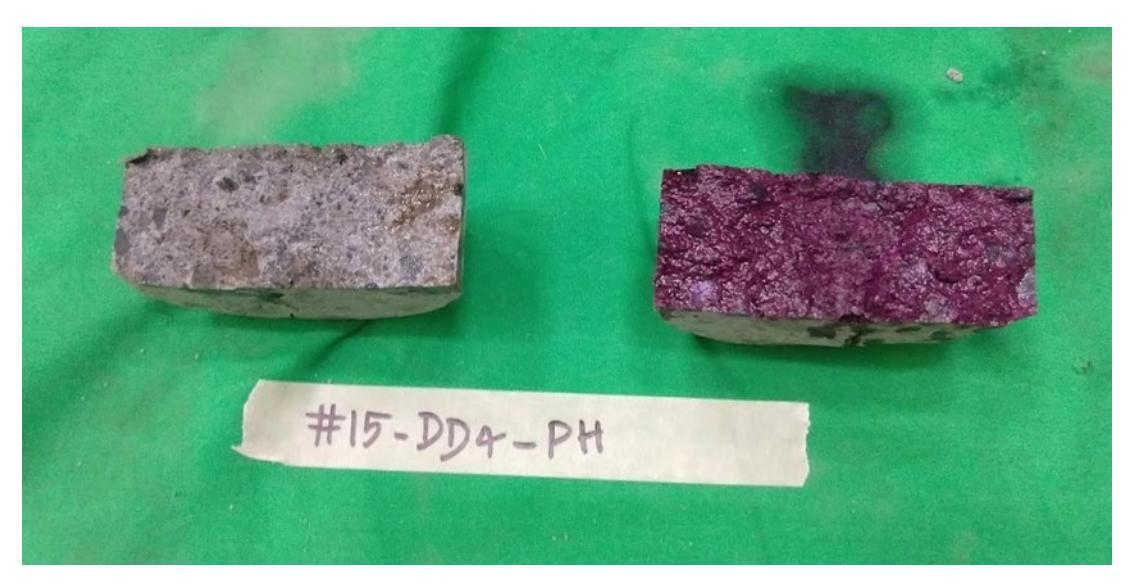
Fig. 65 – Core #15– Representative image for full chloride and zero carbonation depths.

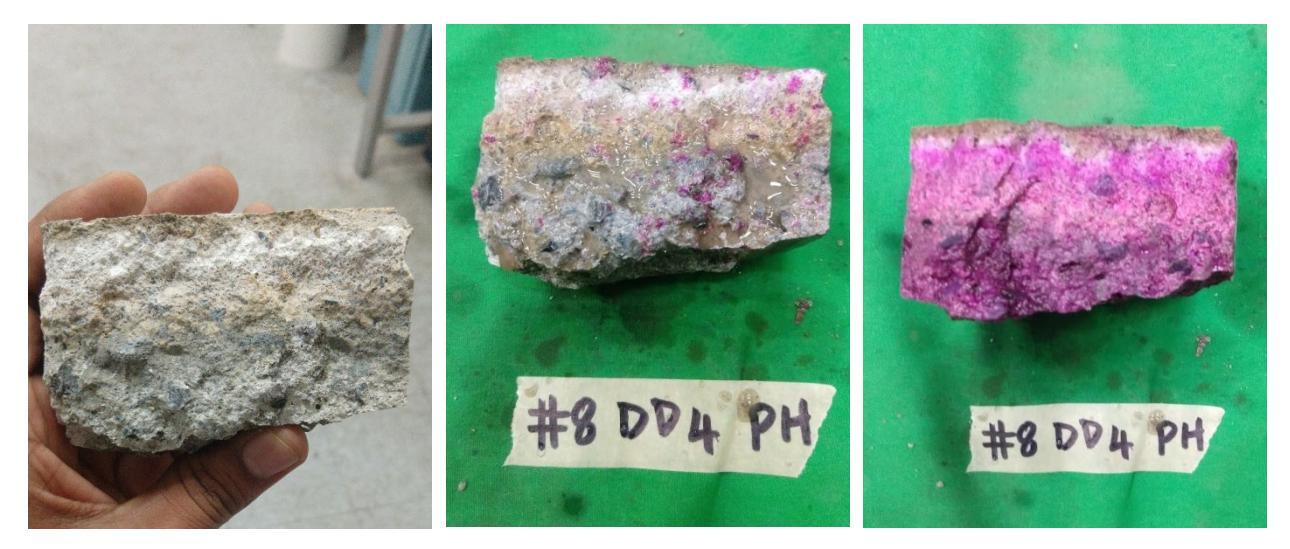
*Fig.* 76 –*Core* #8 – *Discoloration and layers observed in core specimen.*

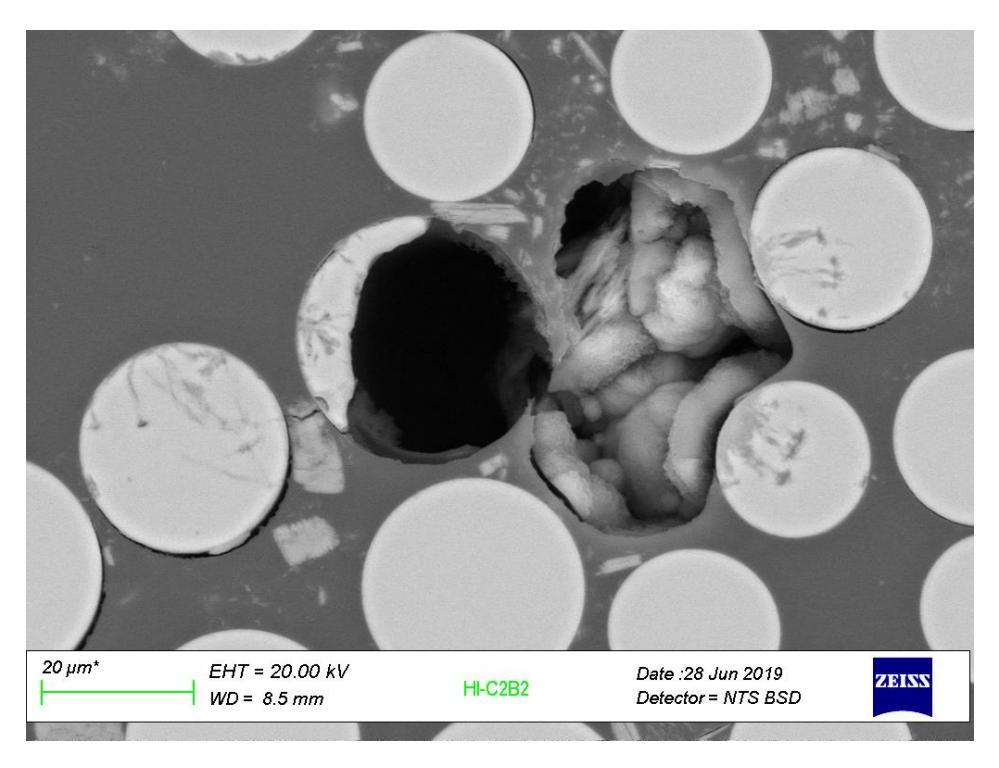
*Fig. 42 – Core #2 Bar #2 damaged fibers at the outer edge of rebar.*

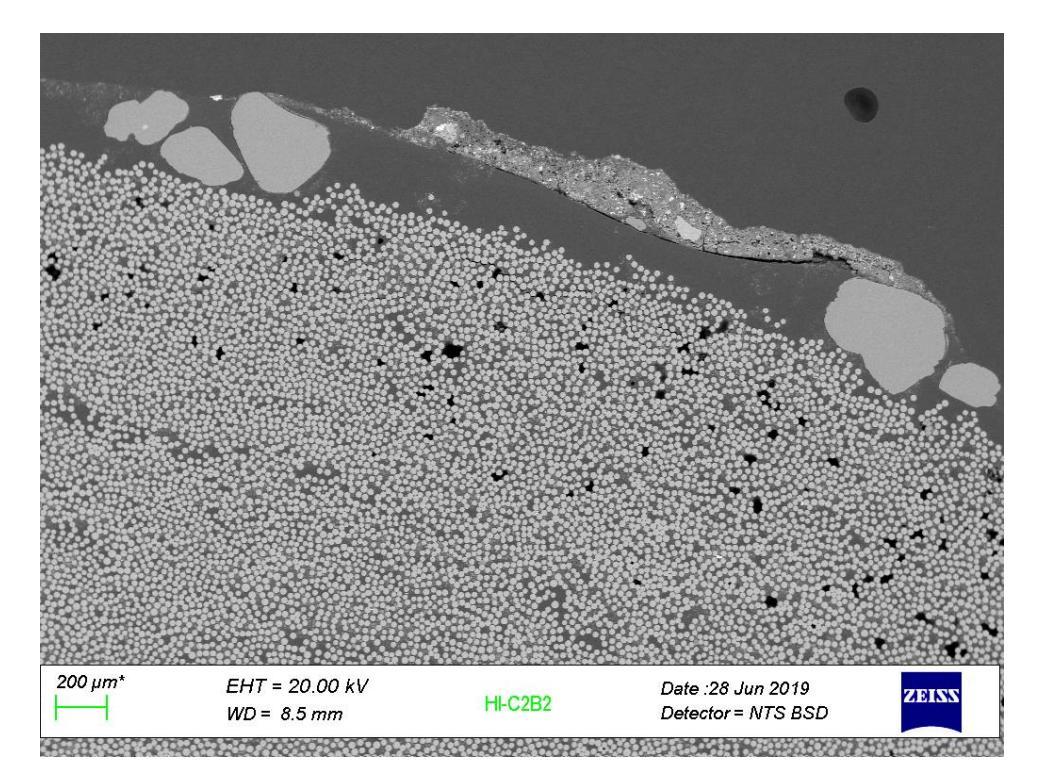
*Fig. 43 – Core #2 Bar #2 at the edge. Some voids in the resin are observed.*

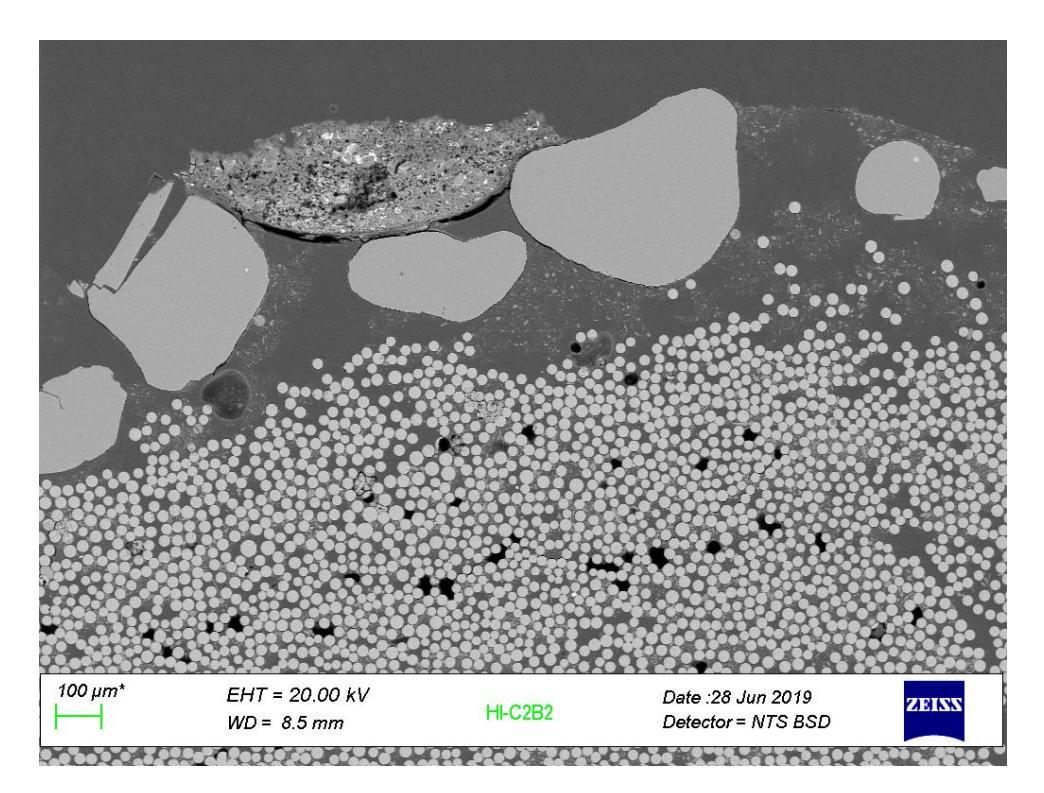
Fig. 44 –Core #2 Bar #2 at edge. Some voids in the resin are observed.

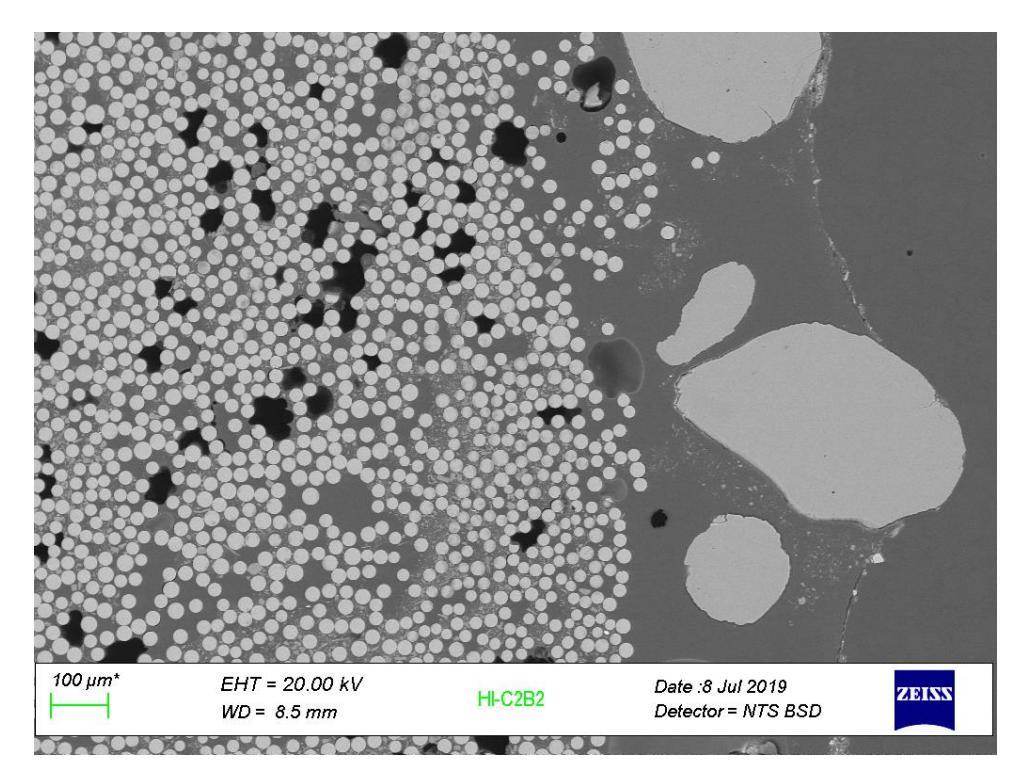
*Fig.* 45 –*Core* #2 *Bar* #2 *at edge. Voids in the resin are observed.*

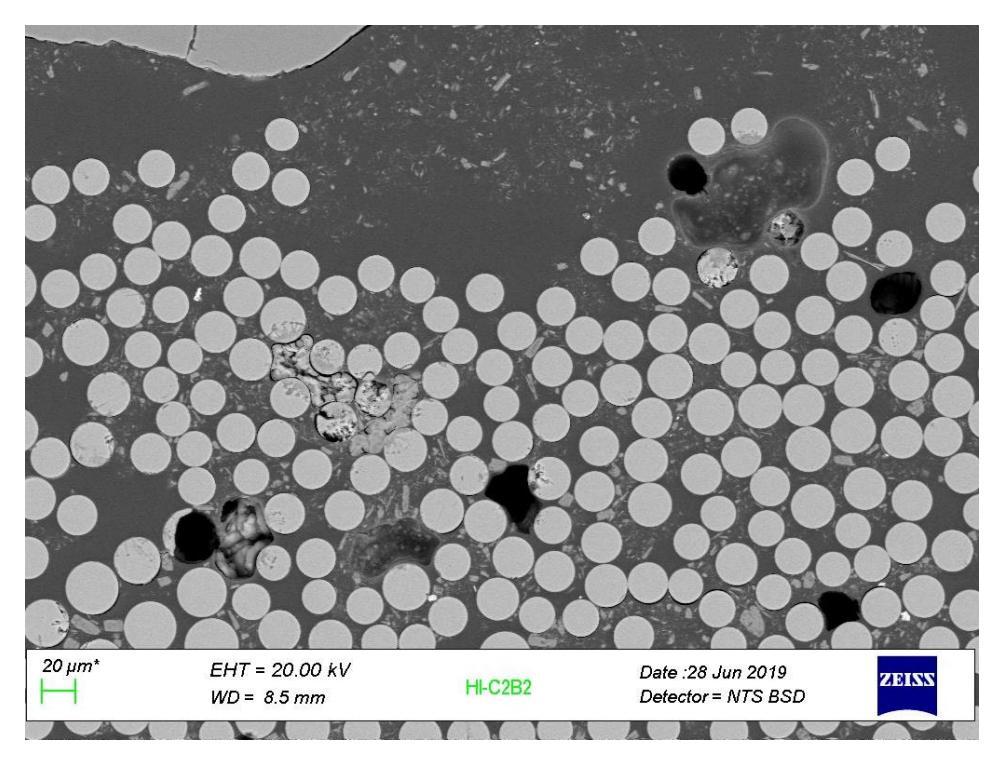
Fig. 46 – Core #2 Bar #2 at edge. Some voids and fiber damaged observed.

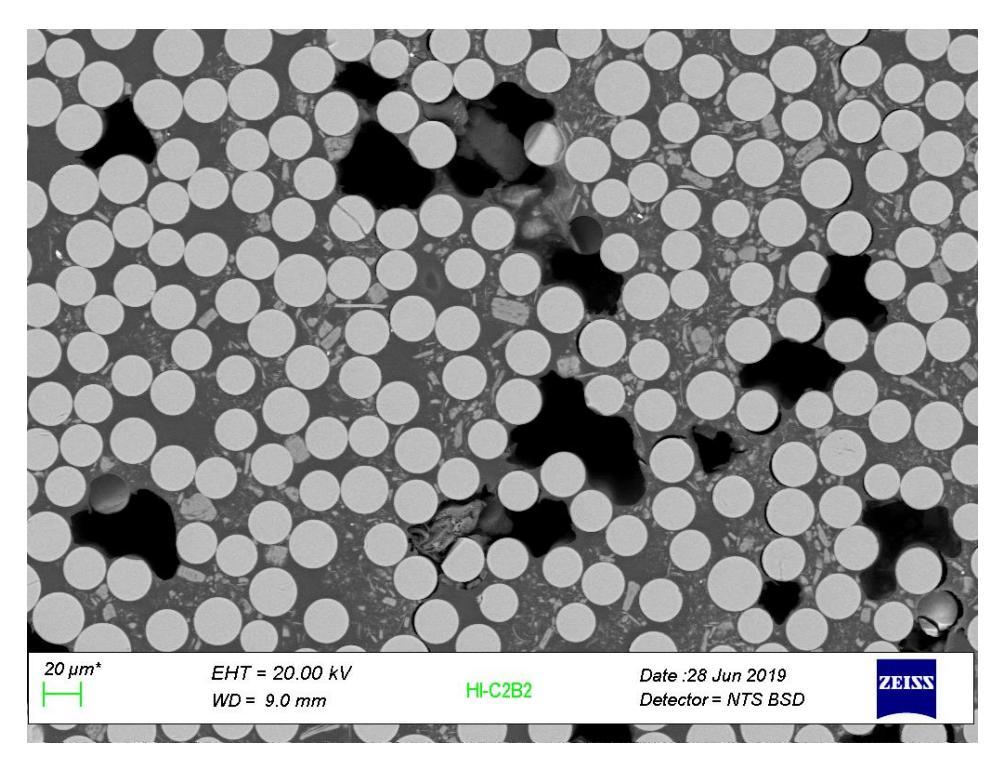
*Fig.* 47 – *Core* #2 *Bar* #2 *at the inner edge. Some resin voids and minor fiber damage.*

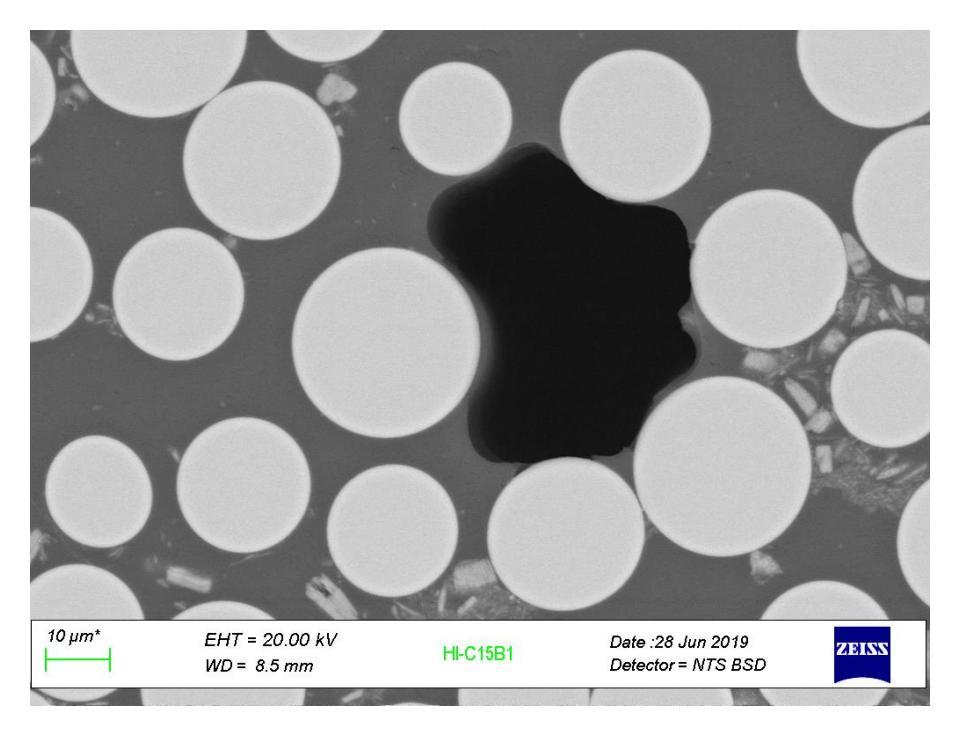
Fig. 54 –Core #15 Bar #1 at edge. Void in resin observed.
