**DEVELOPMENT OF ANCHORAGE SYSTEM FOR FRP
STRENGTHENING APPLICATIONS USING INTEGRATED FRP
COMPOSITE ANCHORS**

Geoffrey N. McGuirk and Sergio F. Breña

Department of Civil and Environmental Engineering
University of Massachusetts Amherst

Report submitted to the
Concrete Research Council of the
ACI Foundation

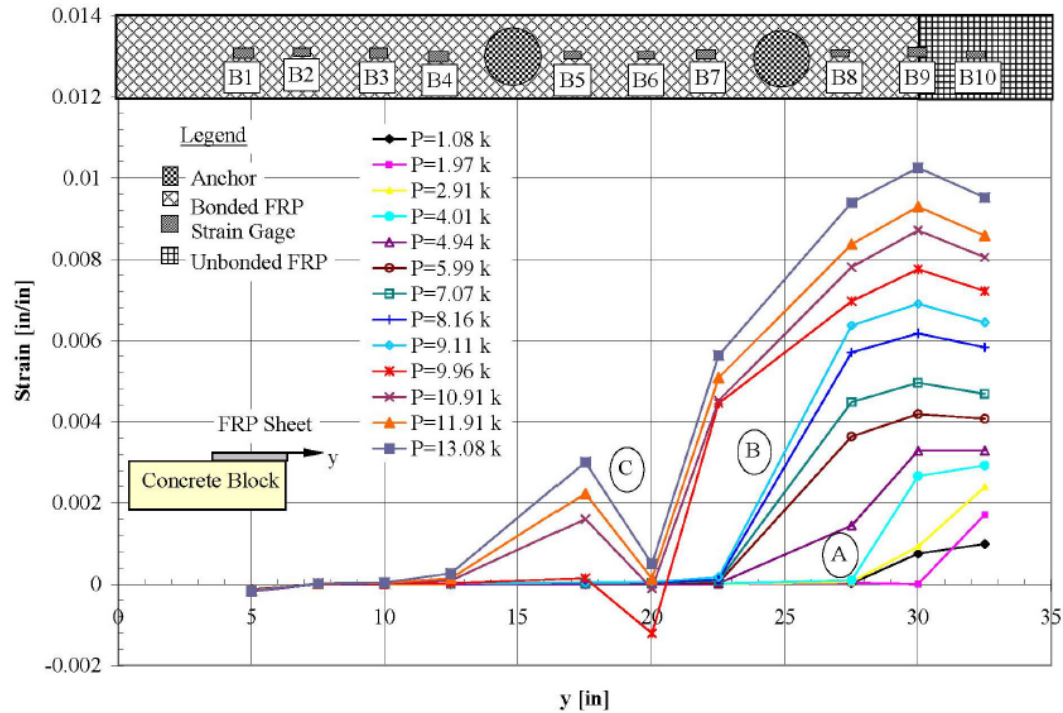
Figure 2.9 Longitudinal strain distribution of anchored FRP sheet (Niemitz, 2008)

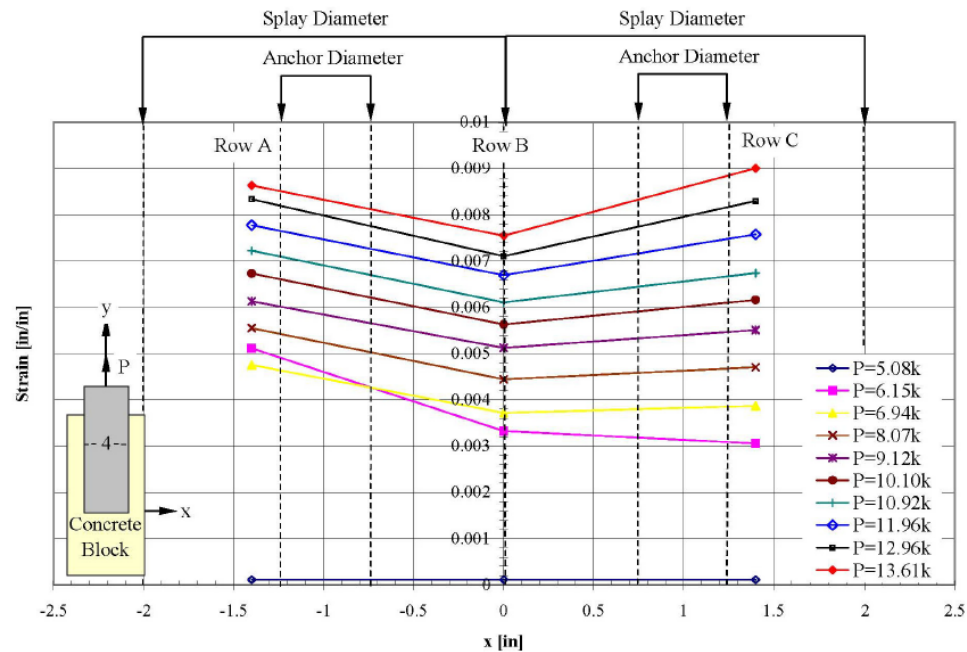
Figure 2.11 Transverse Distribution of Strain Across FRP Sheet Width (Specimen B-X-2-5-4, Niemitz, 2008)

by comparing Figure 2.10 with Figure 2.11. Figure 2.10 shows the transverse strain profile for a sheet with a single anchor in the center. As expected, the strains are significantly higher in front of the anchor. Figure 2.11 shows the strain profile for a sheet with two transversely spaced anchors. Contrary to the sheet with one anchor in the middle, the strain is lowest in the center of the sheet; but like the sheet with one anchor, the strain is highest in line with the anchors.

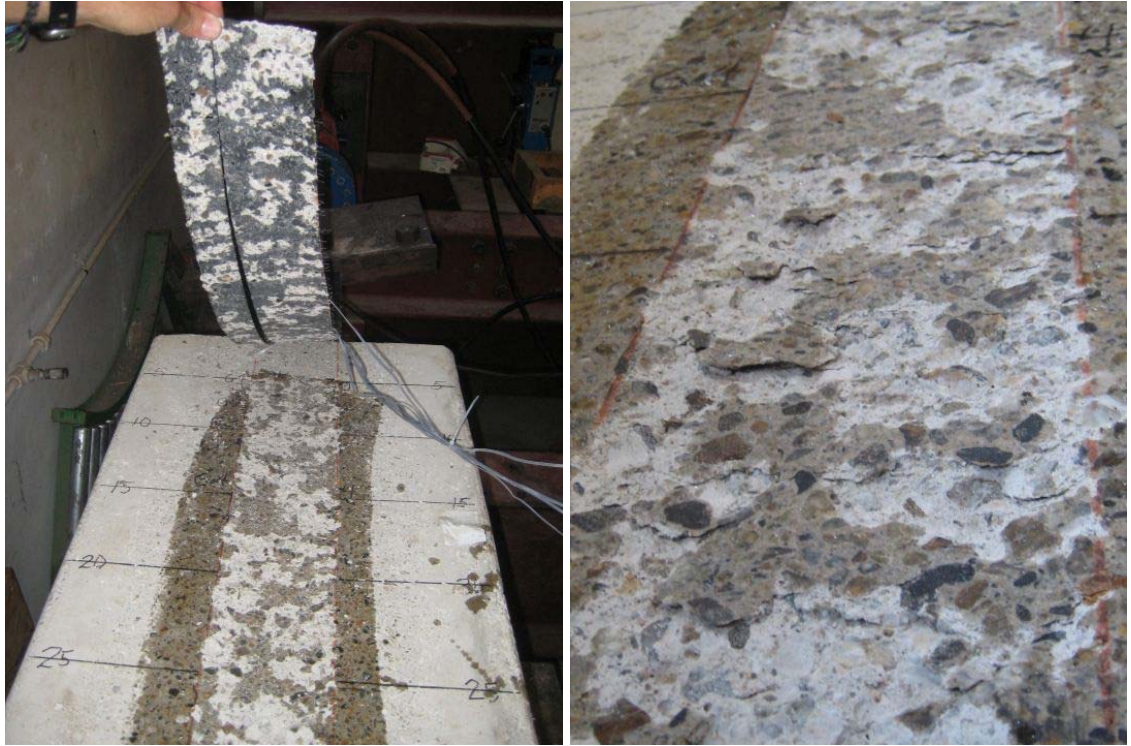
(a) (b)
Figure 4.4 Specimen S1-0a-24 after failure

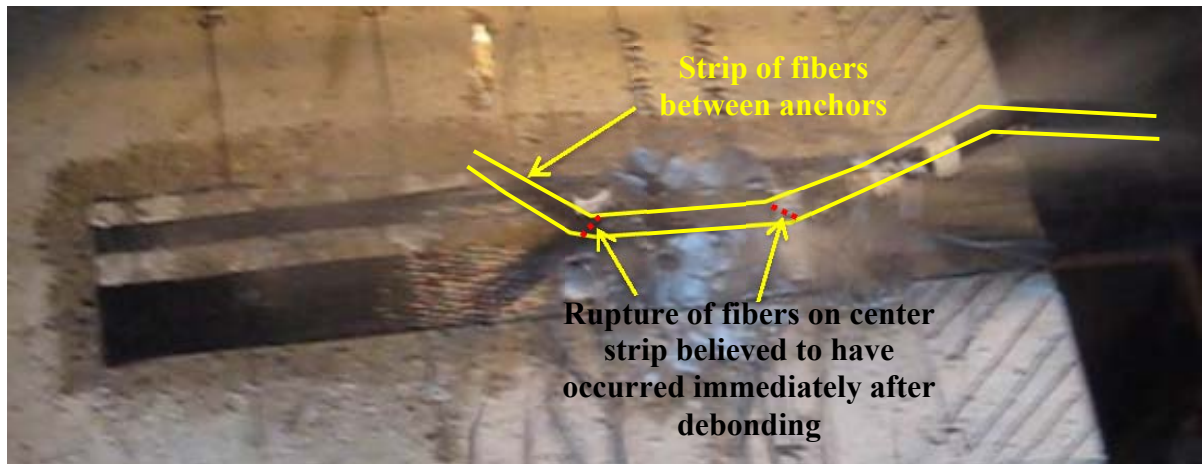
Figure 4.9 First frame from test video of specimen S1-4a-1-24 showing failure
