# **Durability of GFRP Bars Extracted from Bridges with 15 to 20 Years of Service Life** June 1, 2019

# DURABILITY OF GFRP BARS EXTRACTED FROM BRIDGES WITH 15 TO 20 YEARS OF SERVICE LIFE

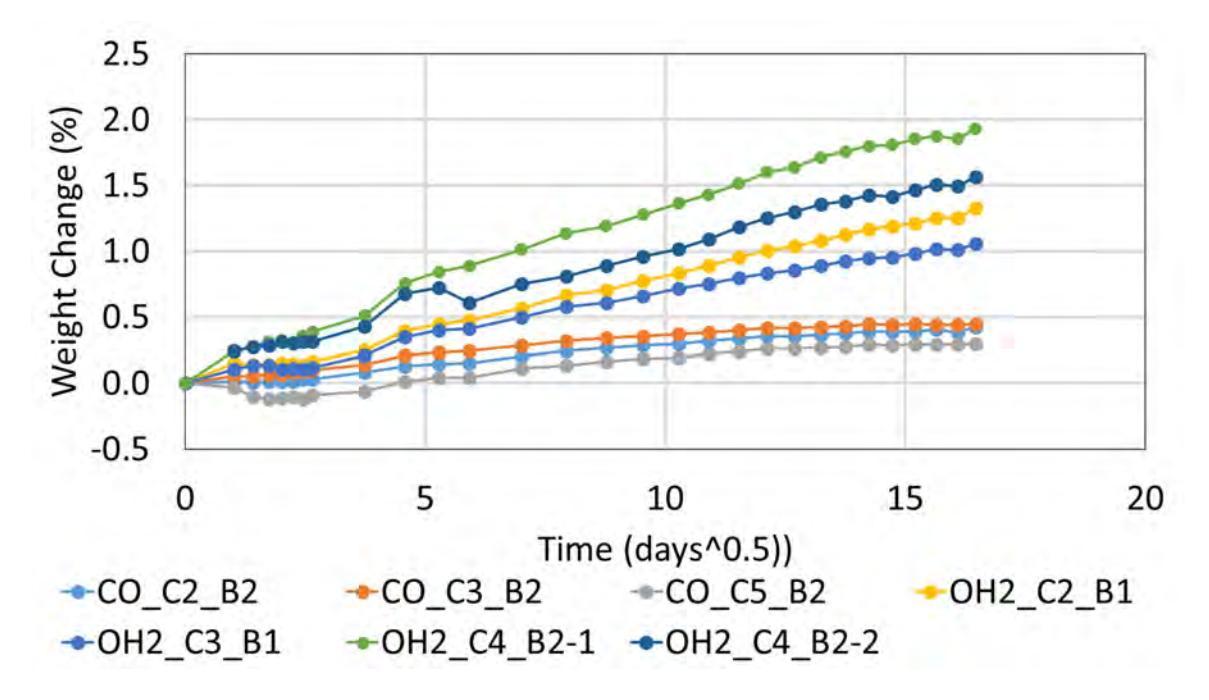
For Cuyahoga and O'Fallon Park bridges, long-term data of moisture uptake and weight gain at equilibrium were analyzed. Percent weight changes for the O'Fallon and Cuyahoga bars up to Dec. 15, 2018 (271 days) are shown on a log time scale in *Fig.* 46. By 259 days, all bars had met the ASTM D570 equilibrium condition of less than 5 mg  $(1.1 \times 10^{-5} \text{ lb})$  average weight gain per two-week period over the last three bi-weekly measurement intervals. Table 10 lists the weight gains at equilibrium and at the last measurement (271 days). The average weight gain for the O'Fallon bars at saturation is 0.30%, which is much less than the 1% qualification limit established in ASTM D7957 for the same test conditions.

*Fig.* 46–*Graph of Cuyahoga and O'Fallon moisture uptake versus square root of time for exposure to* 122°*F* (50°*C*) *distilled water*

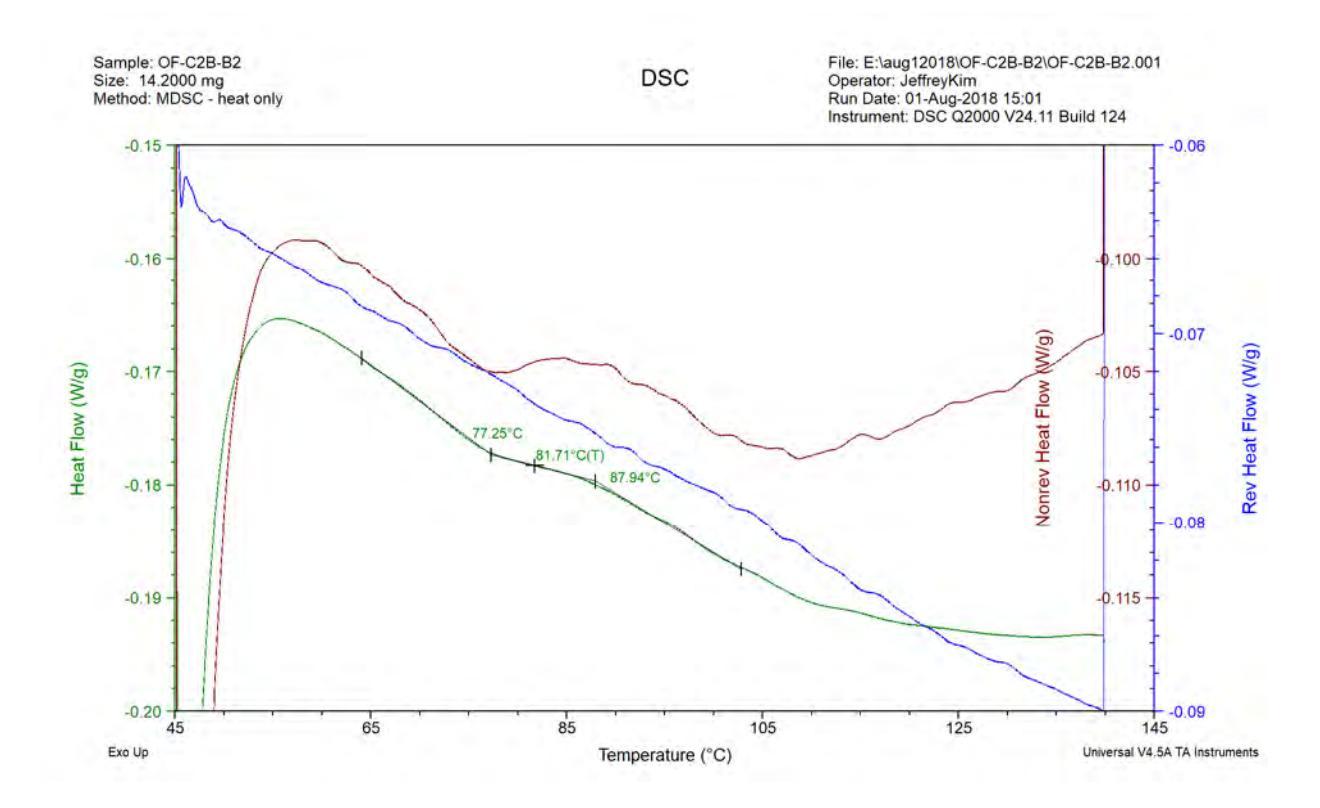
The lowest  $T_g$  was 176°F (80°C) for O'Fallon Park Bridge and the highest was 239°F (115°C) for Sierrita de la Cruz Creek. It should be kept in mind that bars from Sierrita de la Cruz Creek were analyzed using DMA rather than DSC. According to the ASTM D7957 GFRP bar specification, the  $T_g$  is required to be equal to or greater than 212°F (100°C) as a critical parameter in load transfer capability of the resin.

Fig. 48–Example differential scanning calorimetry curve for determining  $T_g$  on a bar from the O'Fallon bridge

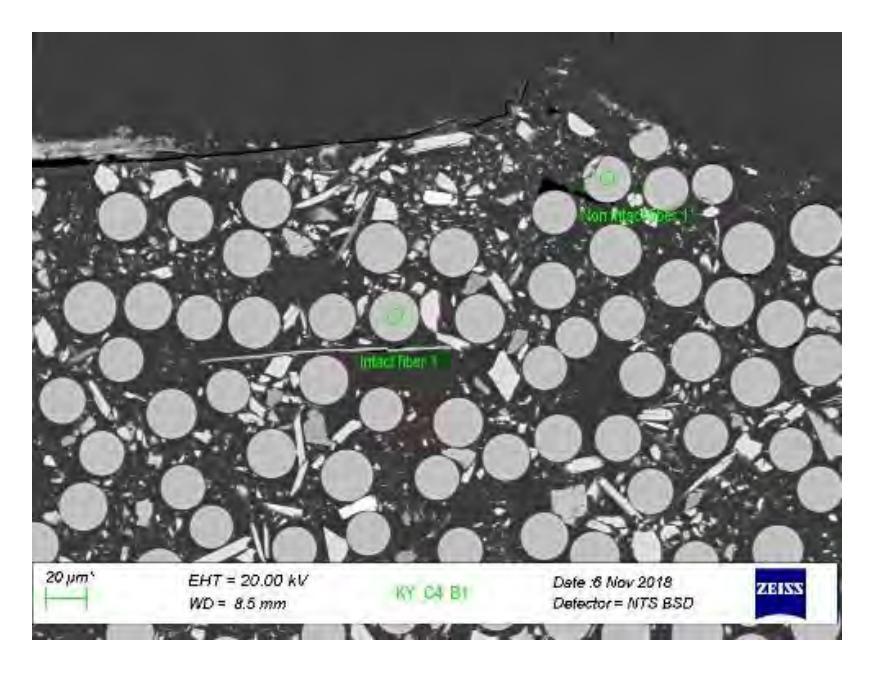
Some bars from McKinleyville and Roger's Creek bridges presented physical damage on fibers on the outer edge of the rebar. This physical damage is likely due to the specimen preparation procedure (saw cutting and polishing). The damaged fibers were typically located near a void in the resin matrix. See section 1.6 and 1.8 in Appendix V.

Fig. 50–Sample from Roger's Creek Bridge - few fibers may be negatively affected by concrete exposure

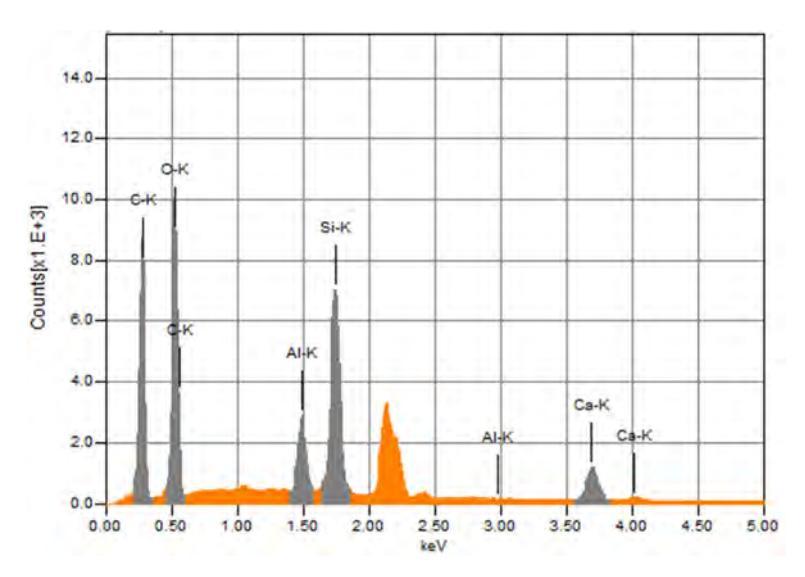
The results of EDS analysis showed the predominance of Si, Al, Ca (from glass fibers) and C (from the matrix) chemical elements in the extracted samples. No change in elemental distribution was found between central fibers and non-intact fibers. *Fig. 51* shows the result of EDS in samples from Walker Box Culvert Bridge.

Fig. 51–Result of the EDS analysis performed on GFRP samples extracted from Walker Box Culvert Bridge

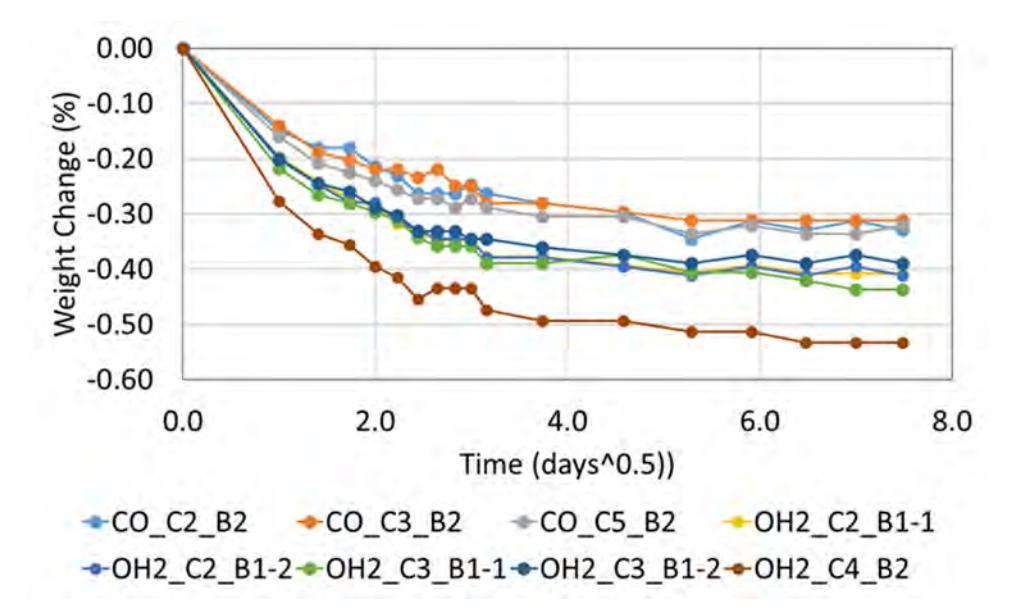
Fig. 52–Weight change versus the square root of drying time, in 176°F (80°C) circulating oven air for Cuyahoga and O'Fallon bridges

The weight changes at equilibrium, as a percent of weight before the drying procedure, are listed in Table 13. Overall, the weight losses from the dry-out procedure ranged from 0.31% to 0.53%. Upon conversion of these results to weight gains from a substantially dry initial state, the asreceived moisture content of these bars due to field exposure likewise ranged from 0.31% to 0.53%. The moisture content of the bars during the several months' time between when the bars were extracted from the bridges to when they were tested could be affected by the environment in which they were stored.
Specimen ID	% Weight Change
CO_C2B_B2	-0.329
CO_C3_B2	-0.312
CO_C5_B2	-0.320
OH2_C2_B1-1	-0.408
OH2_C2_B1-2	-0.411
OH2_C3_B1-1	-0.436
OH2_C3_B1-2	-0.389
OH2_C4_B2	-0.533

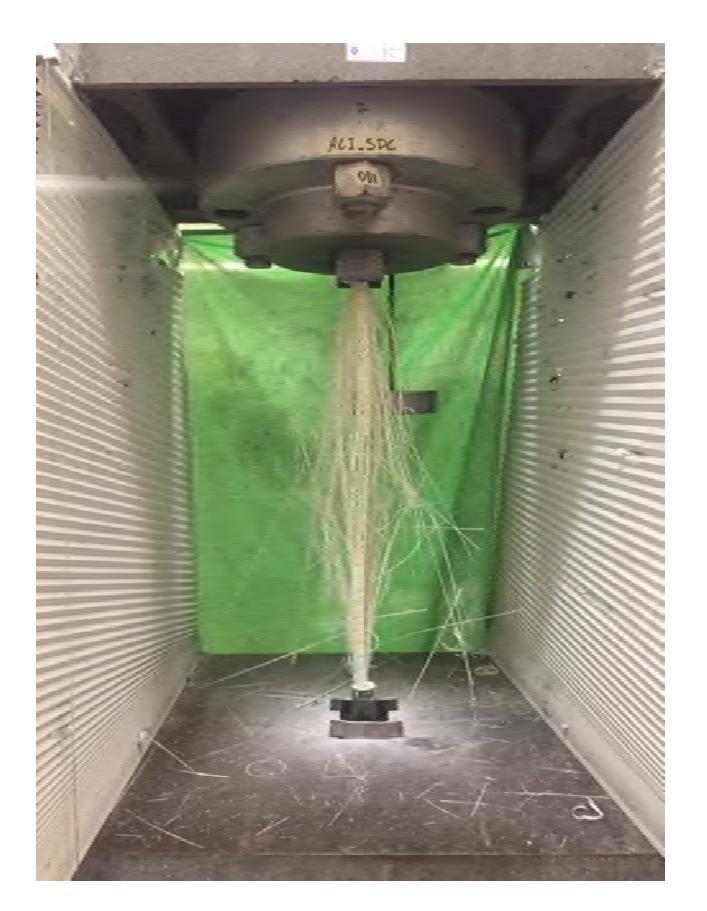
Ten #5 pristine bars were tested for tension capacity at the University of Miami as described in Section 4.1.8.2. The test set up is shown in Fig. 53 and the results of the test is shown in Table 19. The average peak load was 36,989 lbs. (164,535 N), which is similar the manufacture's specification dated 2002. The results of the tension test for each bar is shown in Appendix VI. All bars failed as shown in Fig. 54.

Fig. 54–Pristine GFRP tension failure

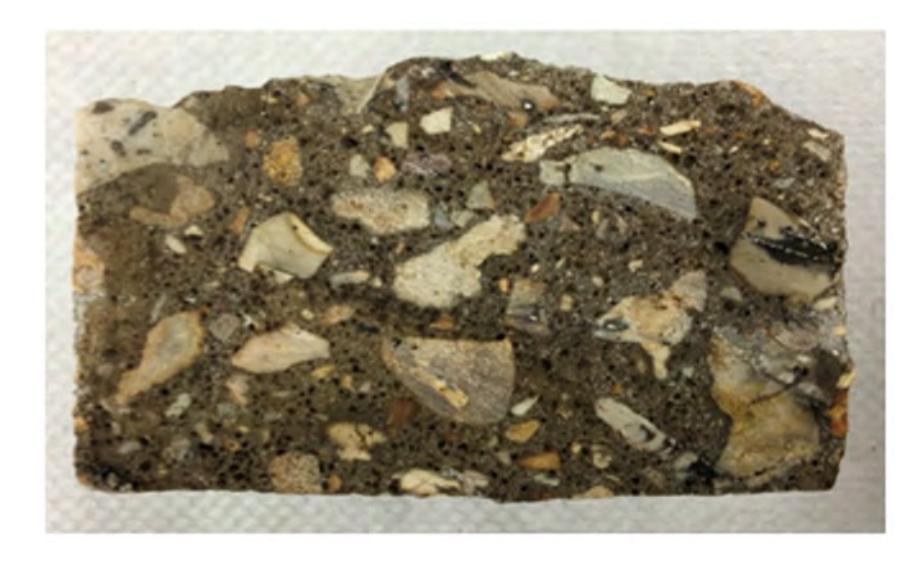
Fig. 56–Southview Bridge sample with no visual chloride penetration

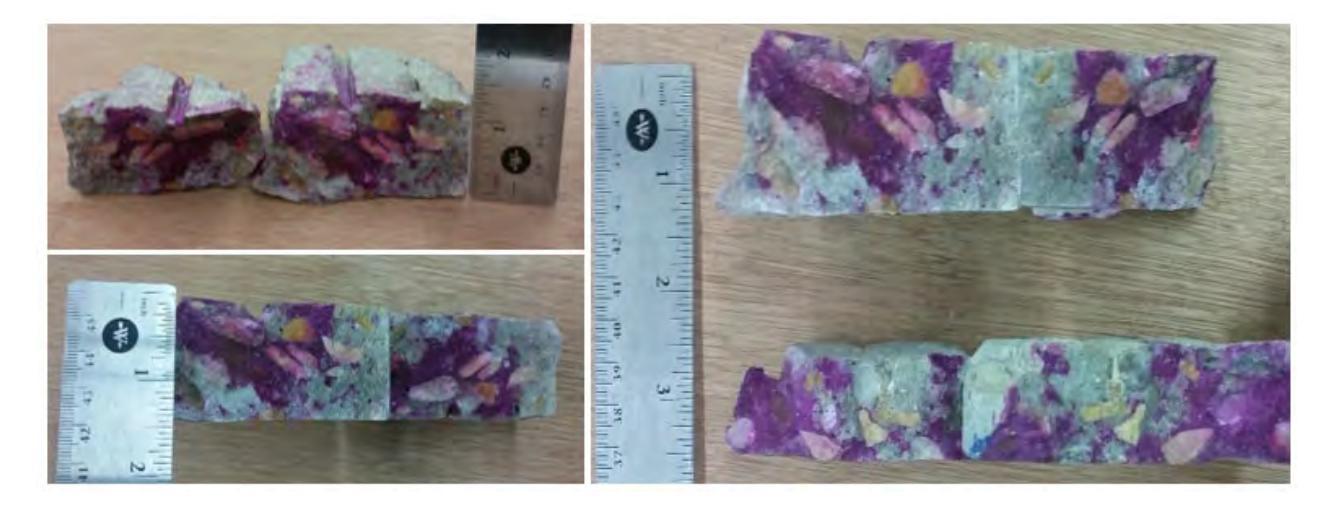
All 11 bridges were tested for carbonation depth. The purple zone indicated no carbonation and the white zone indicates the carbonation depth. Most samples presented some carbonation near the surface, but others presented no carbonation at all. Sierrita de la Cruz Creek Bridge, however, presented significant depth of carbonation reaching near the core of the sample. The samples from Sierrita de la Cruz Creek Bridge tested for carbonation are shown in Fig. 57. Fig. 58 shows an example where carbonation happened near the surface for the case of Cuyahoga Bridge.

Fig. 57–Sierrita de la Cruz Creek Bridge carbonation depth

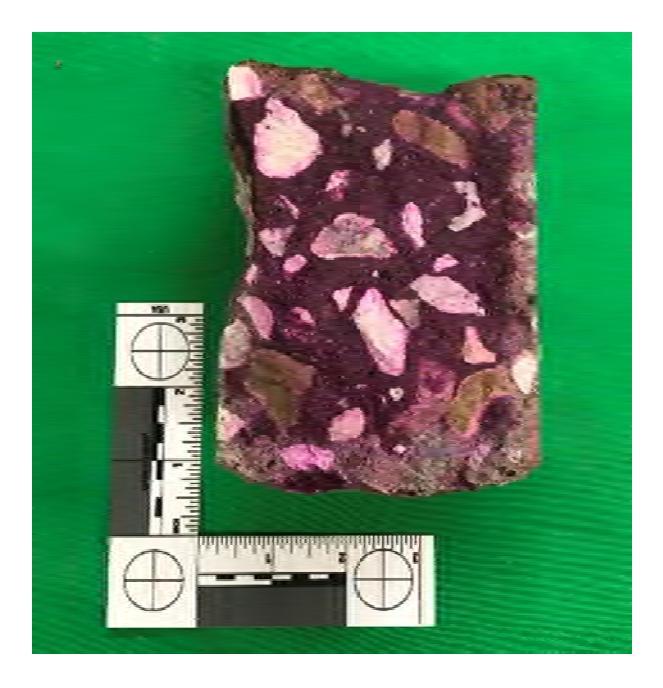
Fig. 58–Cuyahoga Bridge carbonation depth near the surface (deck)

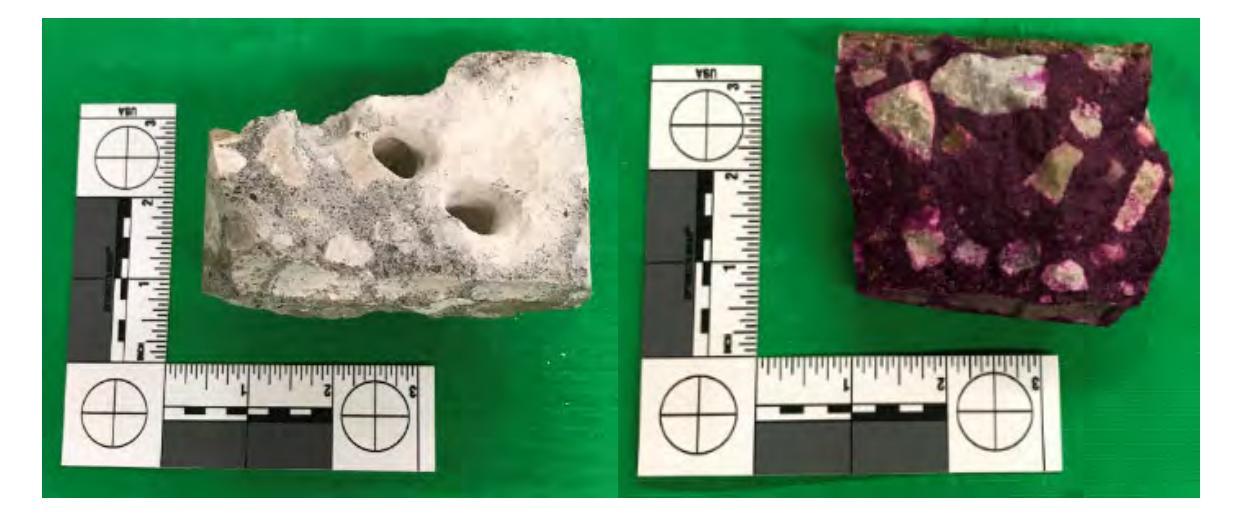
The pH of the samples varied between 9 and 13. The lowest average pH for was 10 for Roger's Creek and McKinleyville Bridge, while the highest average pH was 12.2 for Cuyahoga and Gills Creek Bridge. The average results for each bridge can be observed in Table 23. *Fig. 59* shows a sample tested with phenolphthalein indicator solution for Cuyahoga Bridge and *Fig. 60* its corresponding pH based on color range.

Fig. 59-Cuyahoga Core 4 pH test with phenolphthalein

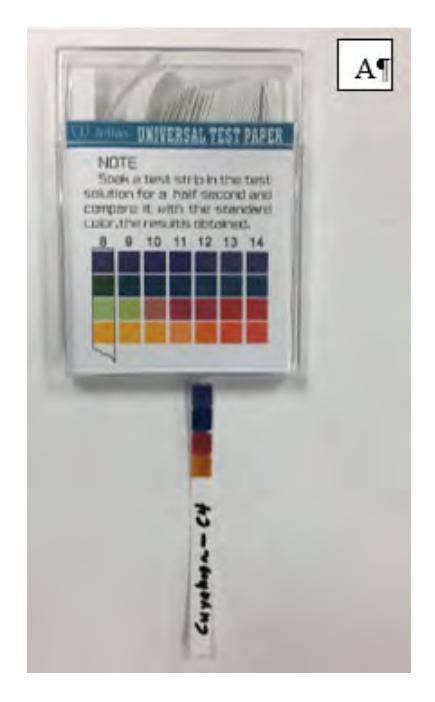
Fig. 60-pH color range for Cuyahoga core 4

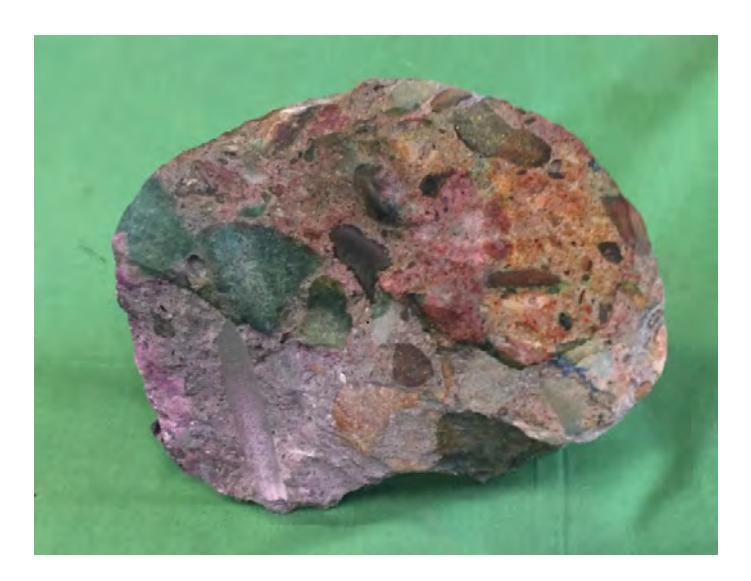
Fig. 61–McKinleyville pH range using the rainbow indicator

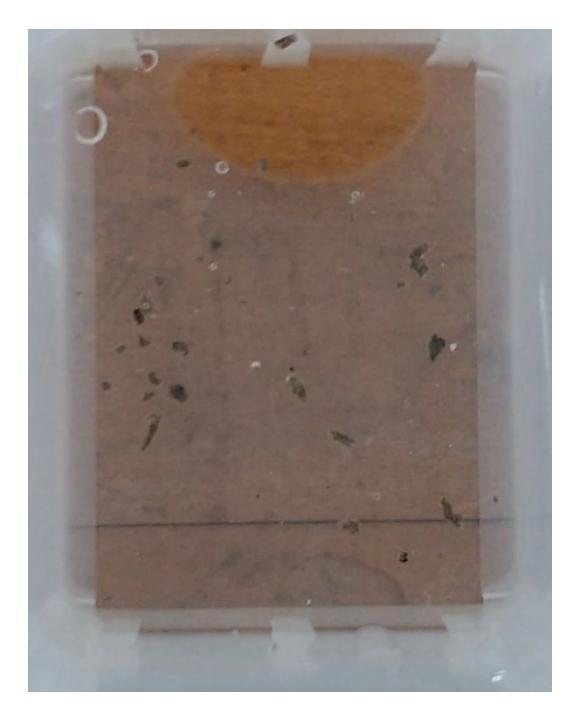
During uptake testing, one specimen lost weight between some of the measurements. Fig. 6 displays the causes for the loss in weight. CO\_C5\_B2 lost many small sand particles over the first two weeks.

Fig. 6. Sand particles at the bottom of the immersion chamber of CO\_C5\_B2

Congruently with the weight loss observed in dry-out tests, the average weight gain of the *O'Fallon* bars is about 0.388%. The CO\_C5\_B2 specimen has less weight gain than the other *O'Fallon* specimens due to the loss of many sand particles as mentioned earlier.

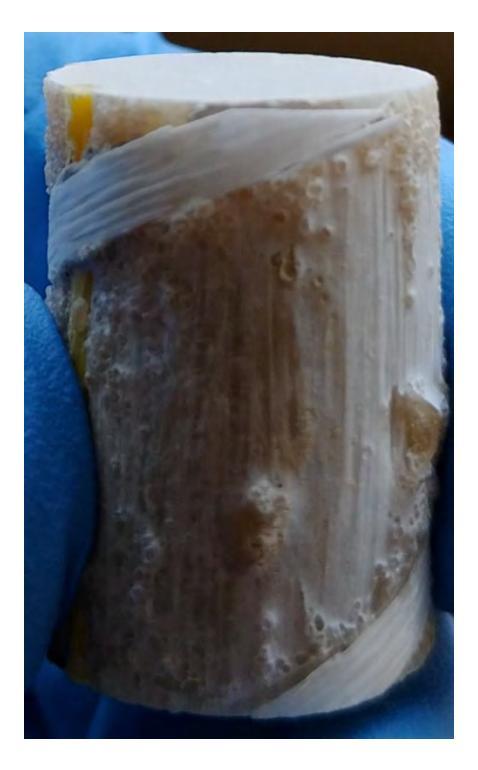
During moisture absorption testing, OH2\_C4\_B2(2) lost weight between some of the measurements. Between 28 and 35 days into uptake testing, lost a large piece of helical wrap. Fig. 8 displays the cause for this loss in weight.

Fig. 8. Part of the helical wrap fell off of OH2\_C4\_B2-2

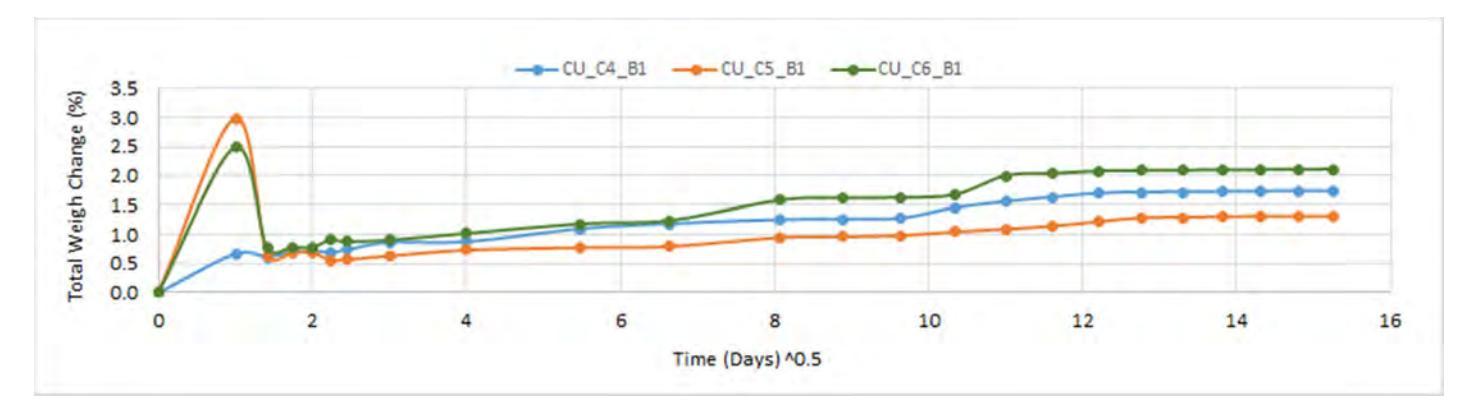
According to ASTM D570, any observation as to warping, cracking or change in appearance of the specimens should be reported. Between 30 and 44 days into uptake testing, CU\_C4\_B1 and CU\_C6\_B1, lost a little piece of helical wrap around 7 mg and 5 mg respectively. In addition to

losing a piece of helical wrap, some residue was noticed in all of the specimens' containers after 6 weeks of testing.

Fig 9. Cuyahoga moisture uptake vs. square root of time - MST

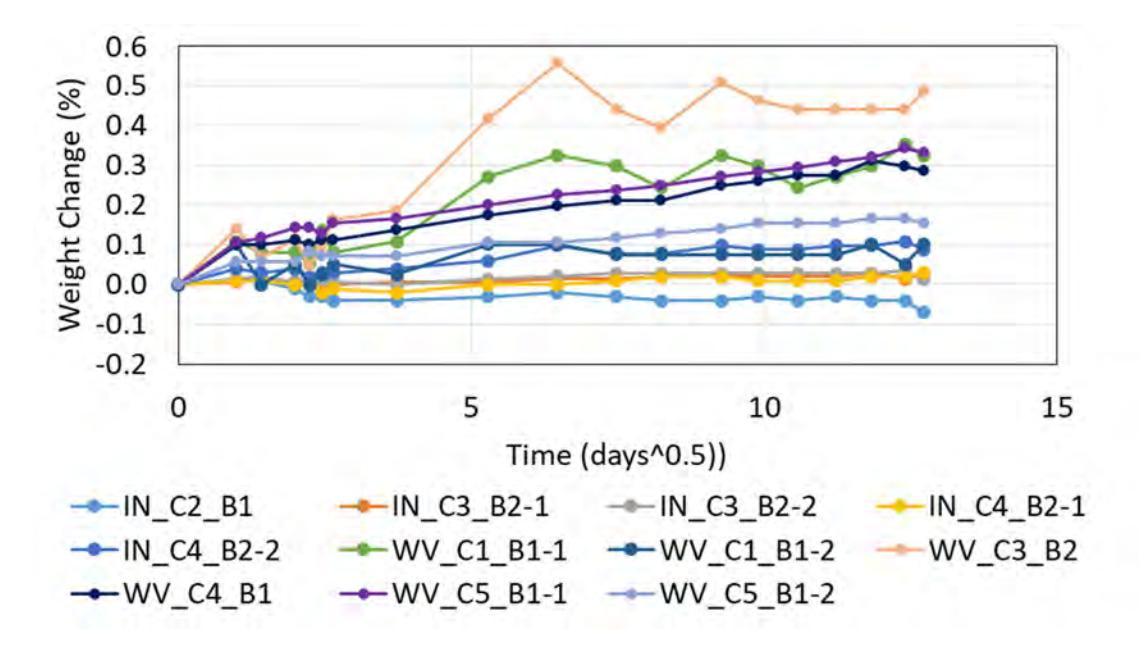
Water absorption tests for the *McKinleyville Bridge* were performed at the Penn State University, according to the procedure depicted in Section 4.1.2. Drying and measurement procedures are described in Appendix II. Percent weight changes for the *McKinleyville and Thayer* bars up to Mar. 9, 2019 (162 days) are shown on a square root of time scale in Fig. 10.

Table 26 lists the weight gains of the WV bars at 24 hours, at equilibrium, and at the last measurement (162 days). Equilibrium was reached in 56 days for the WV bars.

Fig. 10. Moisture uptake vs. square root of time for McKinleyville and Thayer bars - PSU

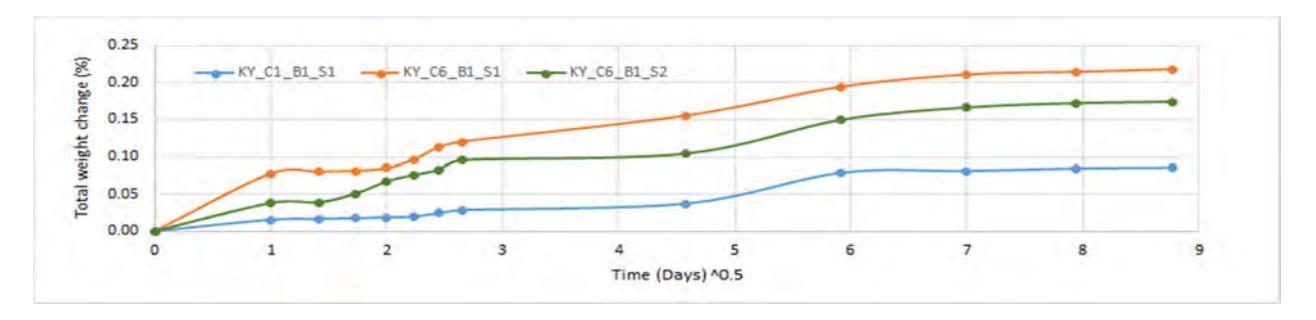
Three bars from Roger's Creek (KY) were tested for Moisture Absorption following the ASTM D570. The bars are: KY\_C1\_B1\_S1, KY\_C6\_B1\_S1, and KY\_C6\_B1\_S2. They reached moisture equilibrium at 77 days with a total change in weight of 0.16%, as seen in Fig. 11 and Table 28. There were no signs of delamination of wrapping or shedding some parts of the bar.

Fig. 11. Roger's Creek moisture uptake vs. square root of time - MST

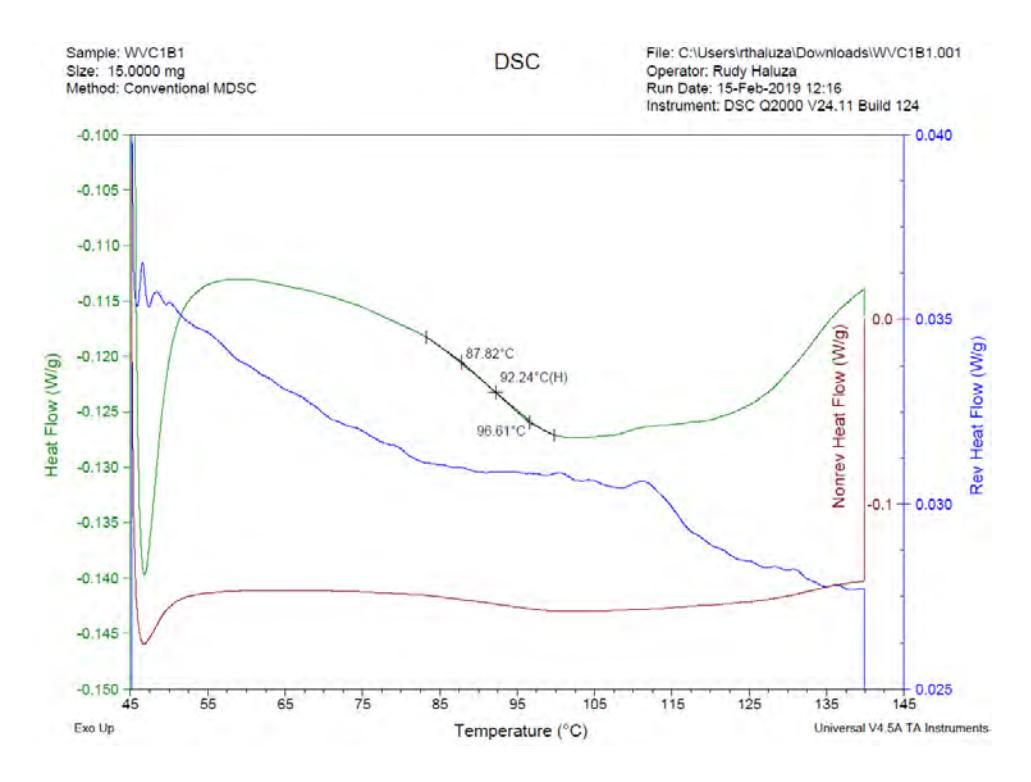
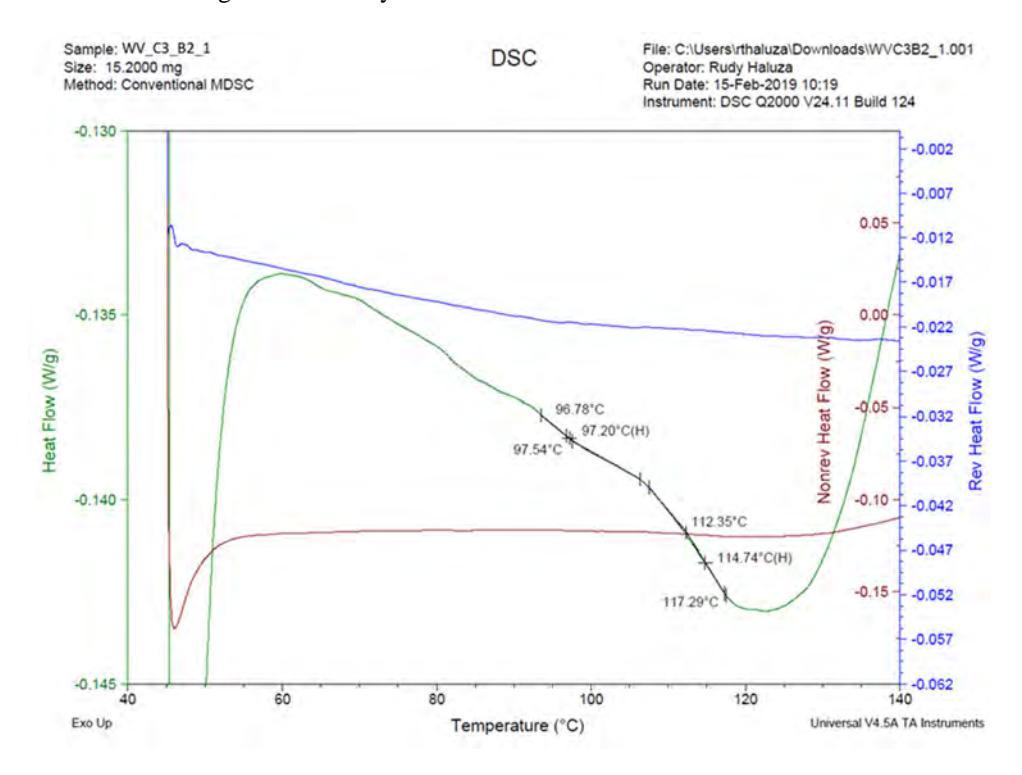
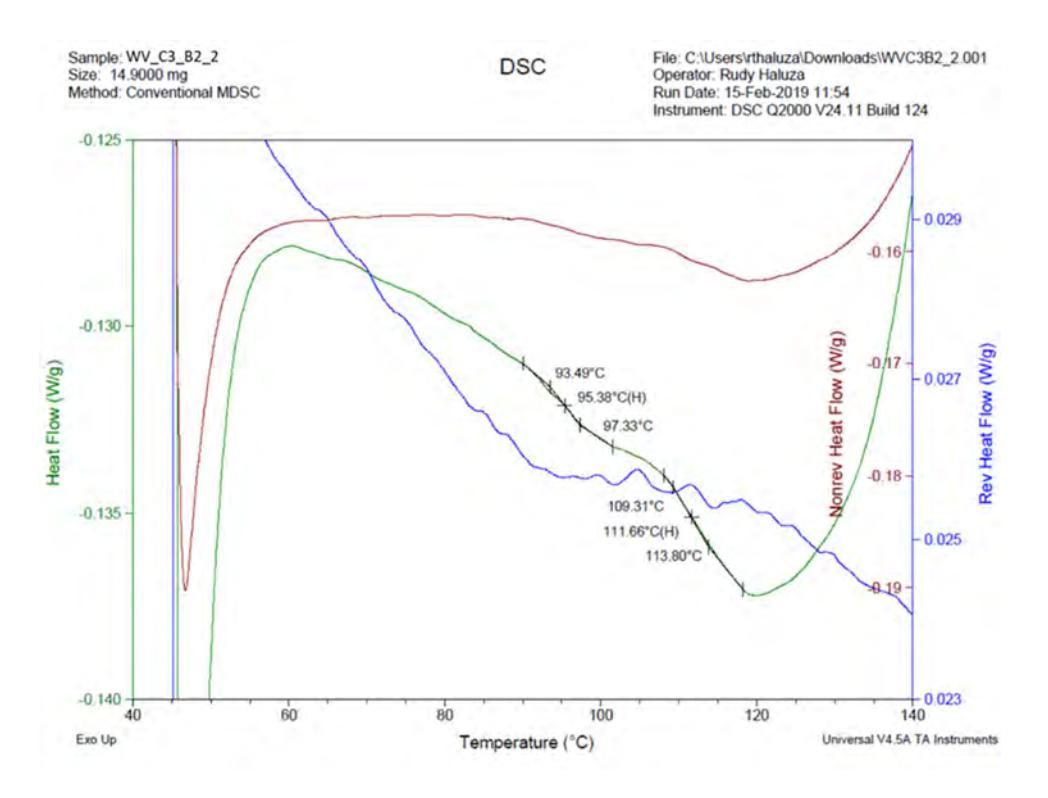
MDSC analysis of bars from the *McKinleyville Bridge* was performed at Penn State University using the procedure described in Section 4.1.4. The results are summarized in Table 50 and the graphical results for each bar are shown in Fig. 44 through Fig. 46. The *McKinleyville* bars displayed no discernable inflection point in the reversible heat flow curves, although nearly all of the total heat flow curves for these bars had two separate  $T_g$  values. The lower and upper  $T_g$  values are both reported for the bars in Table 50. Only the lower  $T_g$  average is reported in the main body of this report, as it is considered the more relevant one for bar performance. The lower  $T_g$  values to not satisfy the contemporary GFRP bar specification (ASTM-D7957-17, 2017) of 212°F (100°C), but the upper ones do.

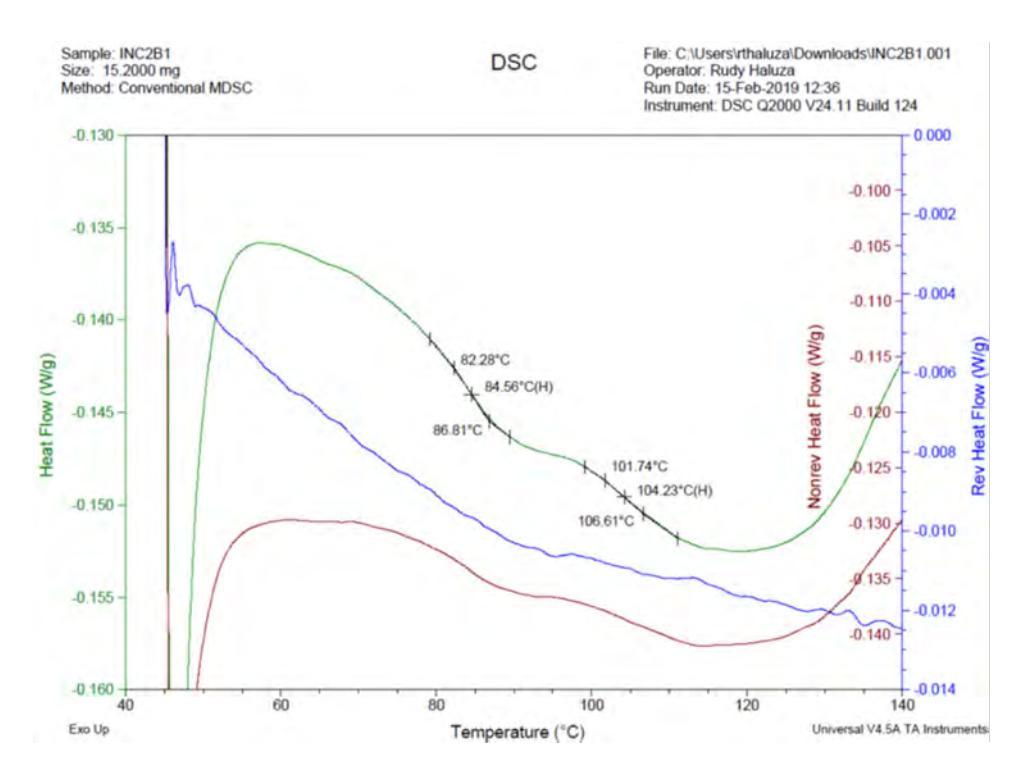
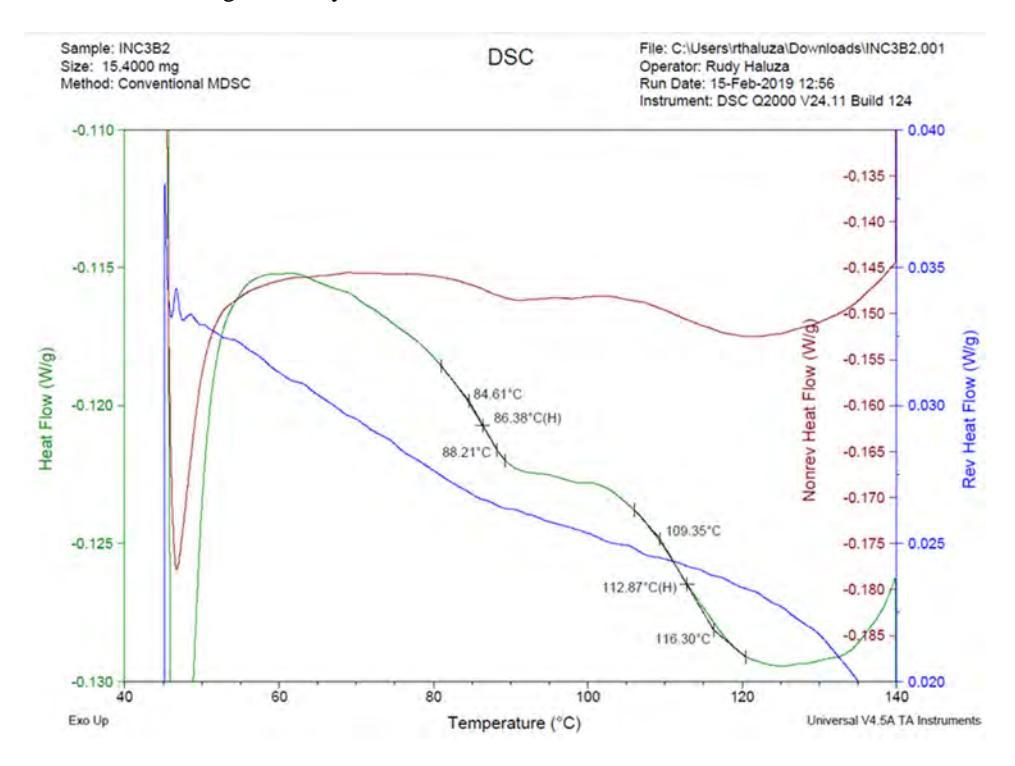
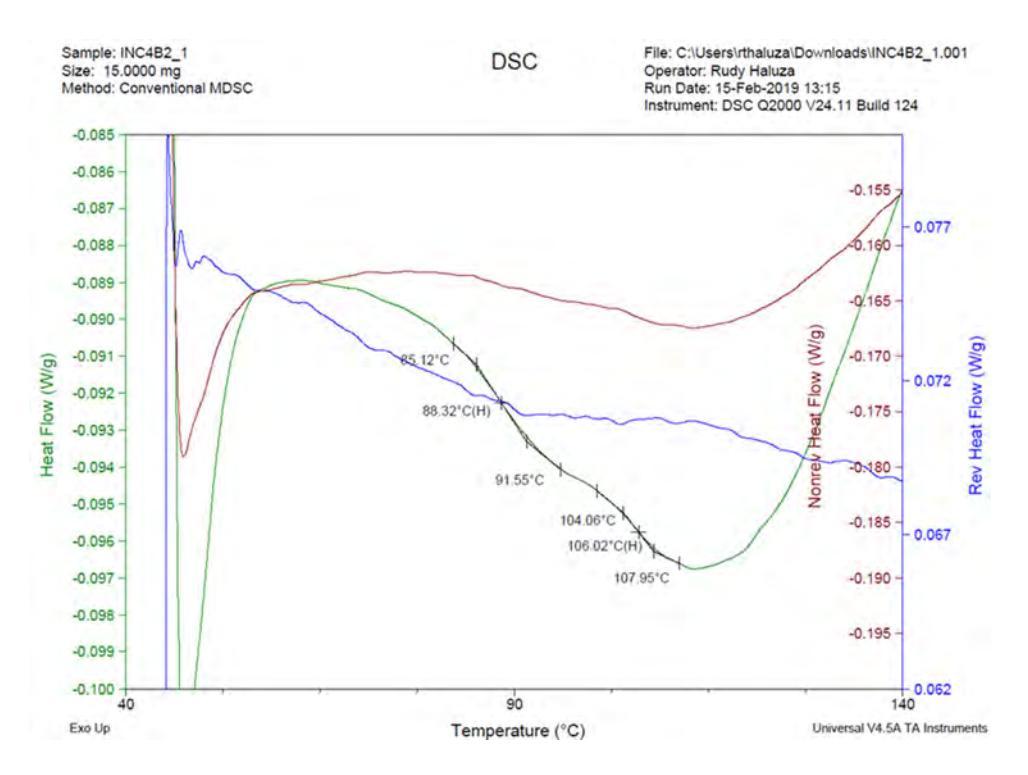
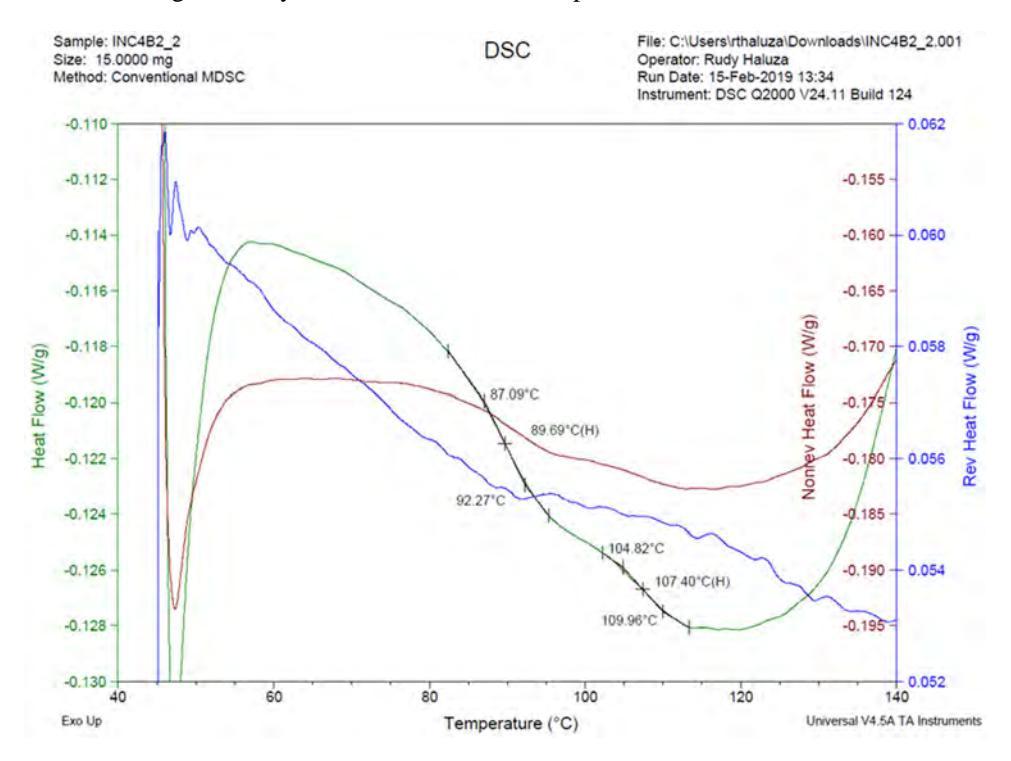
MDSC analysis of bars from the *Thayer Road Bridge* was performed at Penn State University using the procedure described in Section 4.1.4. The results are summarized in Table 51 and the graphical results for each bar are shown in Fig. 47 through Fig. 50. The *Thayer Road* bars displayed no discernable inflection point in the reversible heat flow curves, although all of the total heat flow curves for these bars had two separate  $T_g$  values. The lower and upper  $T_g$  values are both reported for the bars in Table 51. Only the lower  $T_g$  average is reported in the main body of this report, as it is considered the more relevant one for bar performance. The lower  $T_g$  values to not satisfy the contemporary GFRP bar specification (ASTM-D7957-17, 2017) of 212°F (100°C), but the upper ones do.

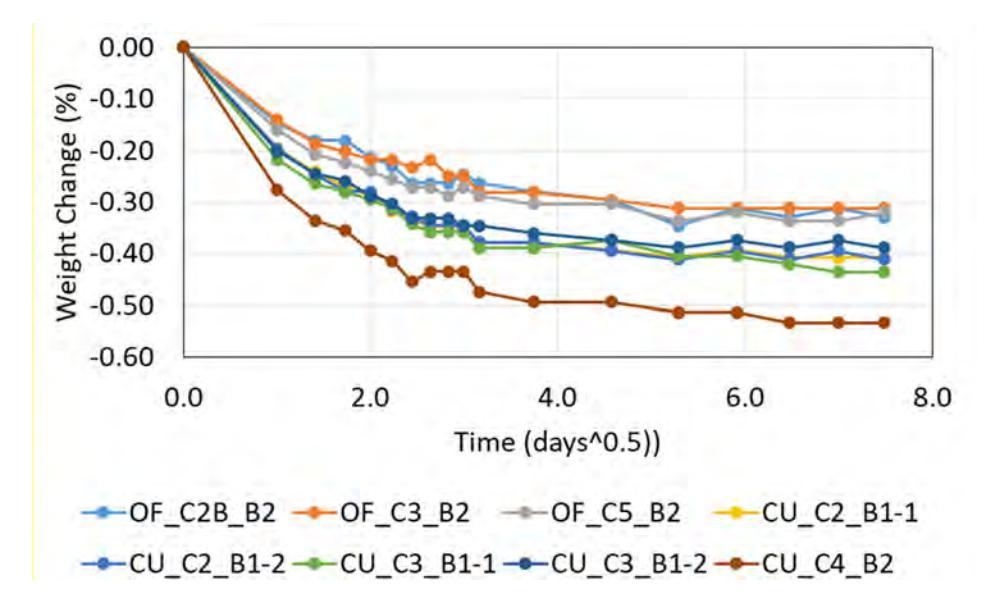
Fig. 51.O'Fallon (OF) weight change versus the square root of drying time, in 176°F (80°C) circulating oven air – PSU

Moisture content for *O'Fallon Park Bridge* was performed at Penn State University according to the method described in Section 4.1.6. All dry-out specimens reached equilibrium after 56 days at 176°F (80°C). A plot of percent weight loss versus the square root of time (in days) is shown in Fig. 51. The acronym used for the *O'Fallon Park Bridge* here is OF instead of CO. It can be seen that the weight loss is not monotonic. It is suspected that the deviations from monotonic weight loss are due to abnormal humidity conditions in the laboratory, although this possibility cannot be verified.

The *O'Fallon Bridge* bars had generally less as-received moisture (0.320%, on average) than the *Cuyahoga Bridge* bars (0.436%, on average). As a point of reference, ASTM D7957 (ASTM D7957, 2017) requires that GFRP bars absorb no more than 1% moisture at saturation at a temperature of 122°F (50°C).

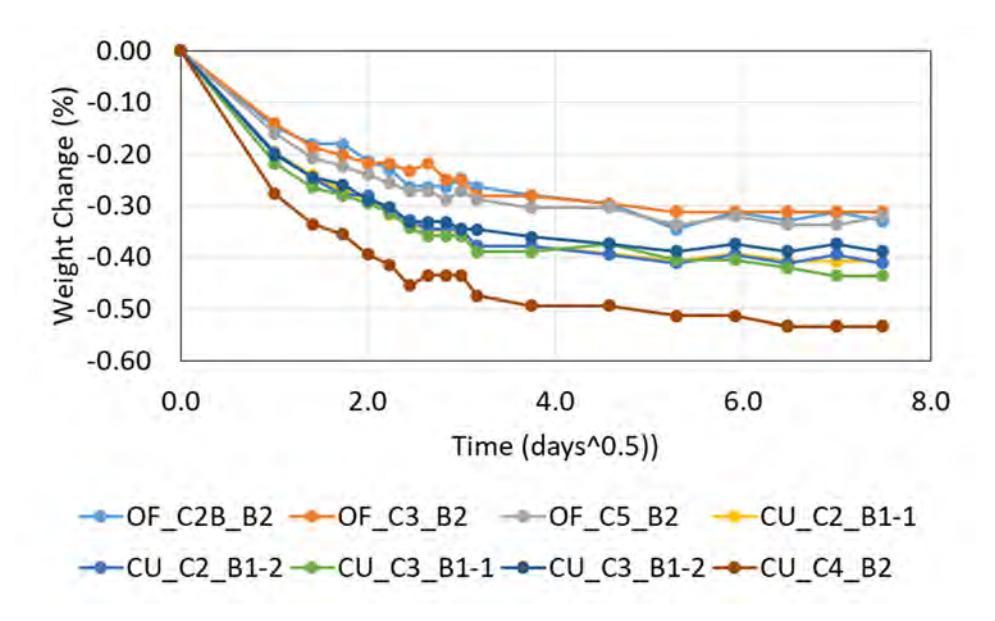
Fig. 52. Cuyahoga weight change versus the square root of drying time, in 176°F (80°C) circulating oven air - PSU

Moisture content for *Cuyahoga Bridge* was performed at Penn State University according to the method described in Section 4.1.6. All dry-out specimens reached equilibrium after 56 days at 176°F (80°C). A plot of percent weight loss versus the square root of time (in days) is shown in Fig. 52. The acronym used for *Cuyahoga Bridge* here is CU instead of OH2. It can be seen that the weight loss is not monotonic. It is suspected that the deviations from monotonic weight loss are due to abnormal humidity conditions in the laboratory, although this possibility cannot be verified.

It is noteworthy that the OH2\_C4\_B2 bar with the highest as-received moisture content of all tested bars is also the only smaller diameter (5/8 in. [16 mm]) bar of all bars tested. The other bars have a larger (3/4 in. [19 mm]) diameter, which according to theory leads to less weight gain/loss for a given immersion/dry-out time because of a larger moisture permeation path in the material.

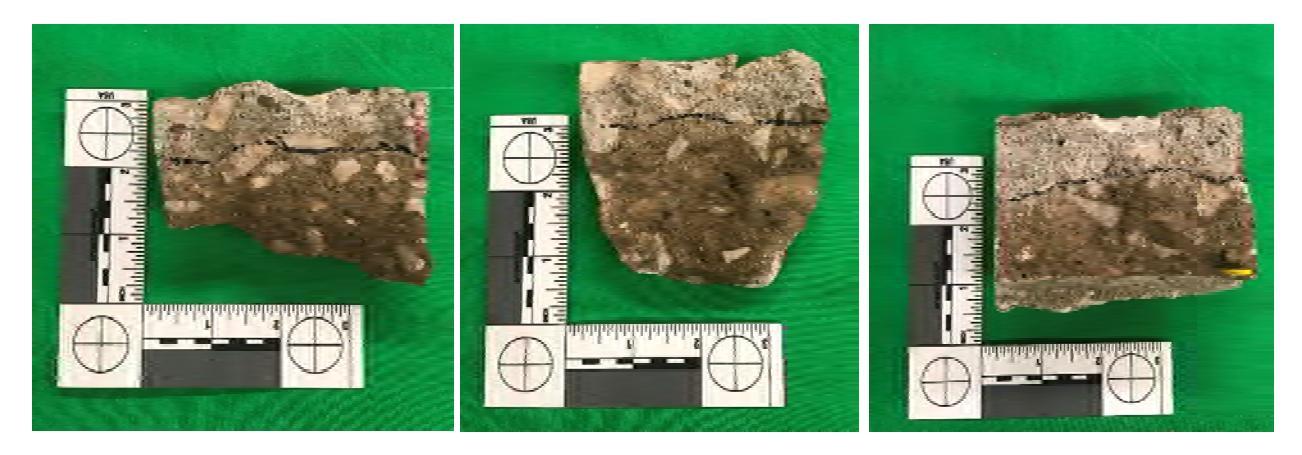
Fig. 1. Bettendorf chloride penetration samples

Chloride penetration depth was determined for three concrete samples from the *Bettendorf Bridge*. The chloride penetration appears to be approximately 1-in. from the exposed face of the concrete, as shown in Fig. 1.

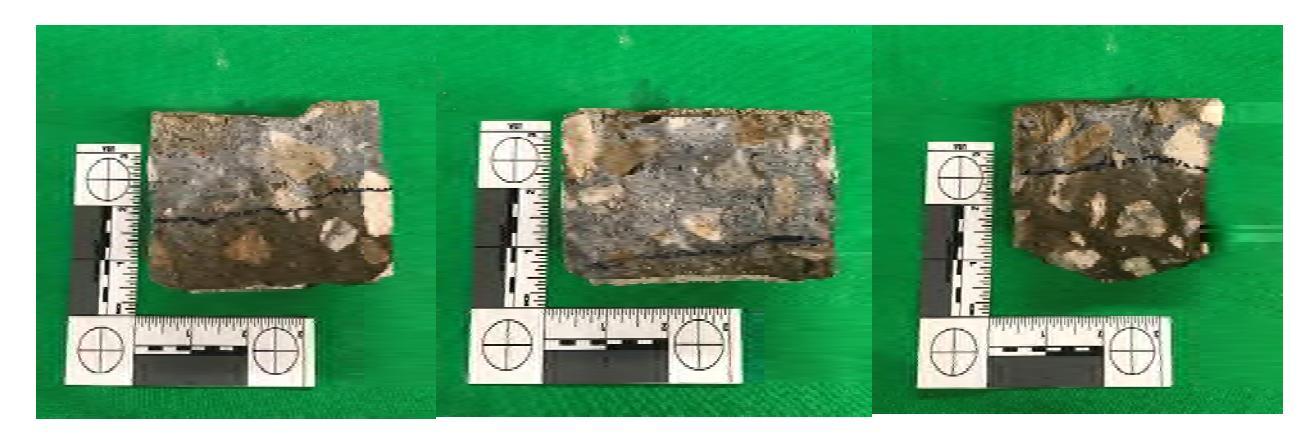
Fig. 2. Cuyahoga chloride penetration samples

Chloride penetration depth was determined for three concrete samples from the *Cuyahoga Bridge*. The chloride penetration varied from approximately 1-in to 2.5-in from the exposed face of the concrete, as shown in Fig. 2.

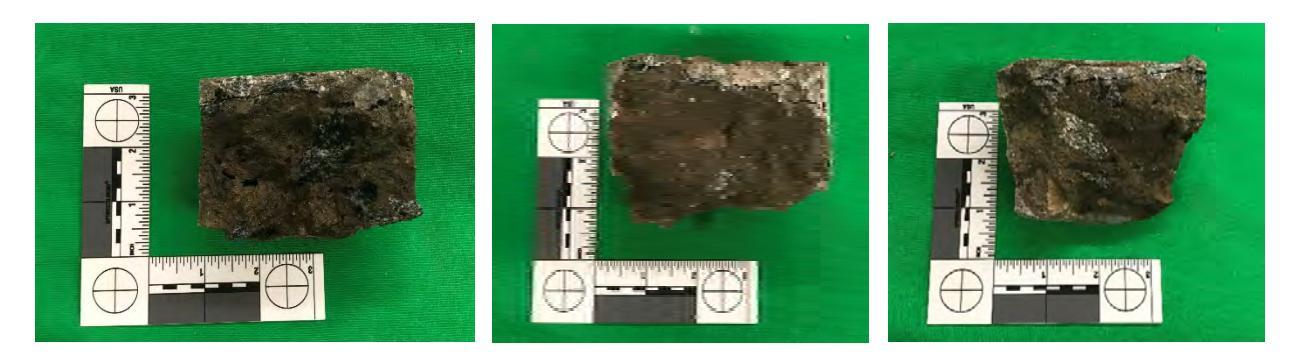
Fig. 3. Gills Creek chloride penetration samples

Chloride penetration depth was determined for three concrete samples from the *Gills Creek Bridge*. The chloride penetration for Gills Creek was small, less than 0.5-in from the exposed face of the concrete, as shown in Fig. 3.

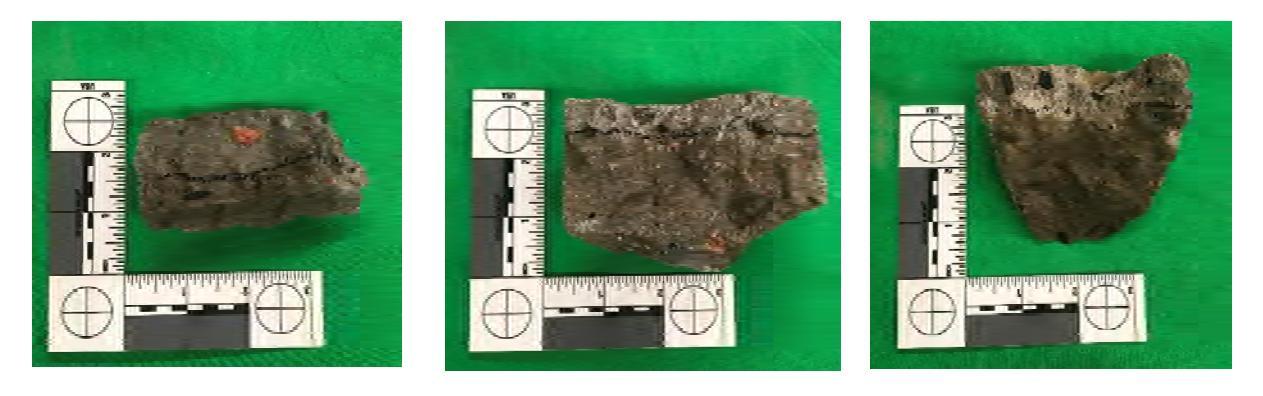
Fig. 4. O'Fallon Park chloride penetration samples

Chloride penetration depth was determined for three concrete samples from the *O'Fallon Park Bridge*. The chloride penetration depth for *O'Fallon Park Bridge* appears to be less than 1-in from the exposed face of the concrete, as shown in *Fig. 4*.

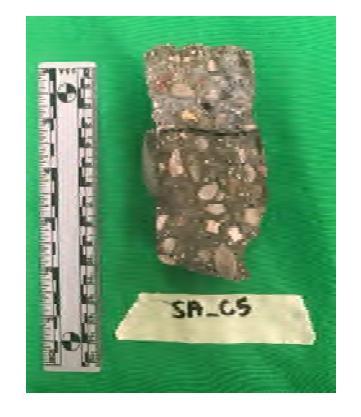
Fig. 5. Salem Ave chloride penetration sample

Chloride penetration depth was determined for one concrete sample from the *Salem Ave Bridge*. The chloride penetration was approximately 1.5-in. from the exposed face of the concrete, as shown in *Fig. 5*.

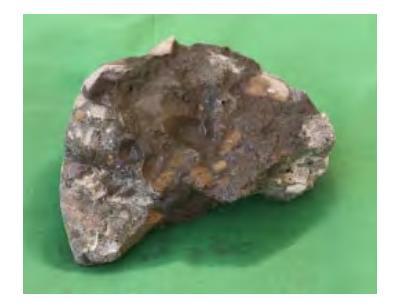
Fig. 6. McKinleyville chloride penetration sample

Chloride penetration depth was determined for one concrete sample from the *McKinleyville Bridge*. Chloride penetration was observed on the very close to the exposed face of the concrete, approximately less than 1-in., as shown in the Fig. 6.

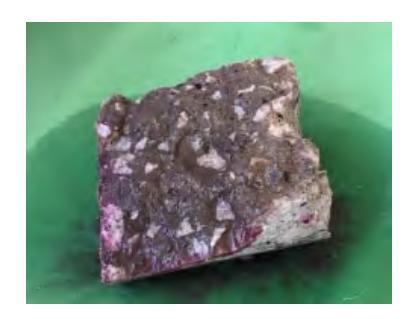
Fig. 7. Thayer Road chloride penetration sample

Chloride penetration depth was determined for one concrete sample from the *Thayer Road Bridge*. Minor chloride penetration appeared near the face of the exposed concrete face, as shown in the *Fig. 7*.

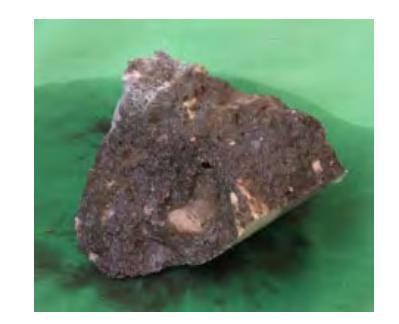
Fig. 8. Roger's Creek chloride penetration sample

No evidence of chloride diffusion was observed in the tested specimens of *Roger's Creek Bridge*. The results are shown in the *Fig. 8*.
