# **Durability of GFRP Bars Extracted from Bridges with 15 to 20 Years of Service Life** June 1, 2019

# DURABILITY OF GFRP BARS EXTRACTED FROM BRIDGES WITH 15 TO 20 YEARS OF SERVICE LIFE

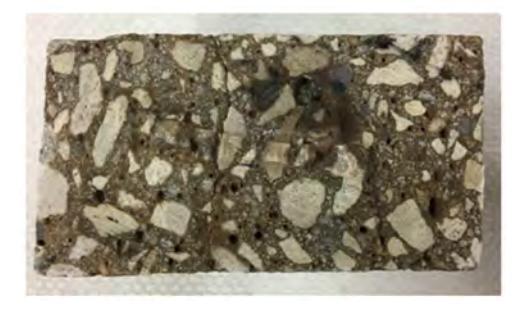
Fig. 9. Walker Box Culvert chloride penetration sample

No clear evidence of chloride diffusion was observed in all the tested specimens using this method. It was noticed that the surface became darker, to a color similar to brown, while there was no visible gray area (*Fig. 9*).

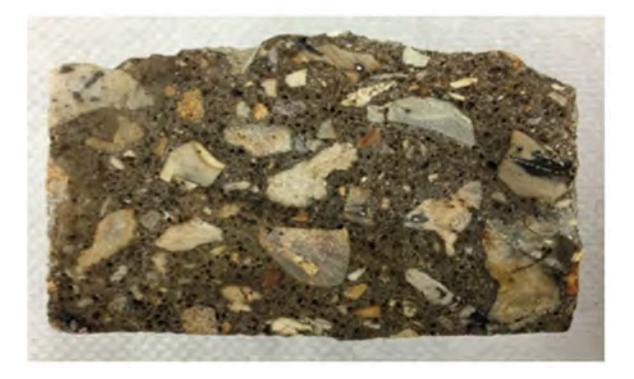
Fig. 10. Southview chloride penetration sample
# 2. Carbonation Depth

No clear evidence of chloride diffusion was observed in all the tested specimens of both bridges using this method. It was noticed that the surface became darker, to a color similar to brown, while there was no visible gray area (*Fig. 10*).

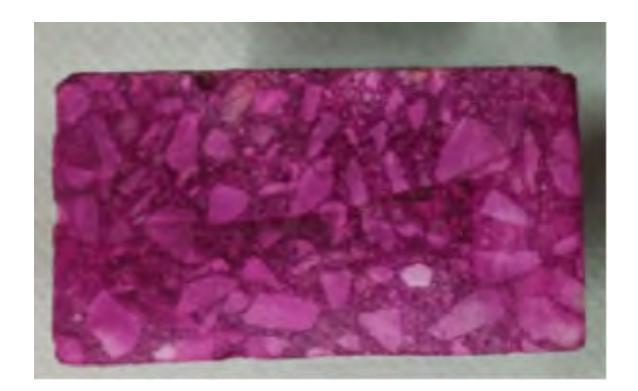
Fig. 17. Walker carbonation depth results

No indication of concrete carbonation was observed in samples extracted from this bridge (*Fig. 17*). While no carbonation of concrete can be considered beneficial to steel rebars because the pH remains at high values, the opposite is true for GFRP reinforcement that is more sensitive to high alkalinity. Thus, the GFRP bars extracted from these cores were subject to an alkaline environment over the 17 years of service in *Walker Box Culvert Bridge*.

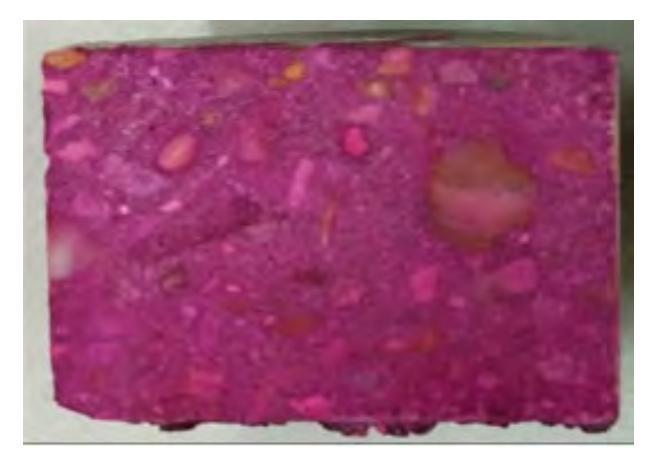
Fig. 18. Southview carbonation depth results

No indication of concrete carbonation was observed in samples extracted from Southview Bridge (*Fig. 18*). While no carbonation of concrete can be considered beneficial to steel rebars because the pH remains at high values, the opposite is true for GFRP reinforcement that is more sensitive to high alkalinity. Thus, the GFRP bars extracted from these cores were subject to an alkaline environment over the 11 years of service.

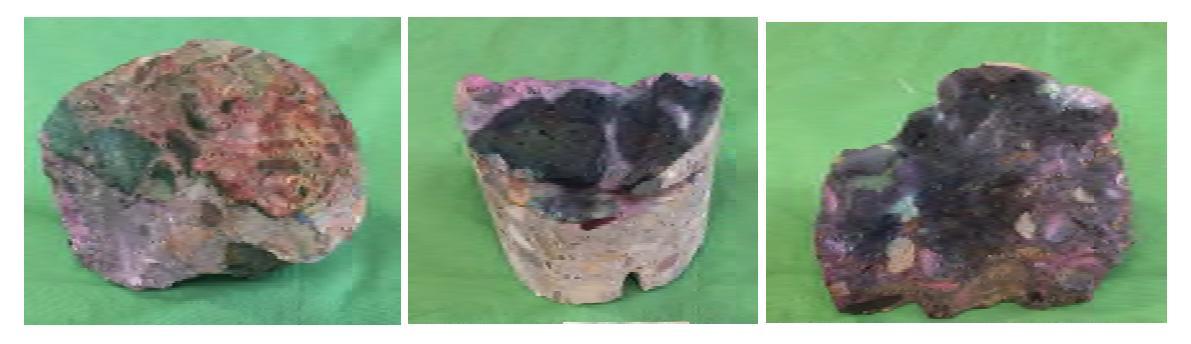
Fig. 30. McKinleyville pH test

All the core samples were tested with the rainbow indicator and the value varied between samples and location of where the indicator was applied. *McKinleyville Bridge* samples indicated a pH of 13 in the inside of the concrete sample and a pH between 7 and 13 on the outside face of the concrete core, as seen in Fig. 30.

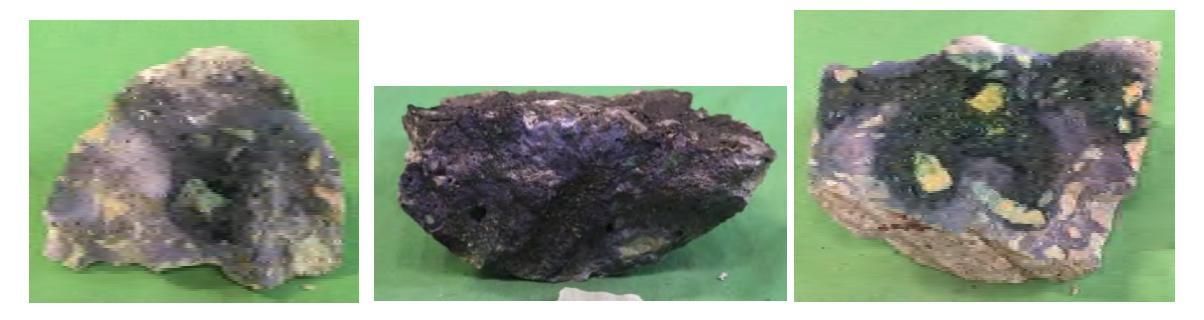
Fig. 31. Thayer Road pH test

The pH obtained for *Thayer Road Bridge* concrete samples only varied between 11 and 13, as shown in *Fig. 31*.

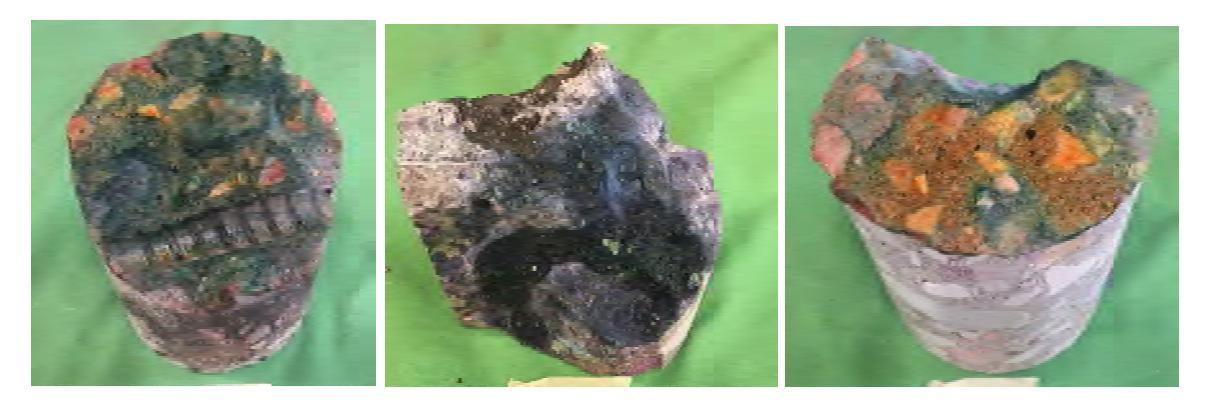
Fig. 32. Roger's Creek pH test

A rainbow indicator was used to observe the pH of the concrete samples. The pH varied between 7 and 13, as shown in *Fig. 32*.

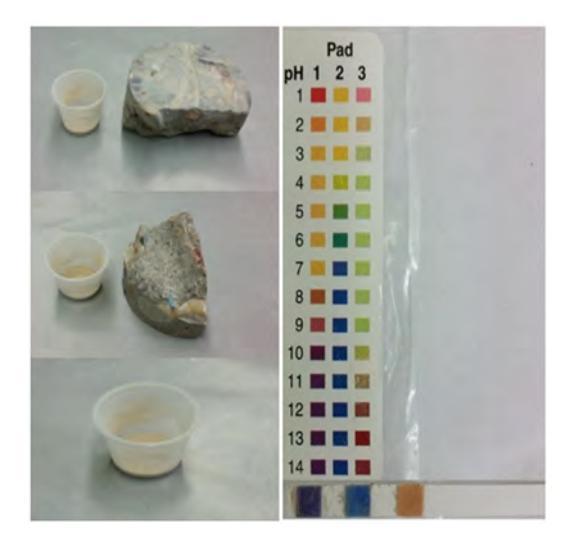
The measured pH values range between 11 and 12 (*Fig. 33*) which is considered acceptable for that type of concrete and age (Grubb et al., 2007). The procedure was performed in three different locations and the results are consistent results for all locations.

*Fig. 33. Concrete pH measurement: ground concrete from extracted cores (left) and pH evaluation using the pH strip (right)*

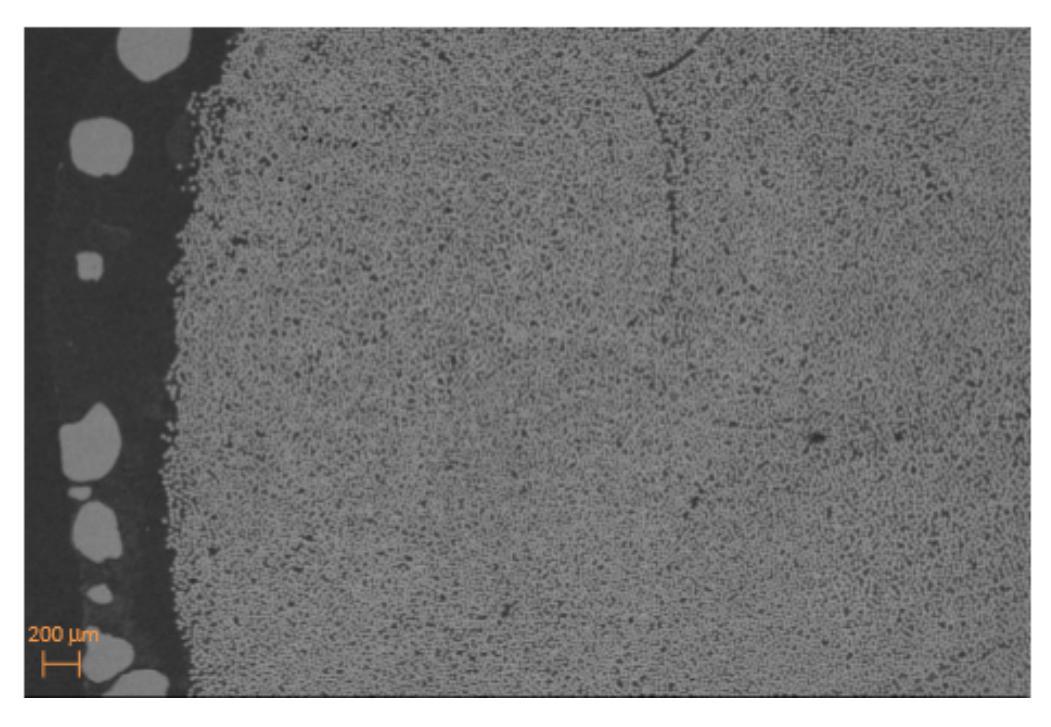
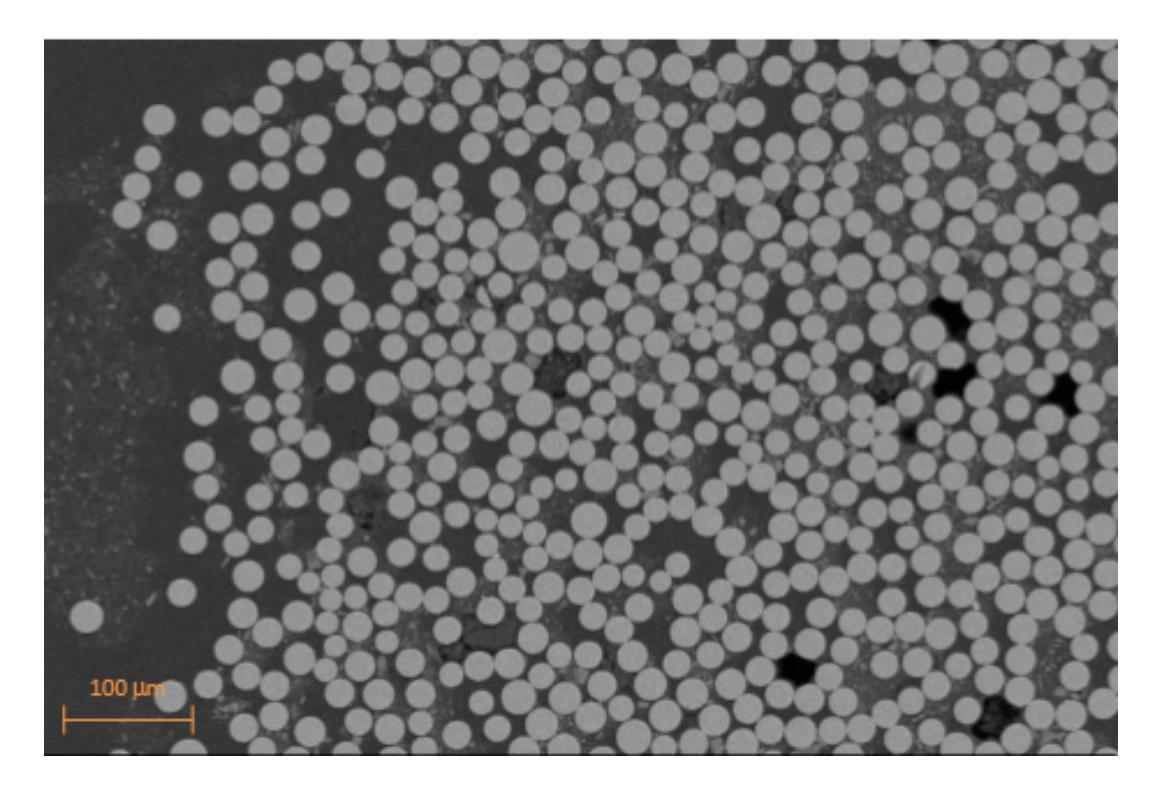
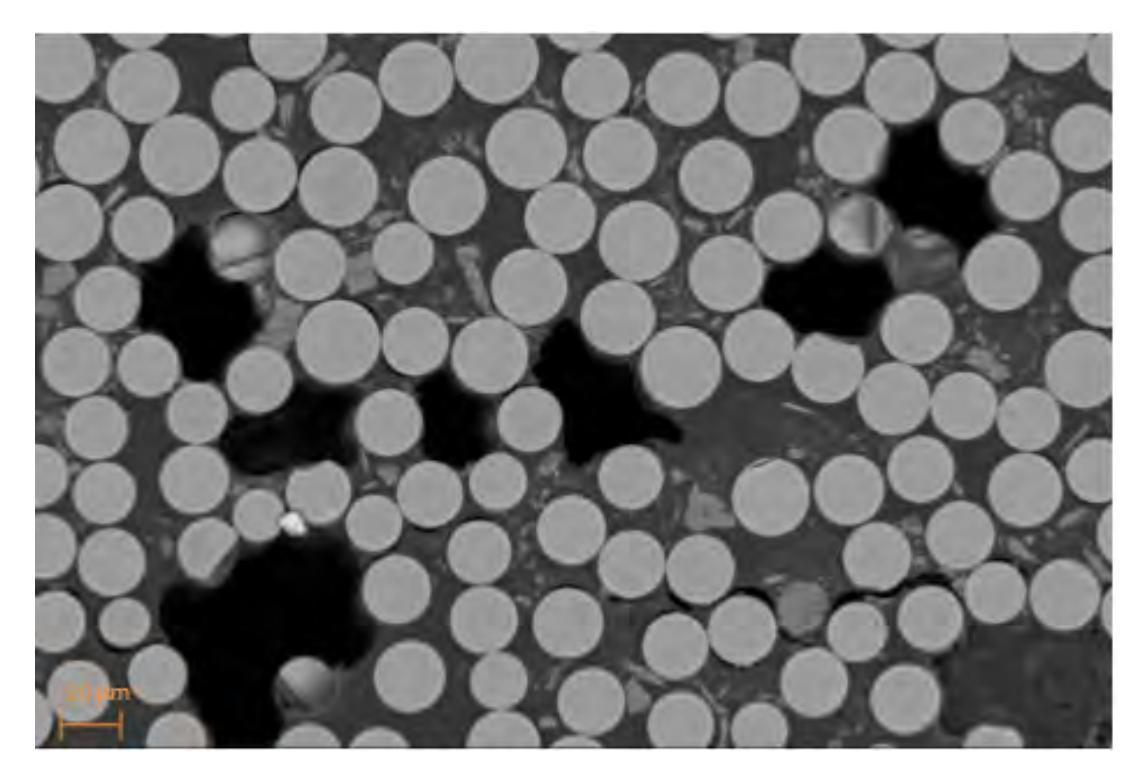
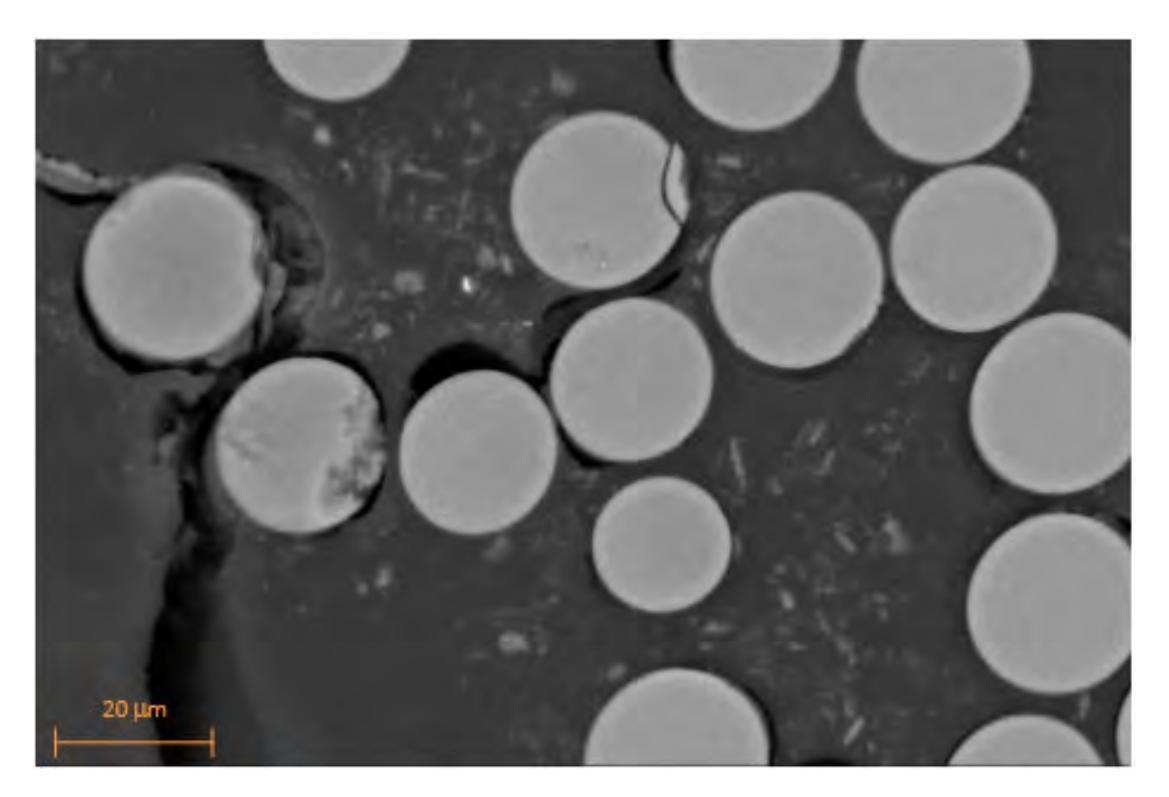
SEM imaging for *Gills Creek Bridge* was performed at Owens Corning. Only between 0.05% to 0.12% of total fibers showed evidence of being negatively affected by concrete environment after 15 years in service. The affected fibers are typically on the outer edge of the rebar and have negligible impact on mechanical properties.

The fibers evidently affected (192 out of 352,000 fibers) were estimated from counting fibers with obvious signs of damage in 1 quadrant, multiplied by 4. The extrapolation for affected fibers (412 out of 352,000 fibers) was estimated from counting fibers with obvious signs of damage and fibers with polishing artifacts in 1 quadrant, multiplied by 4. This quantity is much less than expected or predicted by accelerated test methods, The results of each bar is shown in Fig. 28 through Fig. 31.

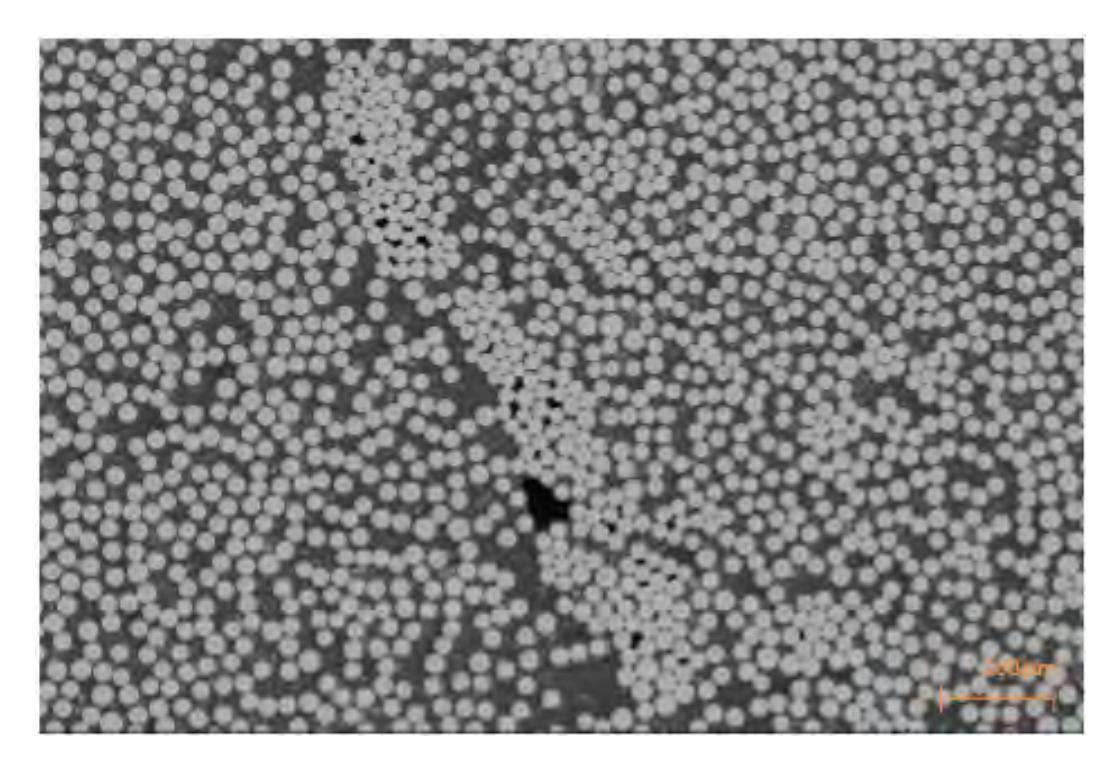
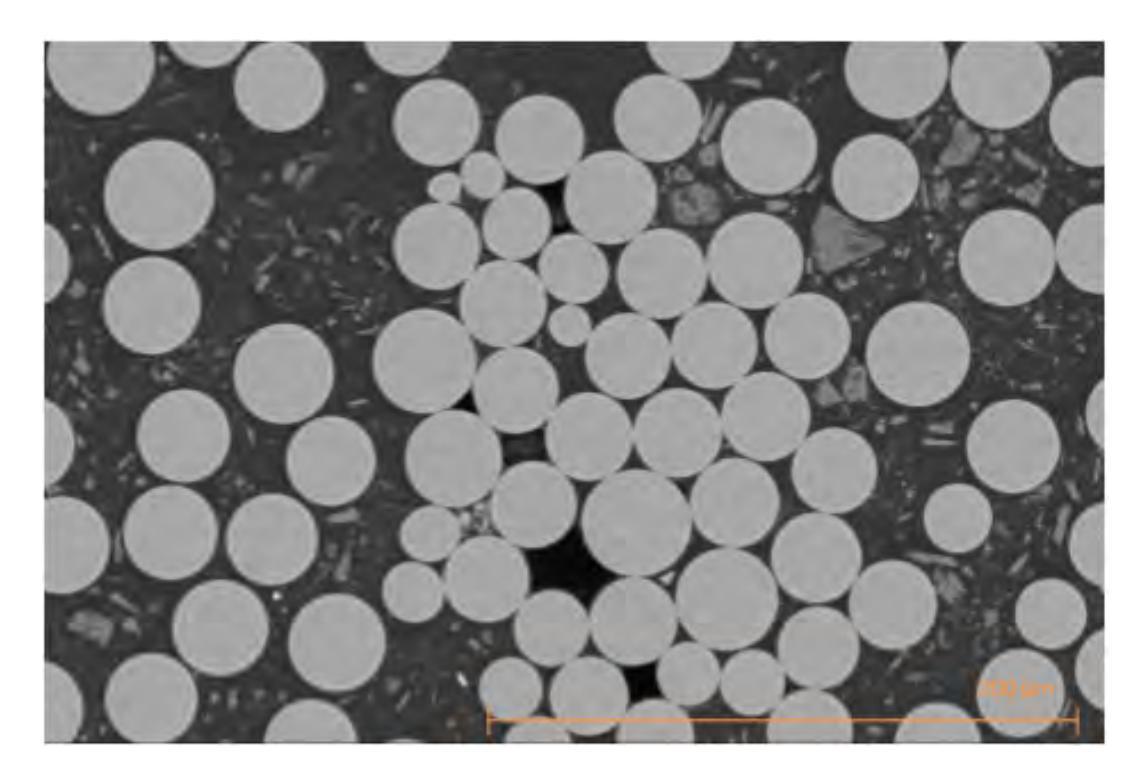
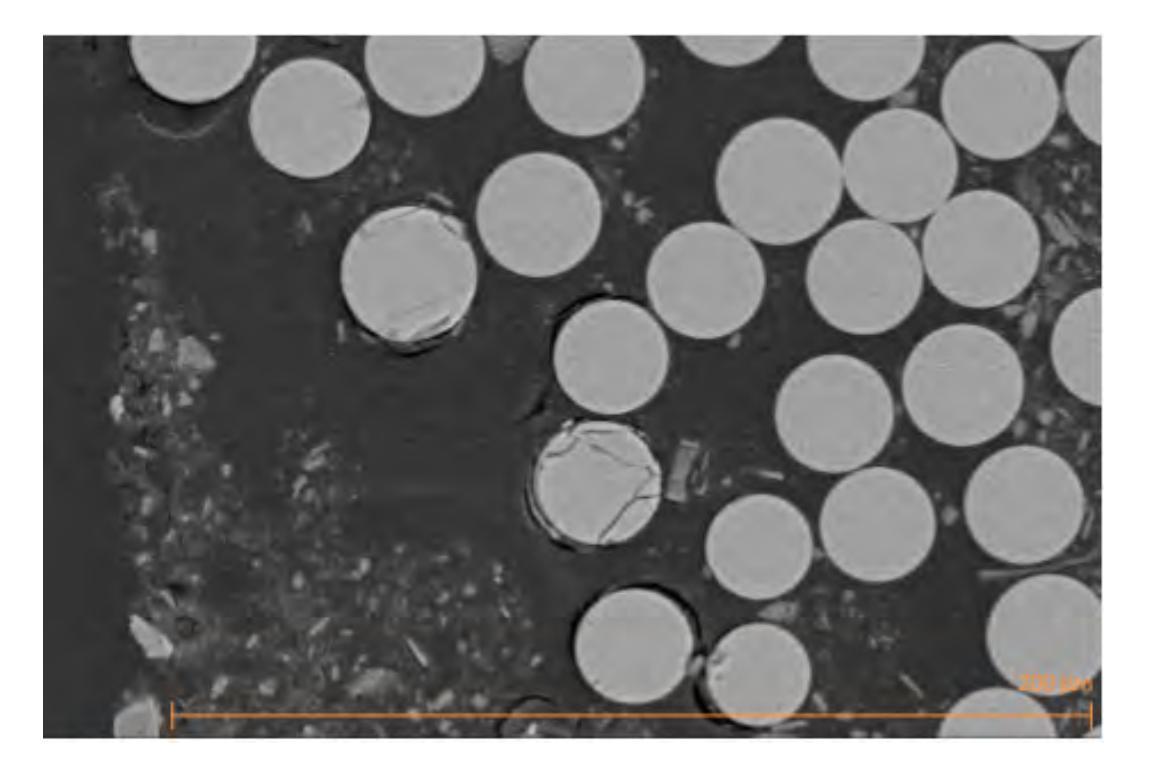
SEM imaging for *Cuyahoga Bridge* was performed at Owens Corning. GFRP rebar extracted from Cuyahoga bridges show some damage on 0.05 to 0.12 % of the glass fibers. This is much less than expected or predicted by accelerated test methods, and has a negligible impact on mechanical properties. The affected fibers were typically on the outer edge of the rebar. The results of each bar is shown in Fig. 32 through Fig. 35.

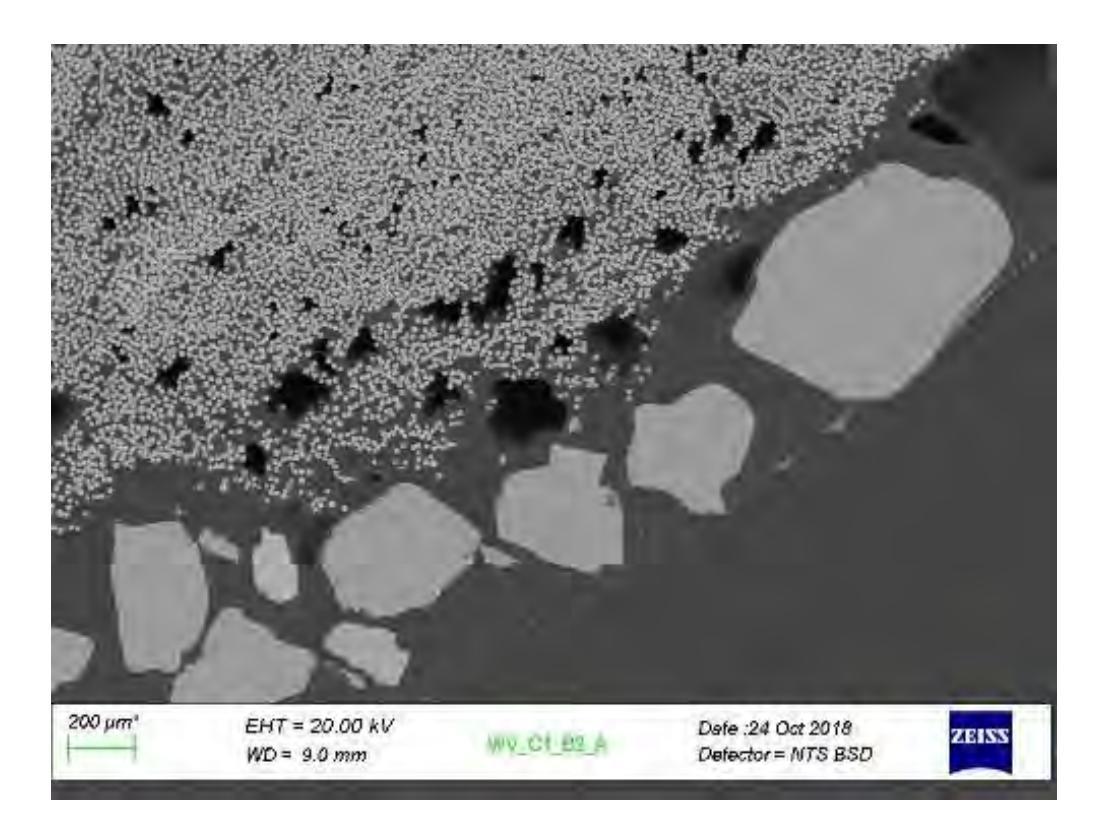
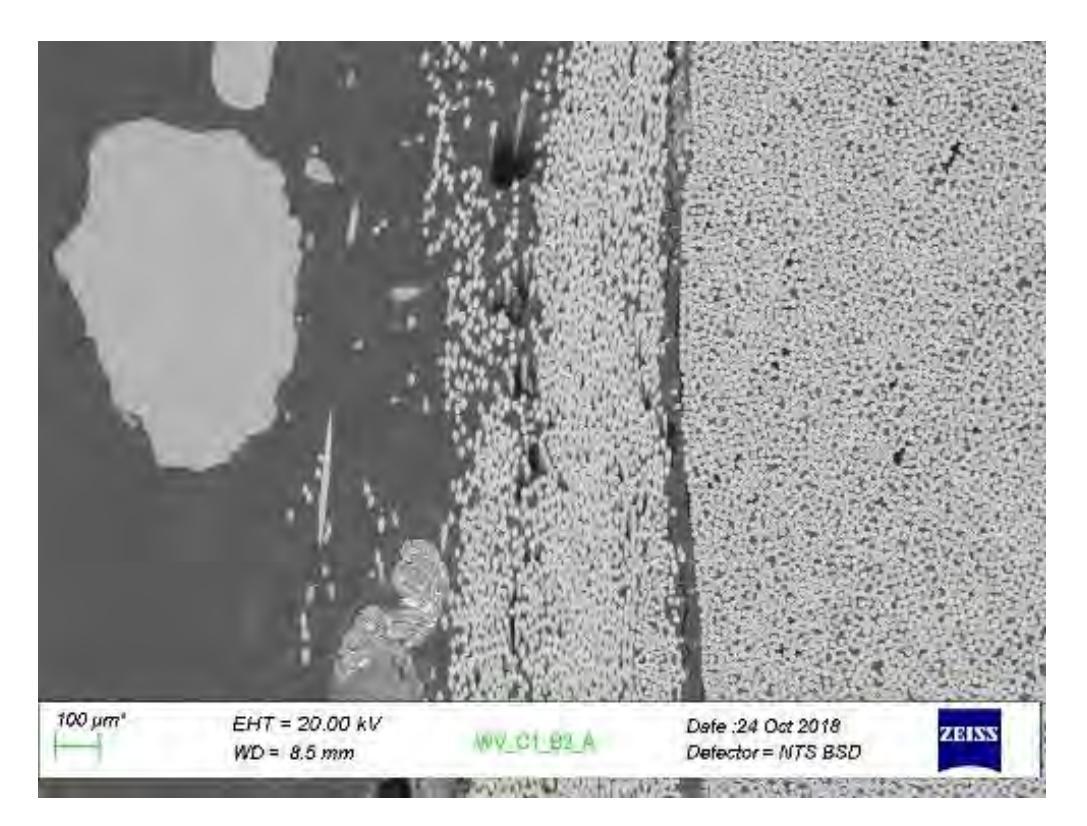
SEM imaging for *McKinleyville Bridge* was performed at Owens Corning. Nearly no negatively affected fibers were observed on the interior or exterior of in-service rebar. The few negatively affected fibers appear to have physical damage from specimen preparation as they are near resin voids. The SEM images of each bar is shown in Fig. 36 through Fig. 80.

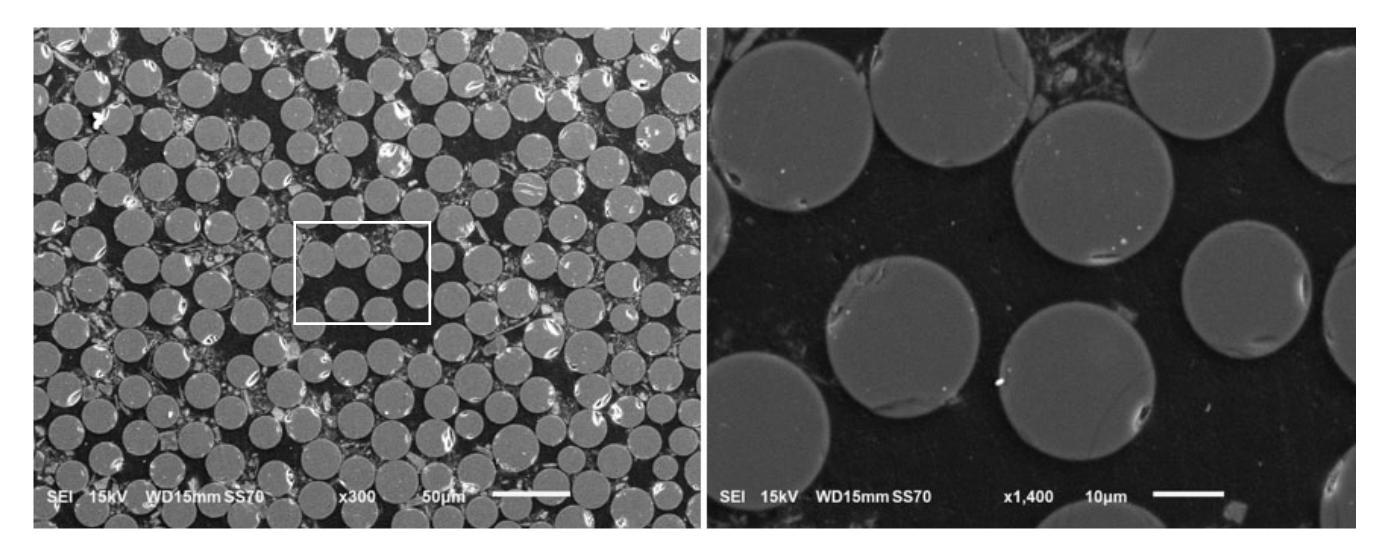
The full cross-sections of three slices of No.5 GFRP bars were scanned at different levels of magnification and images were taken at random locations. A representative image is shown in Fig. 110. The image of a single fiber is shown in Fig. 111.

Fig. 110. SEM images of fibers at magnifications of 300X (left) and 1400X (right))

SEM analysis confirmed that there was no sign of deterioration in the GFRP coupons. Glass fibers were intact without a loss of cross-sectional area. Similarly, fibers were surrounded by the resin matrix and no sign of loss of bond between matrix and fiber was observed.

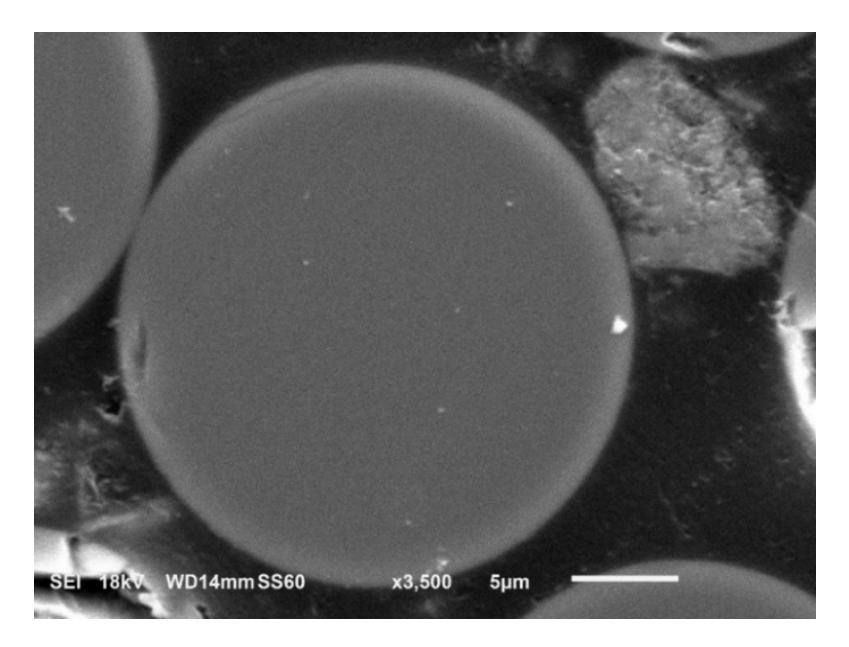
Fig. 111. SEM image of a single fiber at magnification of 3500X

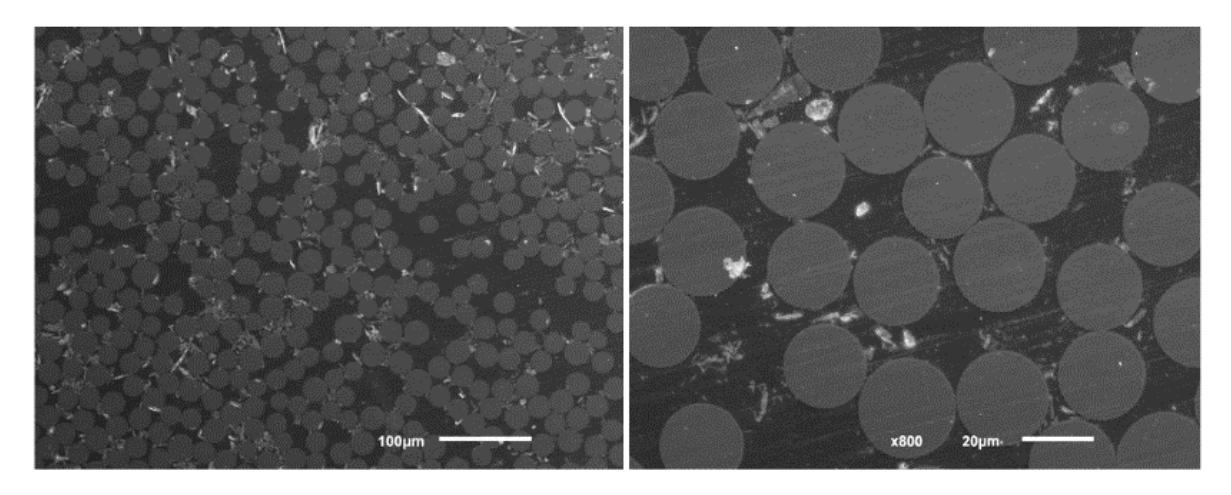
SEM analysis suggests that there was no apparent sign of deterioration in the GFRP coupons. No damage was observed in the matrix and at the matrix-fiber interface. Glass fibers appeared to be intact without no loss of cross-sectional area.

Fig. 113. SEM image of GFRP bar after 16 years of service in Walker Bridge at magnifications of 200x (left) and 800x (right)

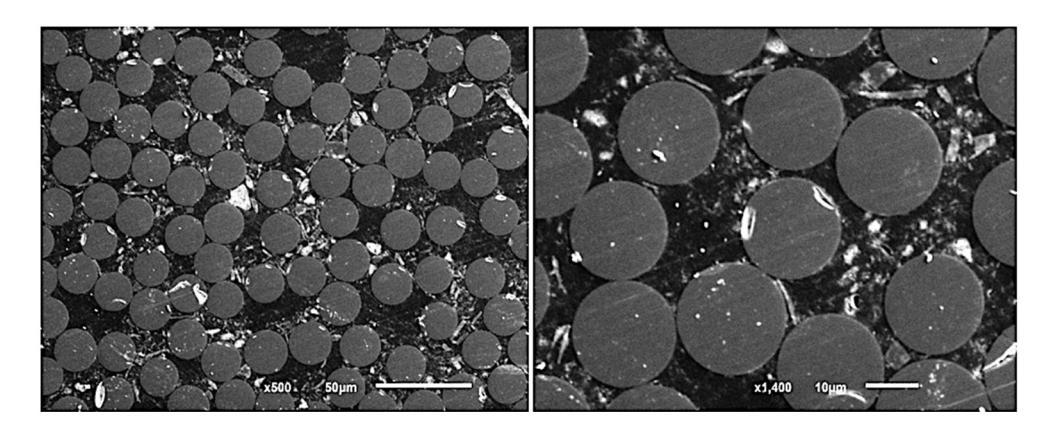
SEM imaging for *Southview Bridge* was performed at the University of Miami. The results of each bar is shown in Fig. 114 through Fig. 110. SEM analysis suggests that there was no apparent sign of deterioration in the GFRP coupons. No damage was observed in the matrix and at the matrix-fiber interface. Glass fibers appeared to be intact without no loss of cross-sectional area.

Fig. 114. SEM images of GFRP bar after 11 years if service in Southview Bridge at magnifications of 500x (left) and 1400x (right)

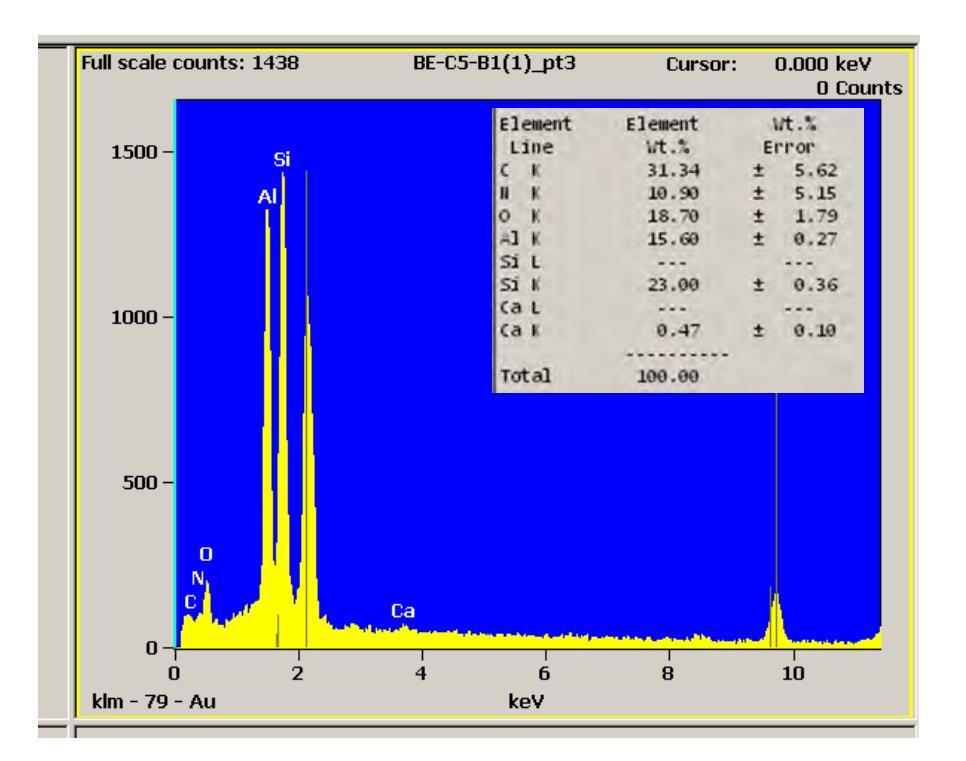
Fig. 119. BE\_C5\_B1-1 pt.3 gold not included. Presence of C, O and N and yielded high aluminum.

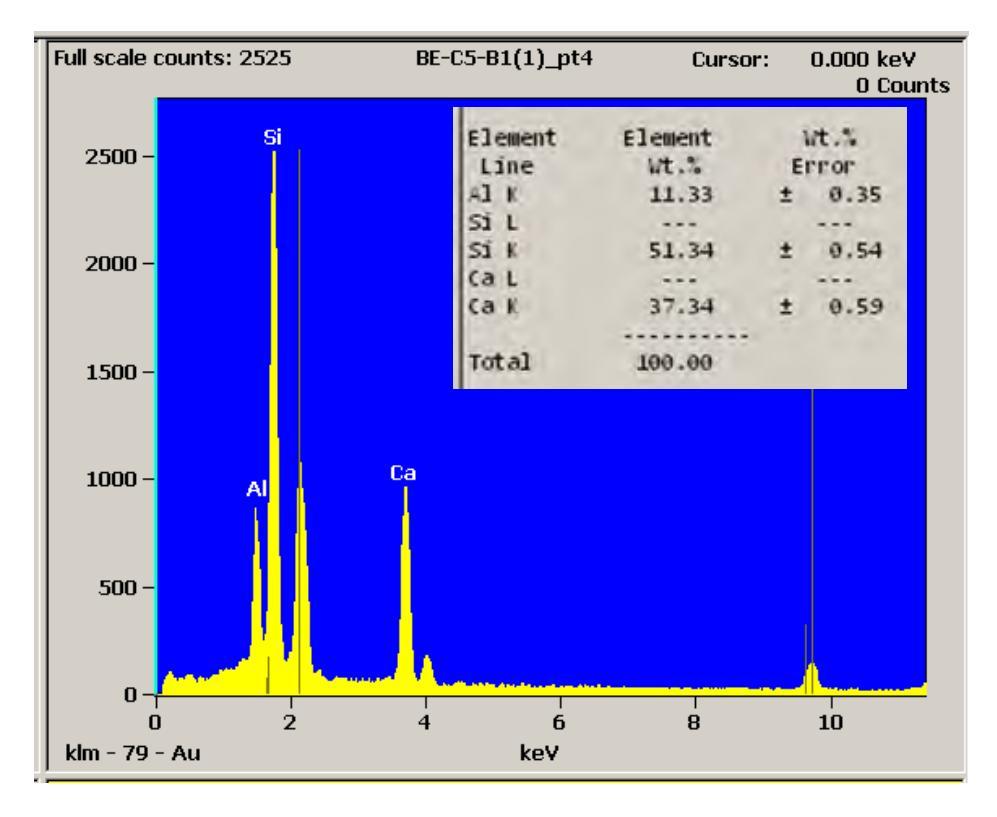
Fig. 120. BE\_CE\_B1-1 pt. 4 gold not included. Yielded Al, Si and Ca.

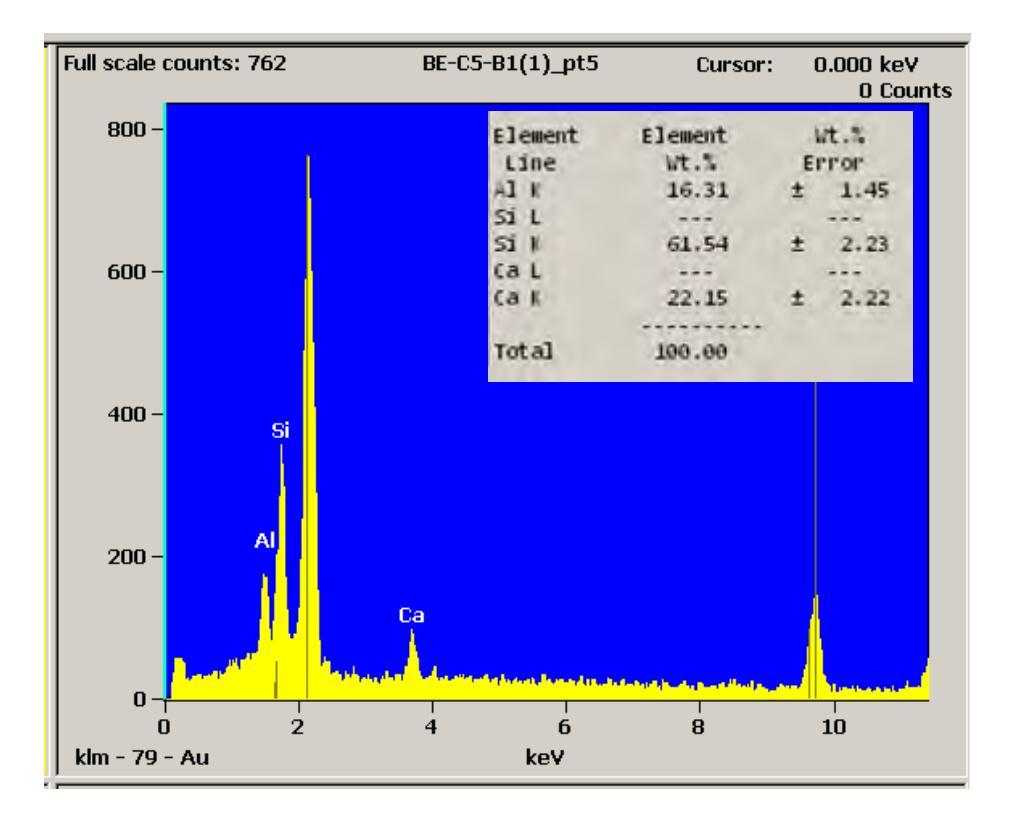
Fig. 121. BE\_C5\_C1-1 pt 5 no gold included. Yielded less Al, Si and Ca.

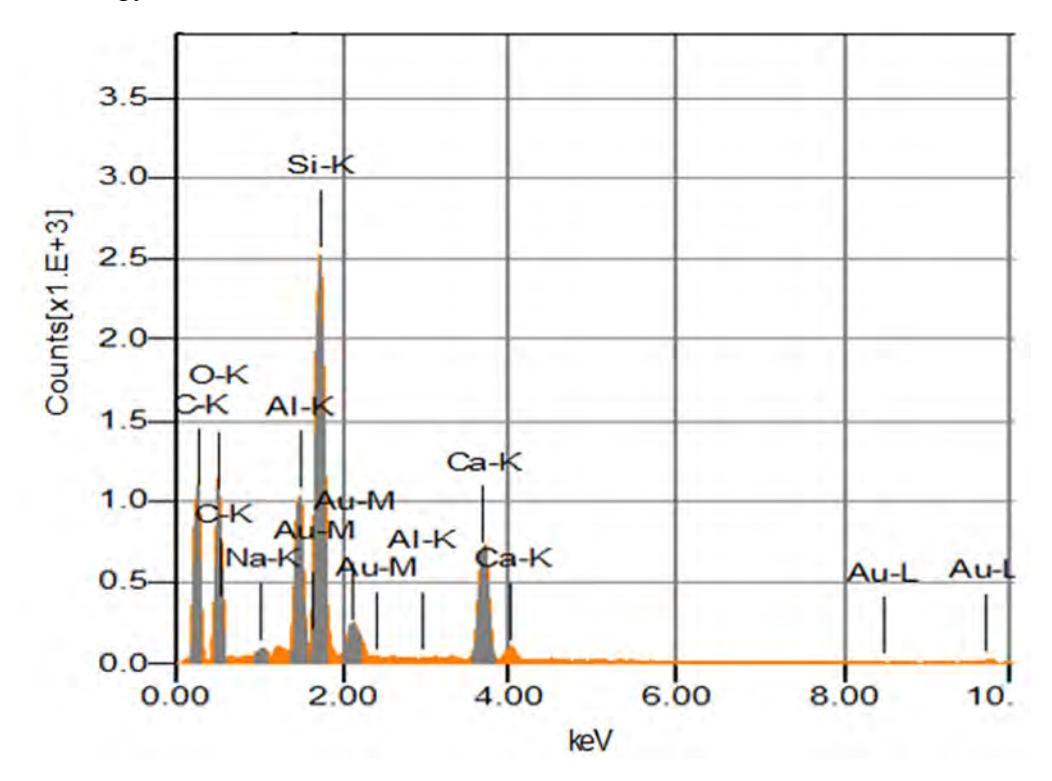
Fig. 144. Sierrita de la Cruz Creek result of the EDS analysis performed on GFRP bars after 15 years of servce

Si, Al, Ca (from glass fibers) and C (from the matrix) were the predominant chemical elements in the extracted samples, which were also identical to the control samples. Although, there is a variation in fiber/resin constituents for GFRP bars produced in 2015 compared to the ones manufactured in 2000, the only difference in detected elements between the two, was the presence of Mg in the control samples, which was not found in extracted bars. Additionally, the presence of Na was observed in both control and extracted samples and may be due to contamination during sample preparation. Comparing the result of EDS analysis performed on the extracted and control samples confirmed that no change in chemical composition of fiber and matrix occurred after 15 years of service.

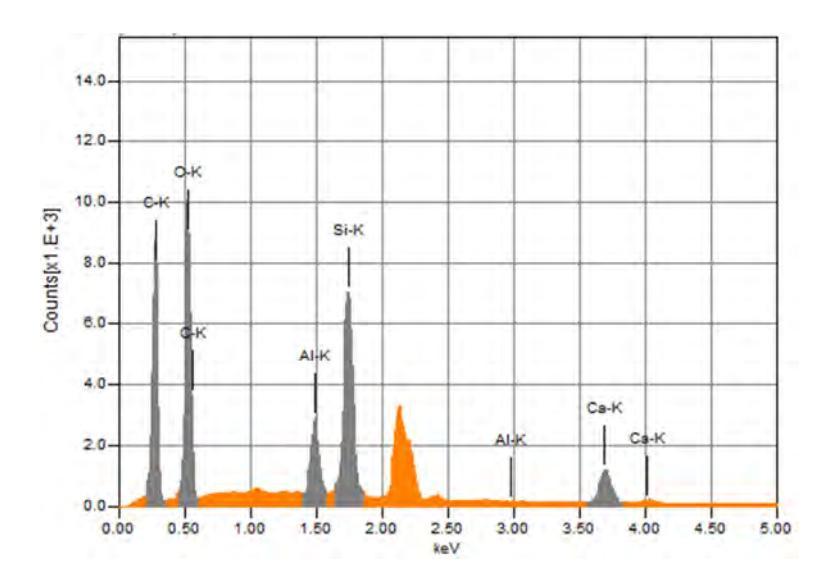
Fig. 146. Result of the EDS analysis performed on GFRP samples extracted from Walker Bridge

EDS for *Walker Box Culvert Bridge* was performed at the University of Miami using the method described in Section 4.1.5. The result of EDS analysis is shown in Fig. 146. Si, Al, Ca (from glass fibers) and C (from the matrix) were the predominant chemical elements in the extracted samples. No apparent sign of any chemical attack was observed in the bars.

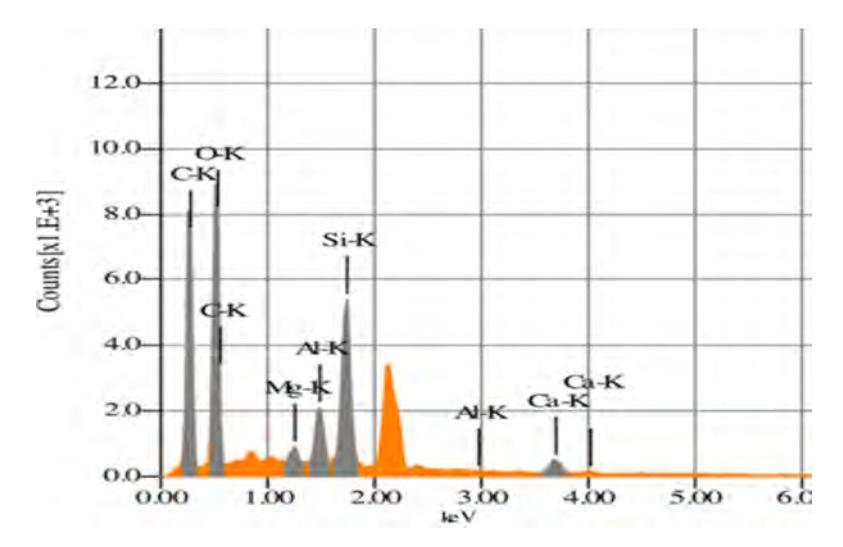
Fig. 147. Result of the EDS analysis performed on GFRP samples extracted from Southview Bridge

The result of EDS analysis is shown in Fig. 147. Si, Al, Ca (from glass fibers) and C (from the matrix) were the predominant chemical elements in the extracted samples. No apparent sign of any chemical attack was observed in the bars.

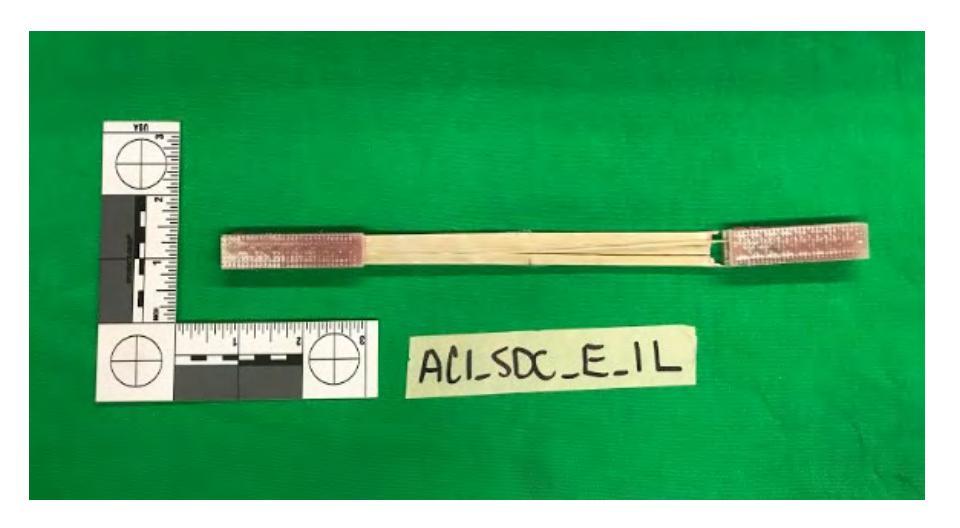
Fig. 4. E\_1L after failure

Sierrita de la Cruz Creek coupon 1 from the left side of the rebar failed at the lateral grip on the top at a peak load of 2,732 lbs. (12 kN) and a peak strain of  $10,000 \times 10^{-6}$ . The coupon before testing and test set up are shown in Fig. 2 and Fig. 3, respectively. The failed coupon and the stress strain curve are shown in Fig. 4 and Fig. 5, respectively. The strain values were recorded with both strain gauges and extensometer; however, the extensometer was removed at 2,500 lbs. Therefore, the stress strain curve uses the values obtained from the strain gauge. A summary of the tensile test results is shown in Table 1.

Since the failure of this coupon happened at the location of the tab, the test is rejected.

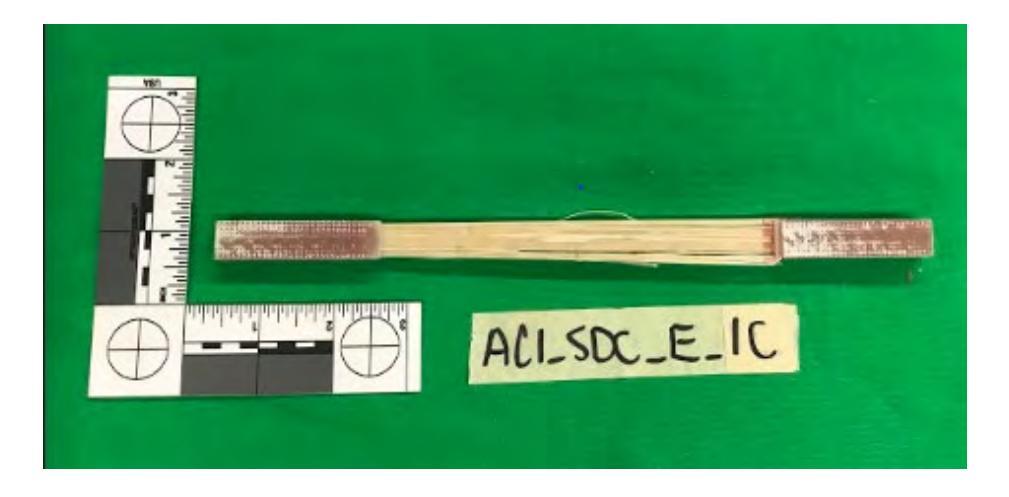
*Fig. 7. Coupon E\_1C after failure*

Sierrita de la Cruz Creek coupon 1 from the center of the rebar failed with the splitting of gage at various points at a peak load of 4,140 lbs. (18 kN) and a peak strain of 12,300x10<sup>-6</sup>. The coupon before testing and after failure are shown in Fig. 6 and Fig. 7, respectively. The strain values were recorded with both strain gauges and extensometer; however, the extensometer was removed at 3,500 lbs. Therefore, the stress strain curve uses the values obtained from the strain gauge. The strain gauge recorded inaccurate values at stresses higher than about 77,000 psi. The stress strain curve for this bar is shown in Fig. 8. A summary of the tensile test results is shown in Table 2.

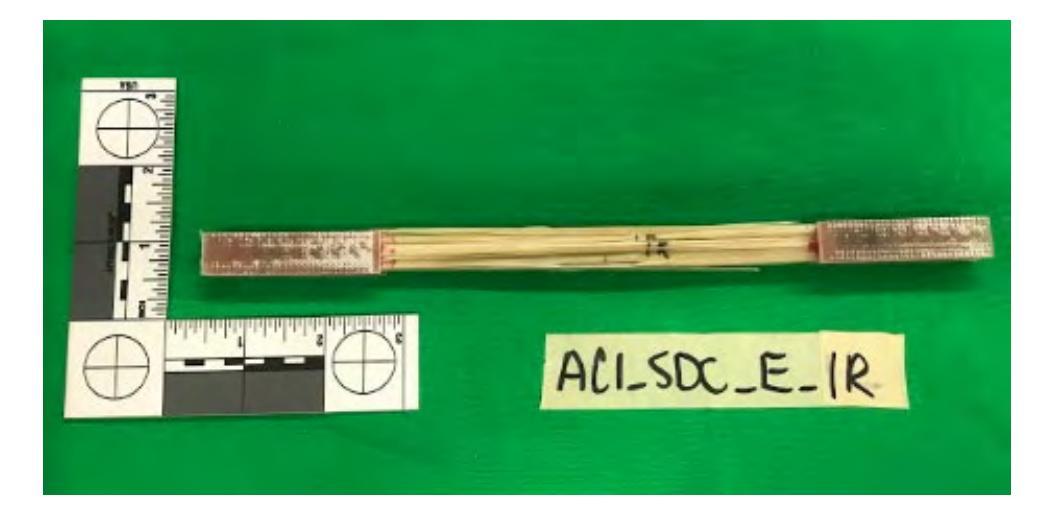
Fig. 10. Coupon E\_1R after failure

Sierrita de la Cruz Creek coupon 1 from the of the right side of the rebar failed with the splitting of gage at various points at a peak load of 5,038 lbs. (22kN) and a peak strain of 12,000x10<sup>-6</sup>. The coupon before testing and after failure are shown in Fig. 9 and Fig. 10, respectively. The strain values were recorded with both strain gauges and extensometer; however, the extensometer was removed at 2,250 lbs. Therefore, the stress strain curve uses the values obtained from the strain gauge. The strain gauge recorded inaccurate values at stresses higher than about 90,000 psi. The stress strain curve for this bar is shown in Fig. 11. A summary of the tensile test results is shown in Table 3.

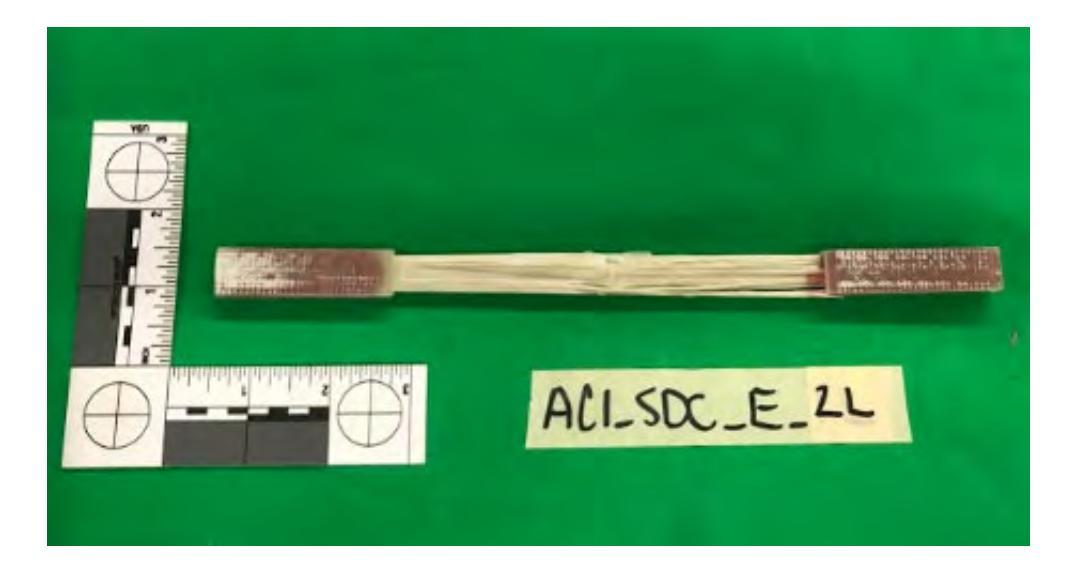
Fig. 13. Coupon E\_2L after failure

Sierrita de la Cruz Creek coupon 2 from the left side of the rebar failed with the splitting of gage at various points at a peak load of 3,649 lbs. (16 kN) and a peak strain of 16,200x10<sup>-6</sup>. The coupon before testing and after failure are shown in Fig. 12 and Fig. 13, respectively. The strain values were recorded with both strain gauges and extensometer; however, the extensometer was removed at 3,500 lbs. Therefore, the stress strain curve uses the values obtained from the strain gauge. The stress strain curve for this bar is shown in Fig. 14. A summary of the tensile test results is shown in Table 4.

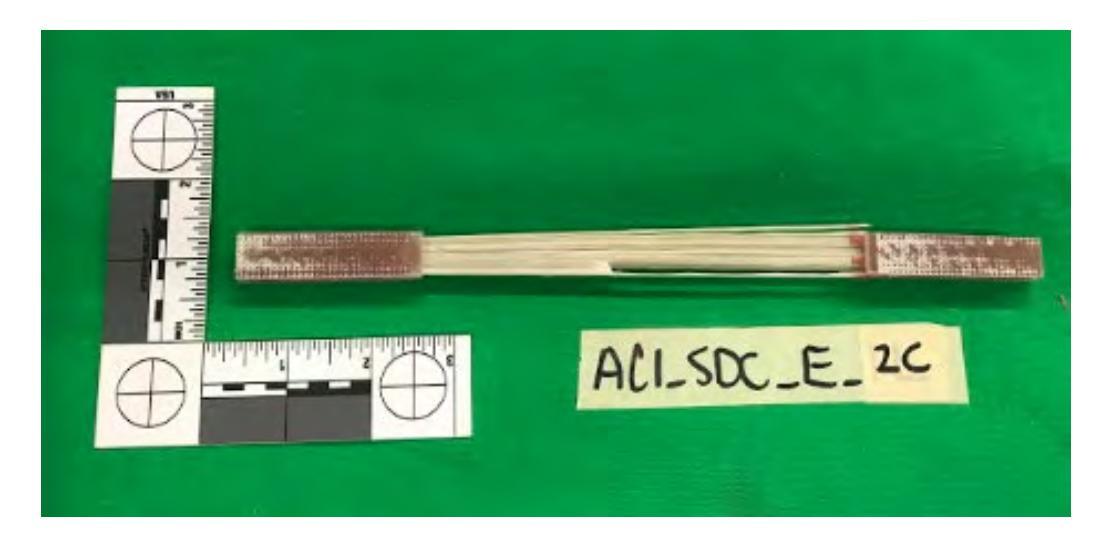
Fig. 16. Coupon E\_2C after failure

Sierrita de la Cruz Creek coupon 2 from the center of the rebar failed at the lateral grip on the top at a peak load of 4,475 lbs. (20 kN) and a peak strain of  $15,300 \times 10^{-6}$ . The strain values were recorded with both strain gauges and extensometer; however, the extensometer was removed at 3,500 lbs. Therefore, the stress strain curve uses the values obtained from the strain gauge. The stress strain curve for this bar is shown in Fig. 17. A summary of the tensile test results is shown in Table 5.
