# **Durability of GFRP Bars Extracted from Bridges with 15 to 20 Years of Service Life** June 1, 2019

# DURABILITY OF GFRP BARS EXTRACTED FROM BRIDGES WITH 15 TO 20 YEARS OF SERVICE LIFE

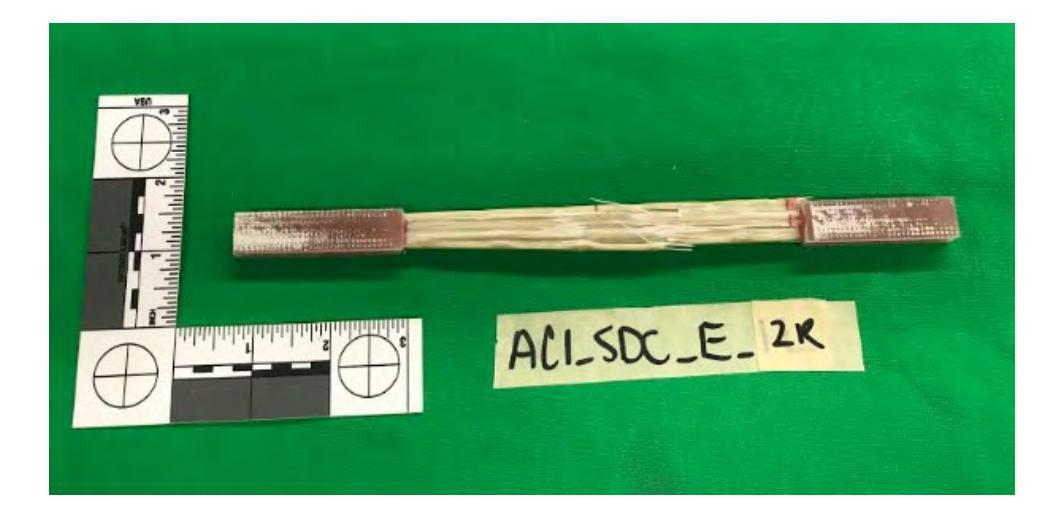
Sierrita de la Cruz Creek coupon 2 from the right side of the rebar failed with the splitting of gage at various points at a peak load of 4,597 lbs. (20 kN) and a peak strain of 13,000x10<sup>-6</sup>. The coupon before testing and after failure are shown in Fig. 18 and Fig. 19, respectively. The strain values were recorded with both strain gauges and extensometer; however, the extensometer was removed at 3,500 lbs. Therefore, the stress strain curve uses the values obtained from the strain gauge. The stress strain curve for this bar is shown in Fig. 20. A summary of the tensile test results is shown in Table 6.

Fig. 19. Coupon E\_2R after failure

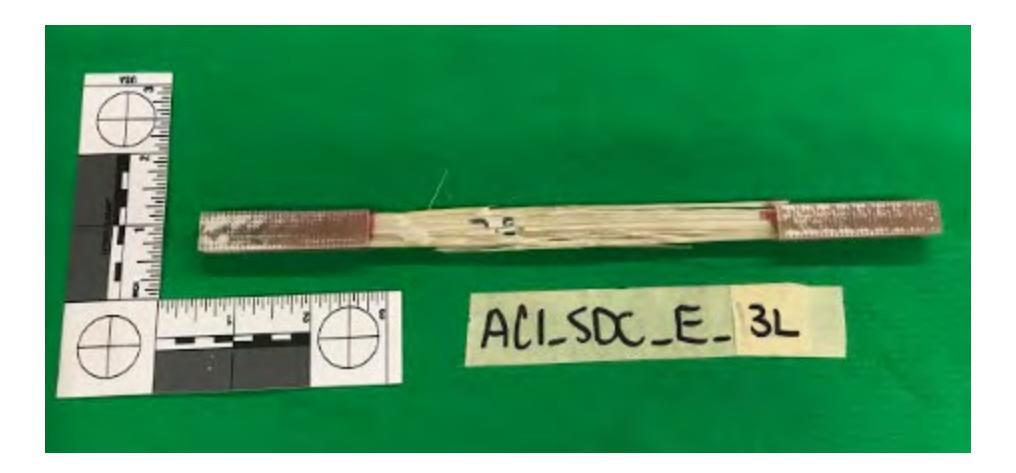
Sierrita de la Cruz Creek coupon 3 from the left side of the rebar failed with the splitting of gage at various points at a peak load of 2,992 lbs. (13 kN) The coupon before testing and after failure are shown in Fig. 21 and Fig. 22, respectively. Due to test issues, the strain for this bar could not be recorded, however, a stress curve is shown in Fig. 23. A summary of the tensile test results is shown in Table 7.

Fig. 22. Coupon E\_3L after failure

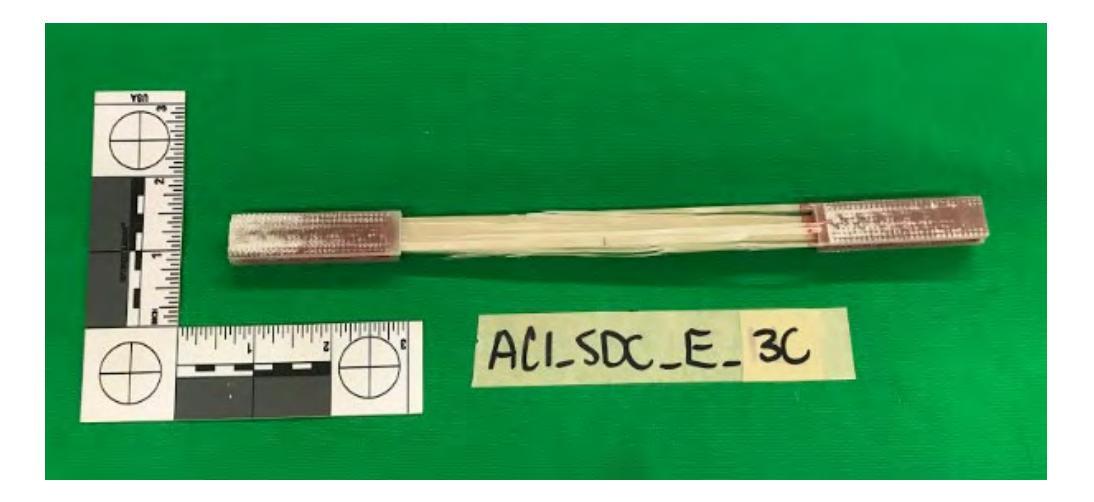
Sierrita de la Cruz Creek coupon 3 from the center of the rebar failed with the splitting of gage at various points at a peak load of 4,621 lbs. (21 kN). The coupon before testing and after failure are shown in Fig. 24 and Fig. 25, respectively. Due to test issues, the strain for this bar could not be recorded, however, a stress curve is shown in Fig. 26. A summary of the tensile test results is shown in Table 8.

Fig. 25. Coupon E\_3C after failure

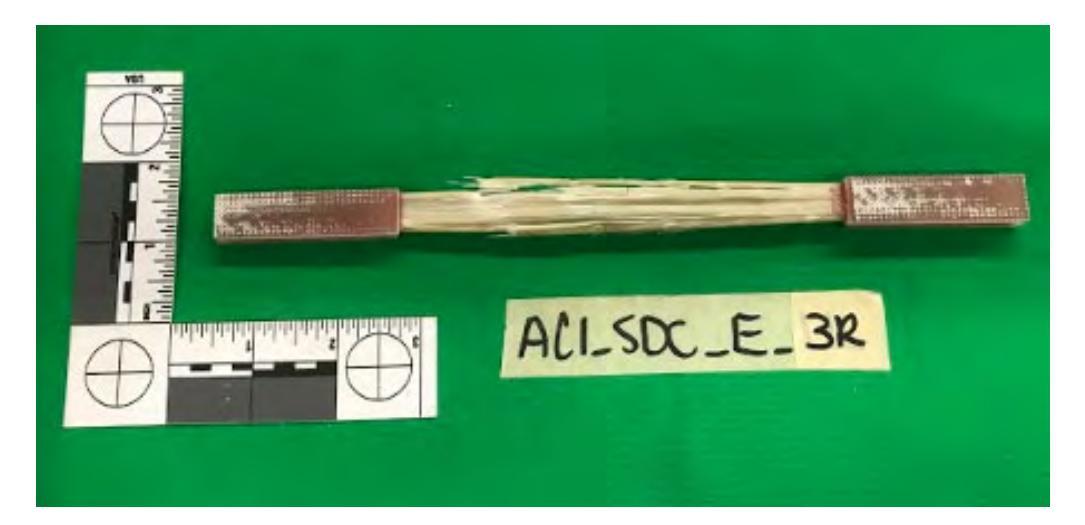
Sierrita de la Cruz Creek coupon 3 from the right side of the rebar failed with the splitting of gage at various points at a peak load of 4,330 lbs. (19 kN) and a peak strain of 13,112x10<sup>-6</sup>. The coupon before testing and after failure are shown in Fig. 27 and Fig. 28, respectively. The strain values were recorded with both strain gauges and extensometer; however, the extensometer was removed at 3,500 lbs. Therefore, the stress strain curve uses the values obtained from the strain gauge. The stress strain curve for this bar is shown in Fig. 29. A summary of the tensile test results is shown in Table 9.

Fig. 28. Coupon E\_3R after failure

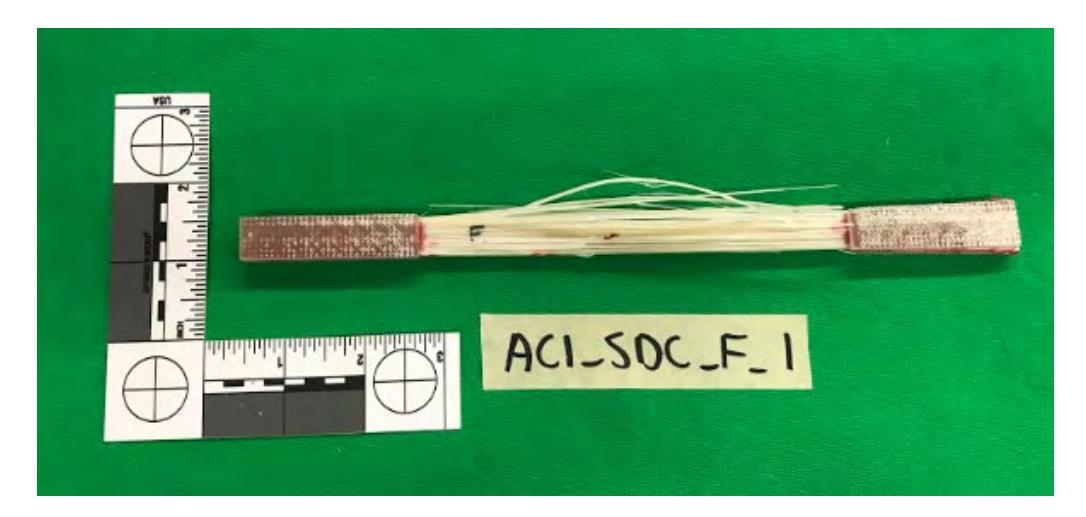
Pristine coupon 1 failed with the splitting of gage at various points at a peak load of 4,929 lbs (22kN) and a peak strain of 17,900x10<sup>-6</sup>. The coupon after failure is shown in Fig. 31. The strain values were recorded with both strain gauges and extensometer; however, the extensometer was removed at 4,000 lbs. Therefore, the stress strain curve uses the values obtained from the strain gauge. The stress strain curve for this bar is shown in Fig. 32. A summary of the tensile test results is shown in Table 10.

Fig. 31. Coupon F\_1 after failure

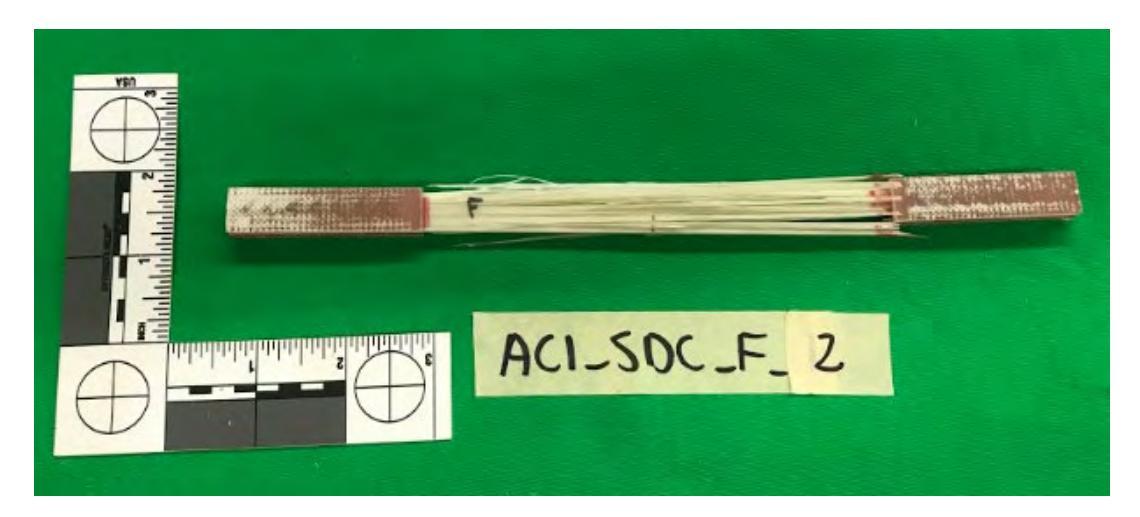
Pristine coupon 2 failed with the splitting of gage at various points at a peak load of 4,609 lbs. (20 kN). The coupon after failure is shown in Fig. 33. Due to test issues, the strain for this bar could not be recorded, however, a stress curve is shown in Fig. 34. A summary of the tensile test results is shown in Table 11.

Fig. 33. Coupon F\_2 after failure

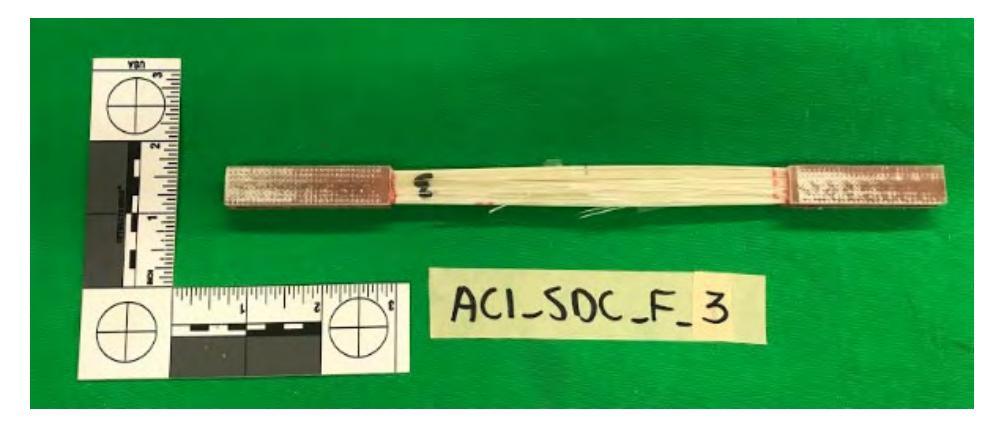
Pristine coupon 3 failed with the splitting of gage at various points at a peak load of 4,894 lbs. (12 kN) and peak strain of 15,000x10<sup>-6</sup>. The coupon after failure is shown in Fig. 35. The strain values were recorded with both strain gauges and extensometer; however, the extensometer was removed at 4,000 lbs. Therefore, the stress strain curve uses the values obtained from the strain gauge. The stress strain curve for this bar is shown in Fig. 36. A summary of the tensile test results is shown in Table 12.

Fig. 35. Coupon F\_3 after failure

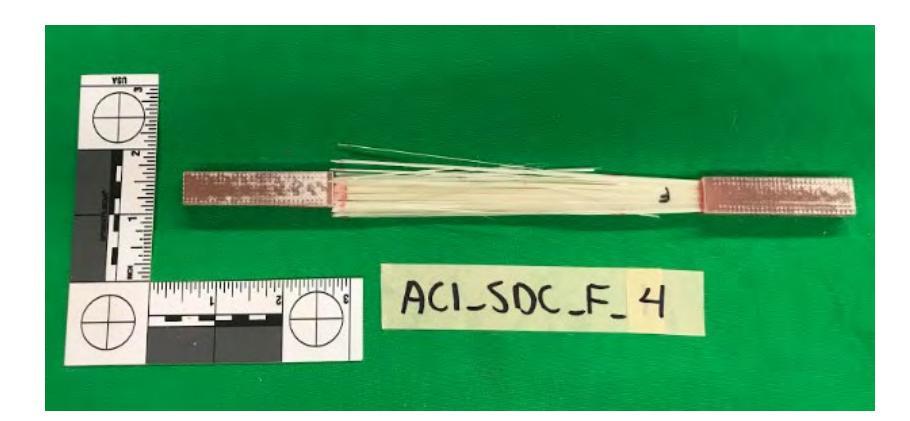
Pristine coupon 4 failed with the splitting of gage at various points at a peak load of 4,538 lbs. (20 kN) and a maximum strain of 15,500x10<sup>-6</sup>. The coupon after failure is shown in Fig. 37. The strain values were recorded with both strain gauges and extensometer; however, the extensometer was removed at 4,000 lbs. Therefore, the stress strain curve uses the values obtained from the strain gauge. The strain gauge recorded inaccurate values at stresses higher than about 98,000 psi. The stress strain curve for this bar is shown in Fig. 38. A summary of the tensile test results is shown in Table 13.

Fig. 37. Coupon F\_4 after failure

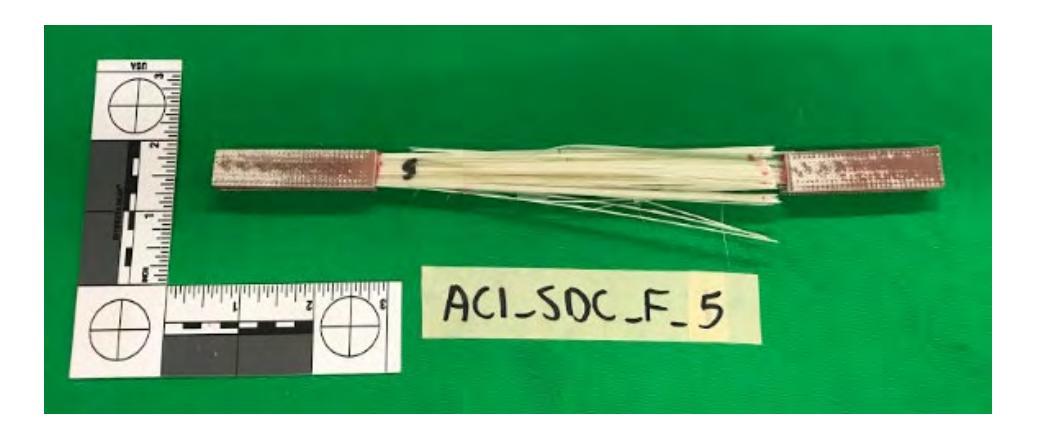
Pristine coupon 5 failed with the splitting of gage at various points at a peak load of 5,321 lbs. (24 kN) and a maximum strain of  $19,400 \times 10^{-6}$ . The coupon after failure is shown in Fig. 39. The strain values were recorded with both strain gauges and extensometer; however, the extensometer was removed at 4,000 lbs. Therefore, the stress strain curve uses the values obtained from the strain gauge. The stress strain curve for this bar is shown in Fig. 40. A summary of the tensile test results is shown in Table 14.

Fig. 39. Coupon F\_5 after failure

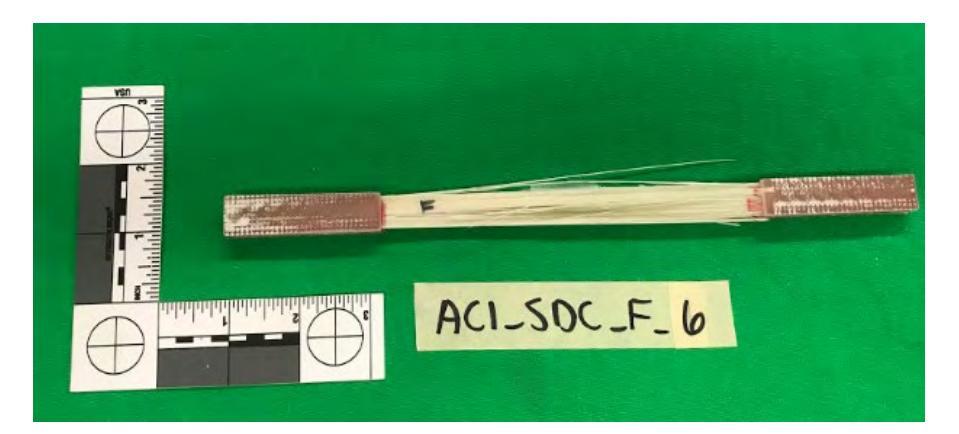
Pristine coupon 6 failed with the splitting of gage at various points at a peak load of 4,065 lbs. and a maximum strain of  $14,077 \times 10^{-6}$ . The coupon after failure is shown in Fig. 41. The strain values were recorded with both strain gauges and extensometer; however, the extensometer was removed at 4,000 lbs. Therefore, the stress strain curve uses the values obtained from the strain gauge. The stress strain curve for this bar is shown in Fig. 42. A summary of the tensile test results is shown in Table 15.

Fig. 41. Coupon F\_6 after failure

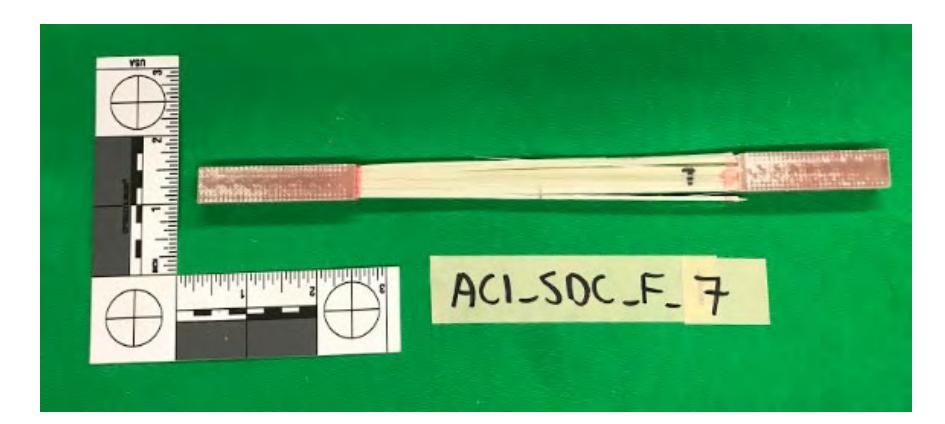
Pristine coupon 7 failed with the splitting of gage at various points at a peak load of 4,110 lbs. (18 kN) and strain of  $15,300 \times 10^{-6}$ . The coupon after failure is shown in Fig. 43. The stress strain curve for this bar is shown in Fig. 44. The strain values were recorded with both strain gauges and extensometer; however, the extensometer was removed at 4,000 lbs. Therefore, the stress strain curve uses the values obtained from the strain gauge. A summary of the tensile test results is shown in Table 16.

*Fig. 43. Coupon F\_7 after failure*

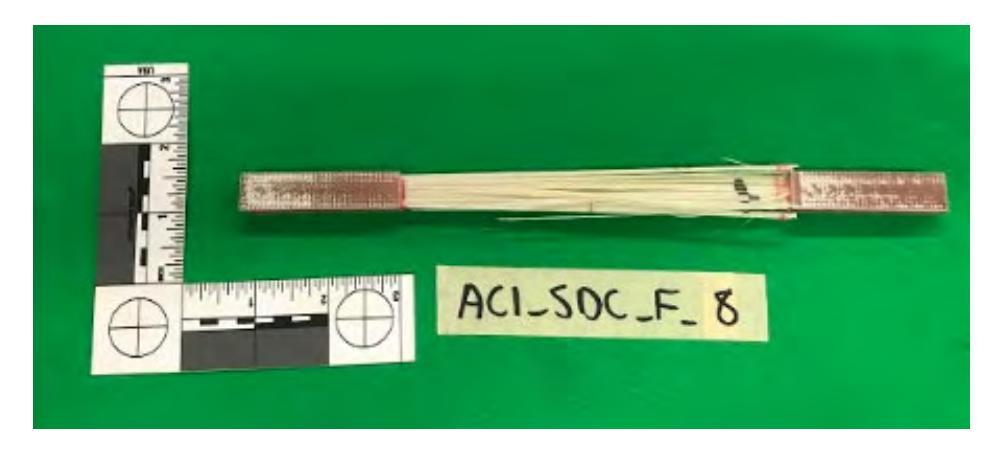
Pristine coupon 8 failed with the splitting of gage at various points at a peak load of 4,609 lbs. (20 kN) and a maximum strain of  $15,900 \times 10^{-6}$ . The coupon after failure is shown in Fig. 45. The stress strain curve for this bar is shown in Fig. 46. The strain values were recorded with both strain gauges and extensometer; however, the extensometer was removed at 4,000 lbs. Therefore, the stress strain curve uses the values obtained from the strain gauge. A summary of the tensile test results is shown in Table 17.

Fig. 45. Coupon F\_8 after failure

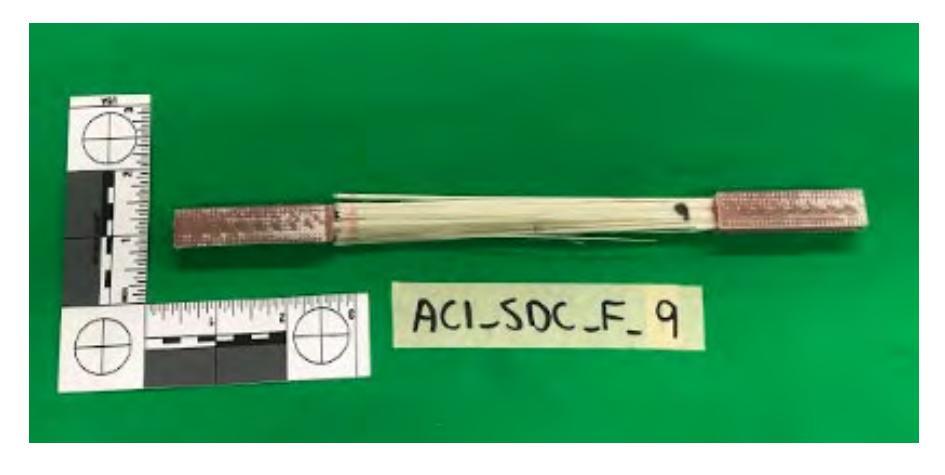
Pristine coupon 9 failed with the splitting of gage at various points at a peak load of 5,207 lbs. (23 kN) and a maximum strain of 15,600x10<sup>-6</sup>. The coupon after failure is shown in Fig. 47. The stress strain curve for this bar is shown in Fig. 48. The coupon before testing and test set up are shown in Fig. 2 and Fig. 3, respectively. The failed coupon and the stress strain curve shown in Fig. 4 and Fig. 5, respectively. The strain values were recorded with both strain gauges and extensometer; however, the extensometer was removed at 4,000 lbs. Therefore, the stress strain curve uses the values obtained from the strain gauge. A summary of the tensile test results is shown in Table 18.

Fig. 47. Coupon F\_9 after failure

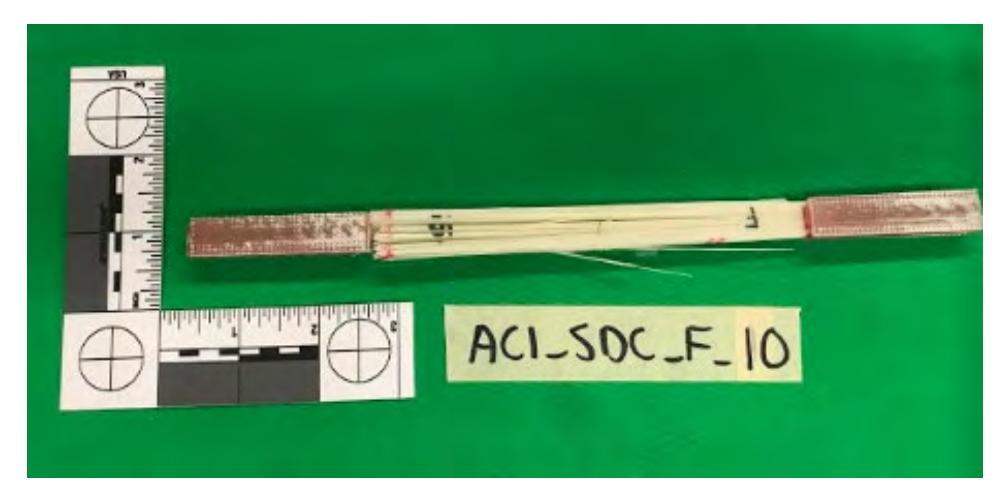
Pristine coupon 10 failed with the splitting of gage at various points at a peak load of 4,618 lbs. (21 kN) and a maximum strain of  $16,500 \times 10^{-6}$ . The coupon after failure is shown in Fig. 49. The stress strain curve for this bar is shown in Fig. 50. The strain values were recorded with both strain gauges and extensometer; however, the extensometer was removed at 4,000 lbs. Therefore, the stress strain curve uses the values obtained from the strain gauge. A summary of the tensile test results is shown in Table 19.

Fig. 49. Coupon F\_10 after failure

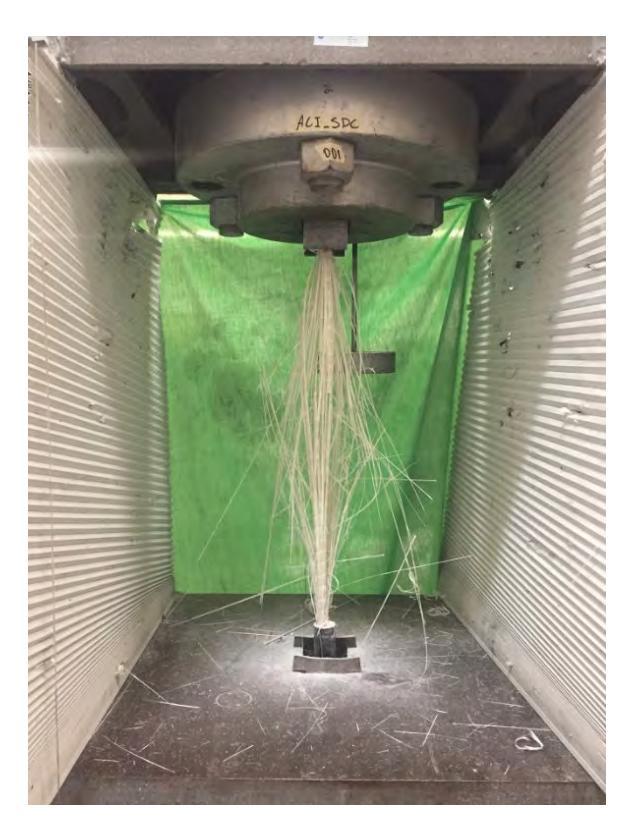
Pristine bar 001 failed at a peak load of 37,312 lbs. (166 kN). The test set up is shown in Fig. 51 and the bar after failure is shown in Fig. 52. The extensioneter was removed at a load of 11,620 lbs., and therefore, the maximum strain could not be determined. The stress strain curve for this bar is shown in Fig. 53. A summary of the tensile test results is shown in Table 21.

Fig. 52. Bar 001 after failure

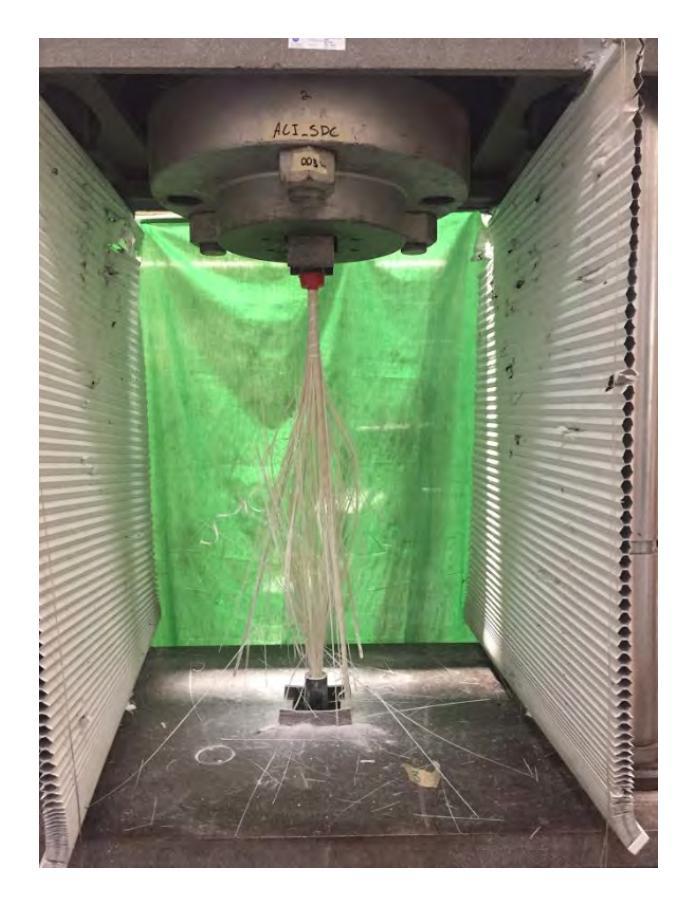
Pristine bar 003 failed at a peak load of 35,608 lbs. (159 kN). A photograph of the bar after failure is shown in Fig. 55. The extensioneter was removed at a load of 11,690 lbs., and therefore, the maximum strain could not be determined. The stress strain curve for this bar is shown in Fig. 56. Due to initial manipulation of the extensioneter, initial conditions show initial deflection at load zero. This curve has A summary of the tensile test results is shown in Table 23.

Fig. 55. Bar 003 after failure

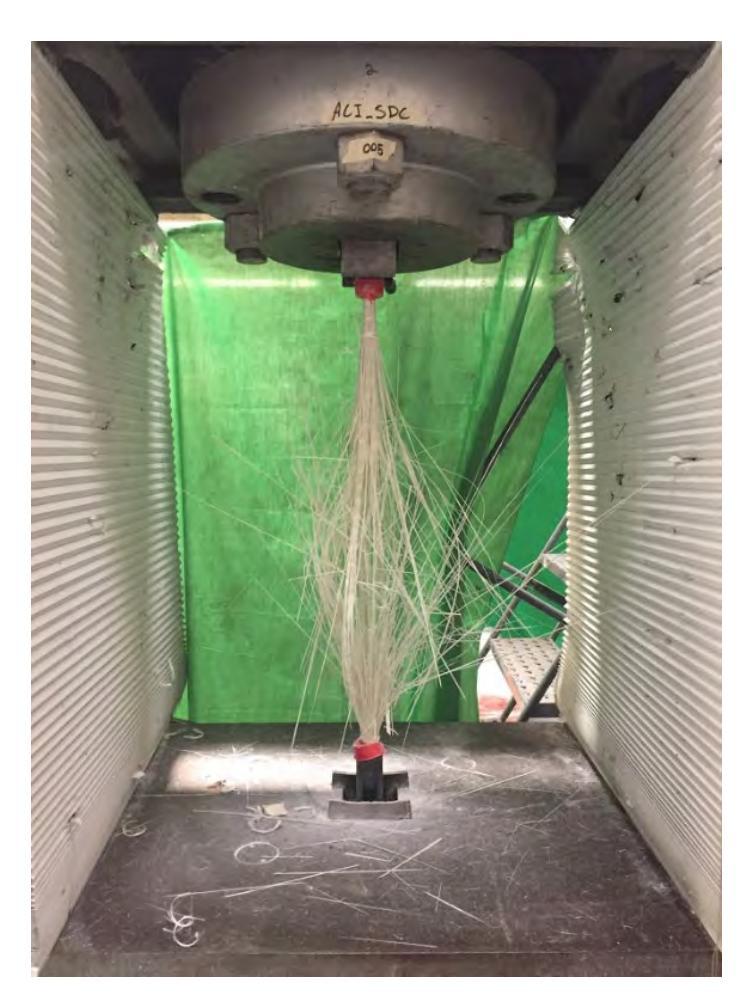
Fig. 58. Bar 005 after failure

Pristine bar 005 failed at a peak load of 38,186 lbs. (170 kN). A photograph of the bar after failure is shown in Fig. 58. The extensometer was removed at a load of 12,150 lbs., and therefore, the maximum strain could not be determined. The stress strain curve for this bar is shown in Fig. 59. A summary of the tensile test results is shown in Table 25.

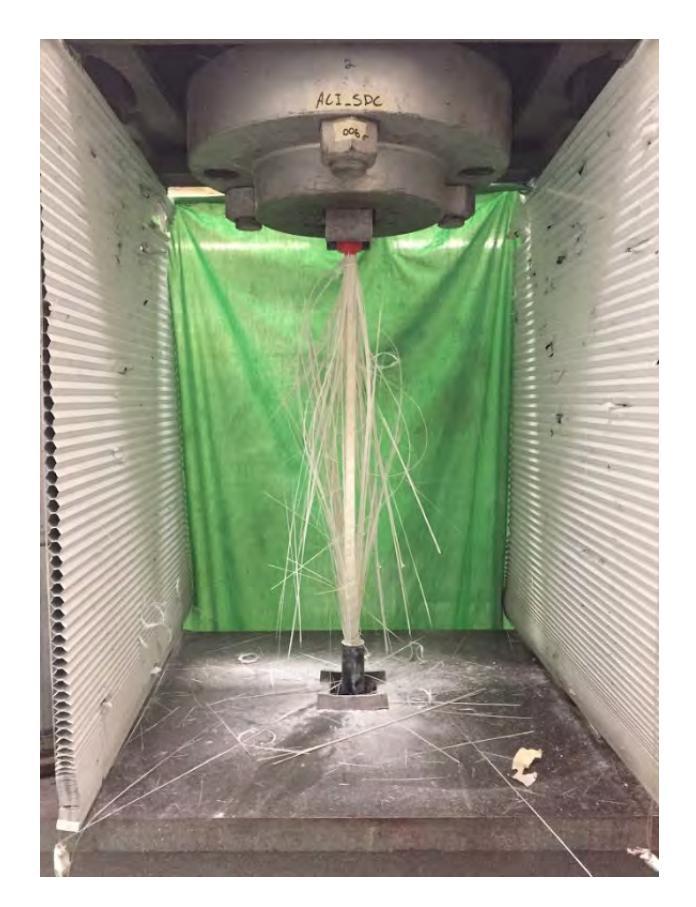
Fig. 60. Bar 006 after failure

Pristine bar 006 failed at a peak load of 35,264 lbs. (157 kN). A photograph of the bar after failure is shown in Fig. 60. The extensioneter was removed at a load of 13,360 lbs., and therefore, the maximum strain could not be determined. The stress strain curve for this bar is shown in Fig. 61. A summary of the tensile test results is shown in Table 26.

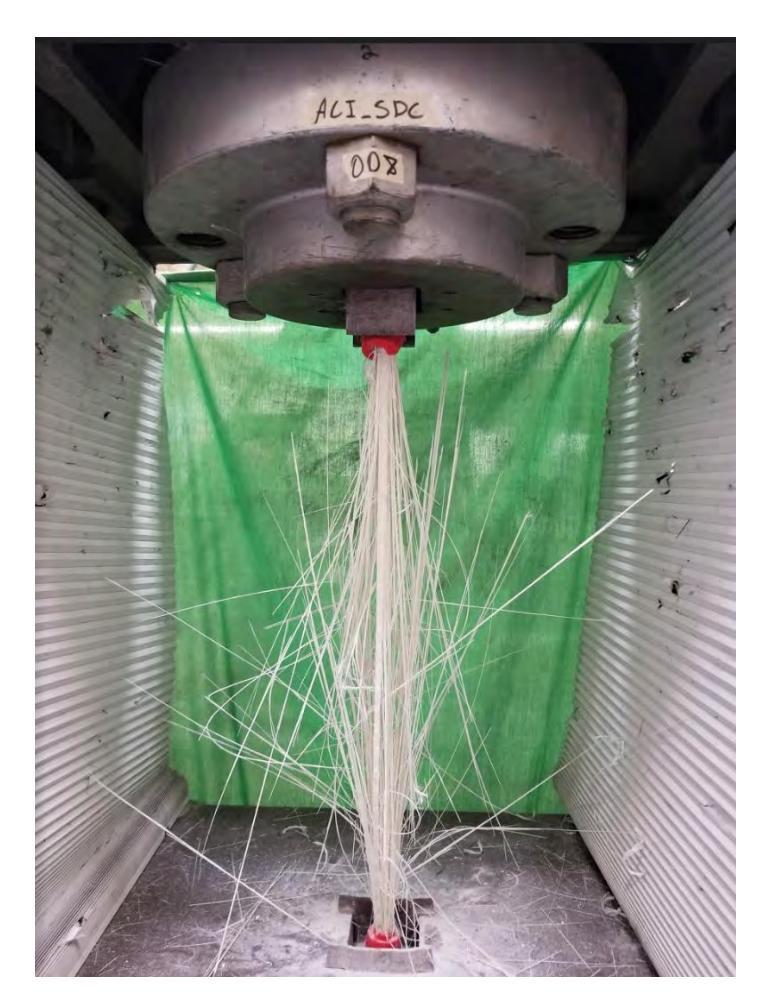
Fig. 63. Bar 008 after failure

Pristine bar 008 failed at a peak load of 37,212 lbs. (166 kN). The extensioneter was removed at a load of 11,880 lbs., and therefore, the maximum strain could not be determined The bar after failure is shown in Fig. 63 and the stress strain curve for this bar is shown in Fig. 64. A summary of the tensile test results is shown in Table 28.

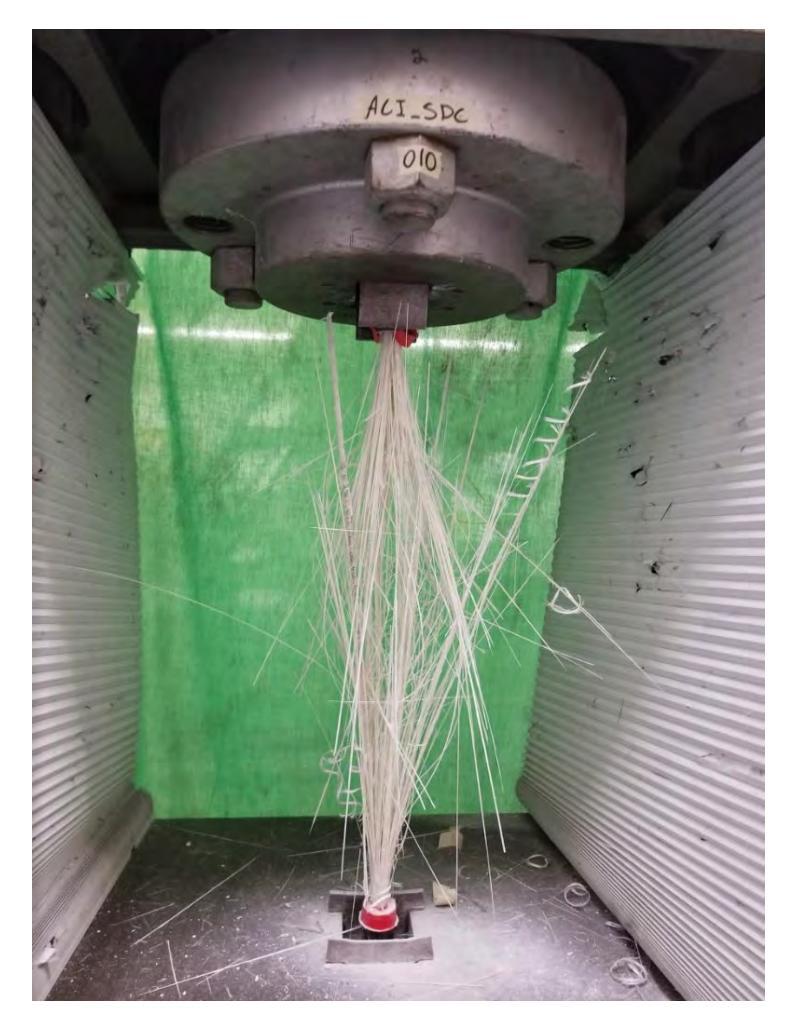
Fig. 66. Bar 010 after failure

Pristine bar 009 failed at a peak load of 36,972 lbs. (165 kN). The extensioneter was removed at a load of 12,100 lbs., and therefore, the maximum strain could not be determined. The bar after failure is shown in Fig. 66 and the stress strain curve for this bar is shown in Fig. 67. Due to initial manipulation of the extensioneter, initial conditions show initial deflection at load zero. A summary of the tensile test results is shown in Table 30.

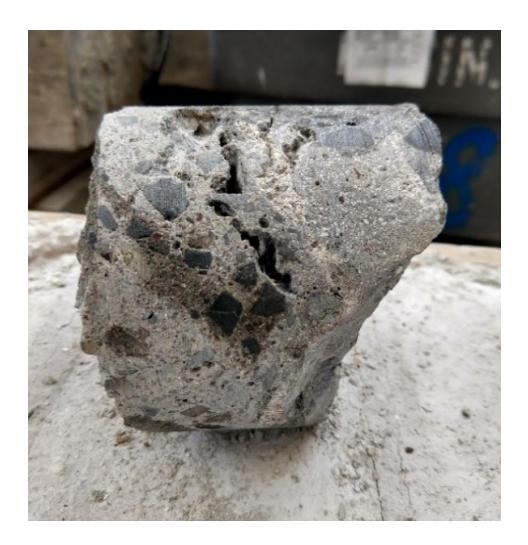
Some of the cores were also in poor condition—they had a significant amount of visible voids, or had extremely irregular end surfaces. These cores were split to obtain carbonation depth and chloride penetration using phenolphtalein and silver nitrate, respectively. An example of a core prior to splitting is shown in Figure 9.

Fig. 9–. Core specimen with irregular ends and voids.

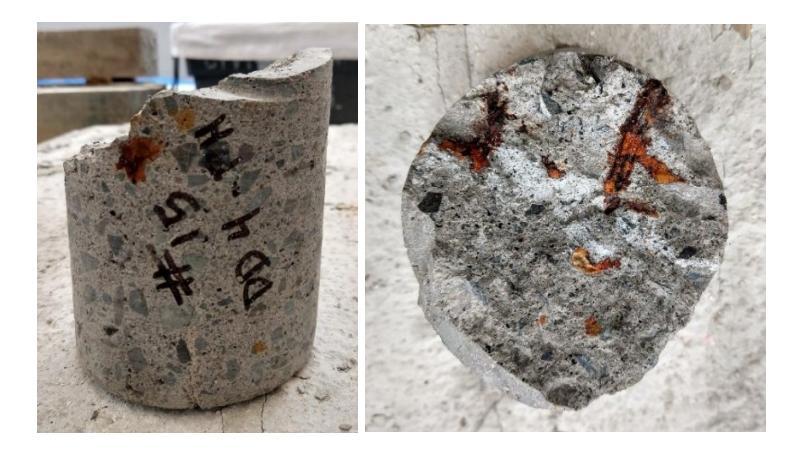
Some of the cores still had steel reinforcement embedded in them. Carbonation and chloride depth were tested on these cores. Evident steel corrosion was observed in these specimens as shown in Figure 10.

Fig. 10–. Core #15 with corrosion from embedded steel bar.

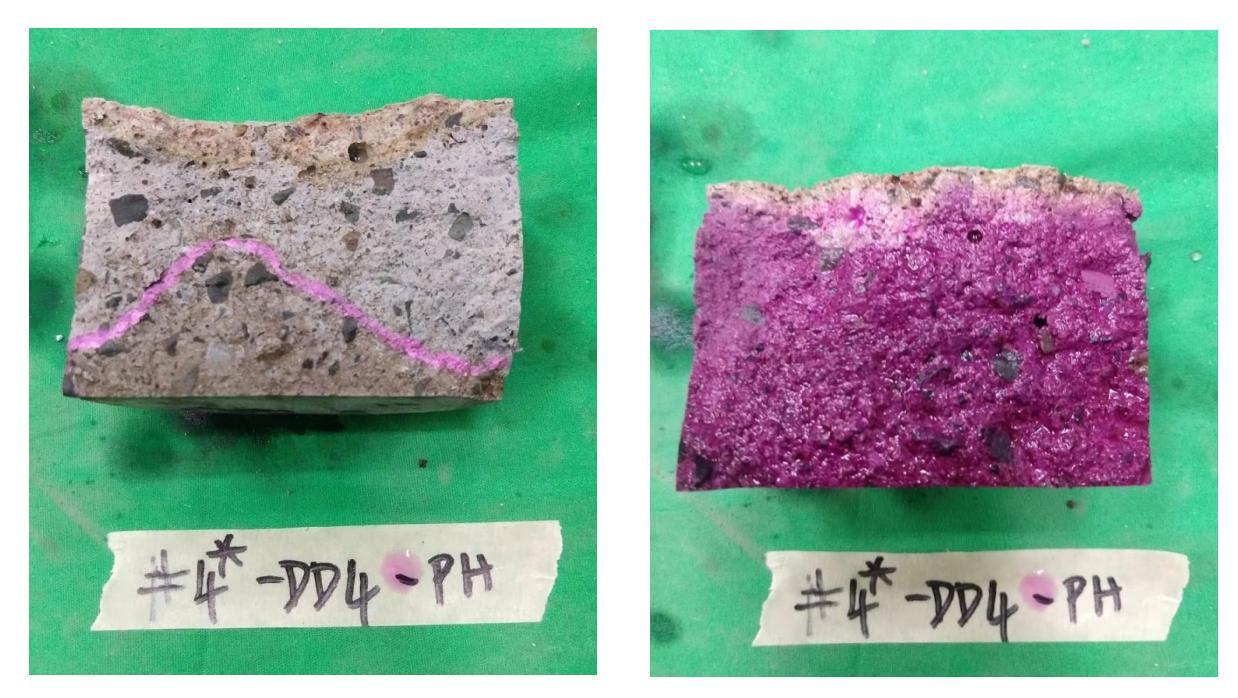
Representative images for chloride and carbonation depths measured (by spraying silver nitrate on one half of the core and phenolphthalein on the other half) are shown in Figure 6. Since some cores tested were partially broken (or not full in length), an exact depth from the surface cannot be calculated without further details. However, the values were measured for the respective cores using a Vernier caliper, and the results are shown in Table 9. Chloride ingress was observed in all specimens and carbonation was observed in eight out of the twelve tested specimens. When no carbonation was observed, N/A was recorded in Table 9.

*Fig.* 54 –*Core* #4\* – *Representative image for chloride and carbonation depths.*

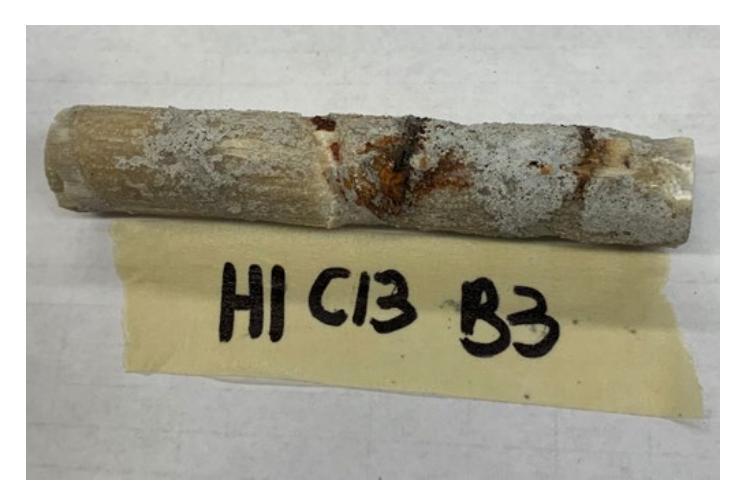
Horizontal shear tests were performed on four coupons from Dry Dock #4. Only one specimen, C14\_B1, presented a clear horizontal shear failure, where a crack on the cross section could be observed. The other specimens presented horizontal cracks on the outside surface, near where the load was being applied as shown in Figures 20 and 21. When specimens C3\_B1 and C13\_B3 were cut to perform fiber content, visual horizontal shear cracks and matrix crack between fiber and resin could be observed at the cross section as shown in Figure 22. This delamination between resin and fiber was later confirmed with SEM images, which can be found in Section 4.5. This could be due to cyclic swelling and shrinking with water and/or temperature exposure, facilitated by a weak interface between fiber and resin.

Fig. 20 –Bar #3 from core #13 after horizontal shear test.

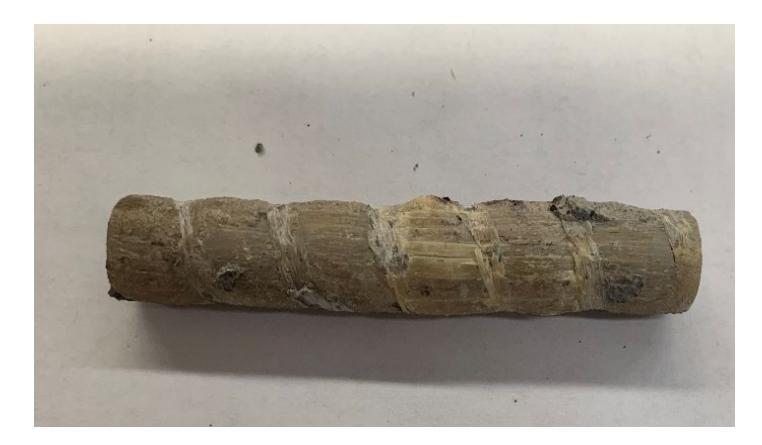
Fig. 211 –Bar #1 from core #3 with horizontal cracks after horizontal shear test.

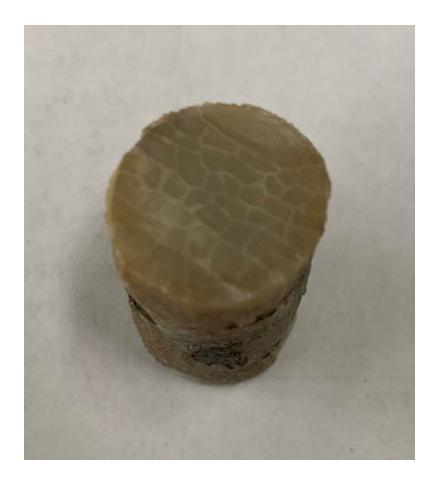
Fig. 22 –Bar #1 from core #3 cross section at midspan with matrix cracking.

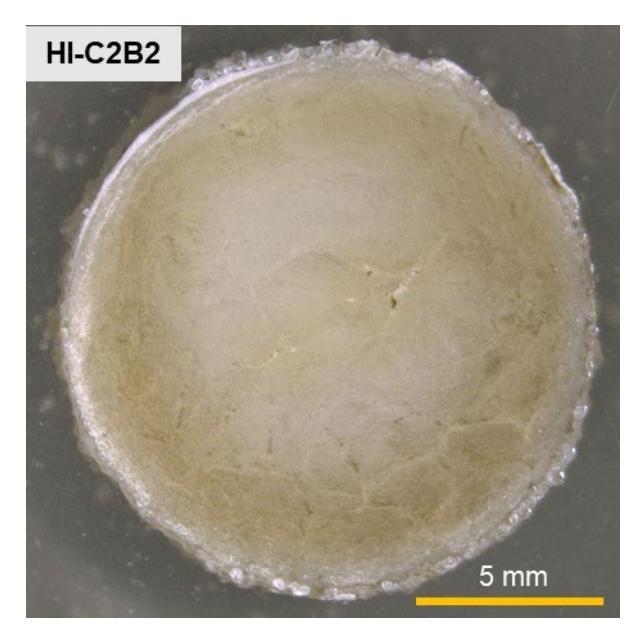
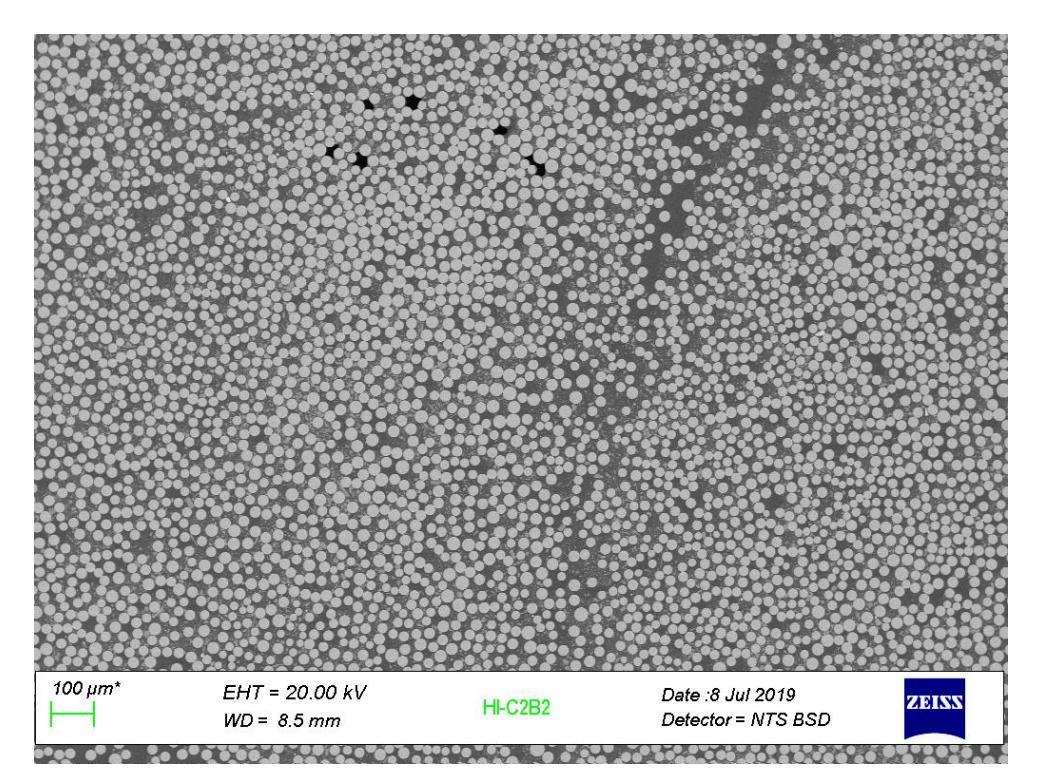
A specimen from bar C2\_B2, as shown in Figure 41, was used for SEM image. SEM images, shown in Figures 42 through 48, suggest deterioration of fibers and resin near the edge of the bar. The fibers in the interior of the bar were intact and the damaged fibers were observed where the resin had heavy deterioration. The fibers negatively affected by the concrete environment were estimated by visual imagery to range between 0.05 to 0.12% of the total number. The damaged fibers were estimated from counting fibers with obvious signs of damage in 1 quadrant, multiplied by 4. Large voids causing delamination among the fibers were observed near the edge of the bar.

*Fig. 48–Core #2 Bar #2 center of rebar.*

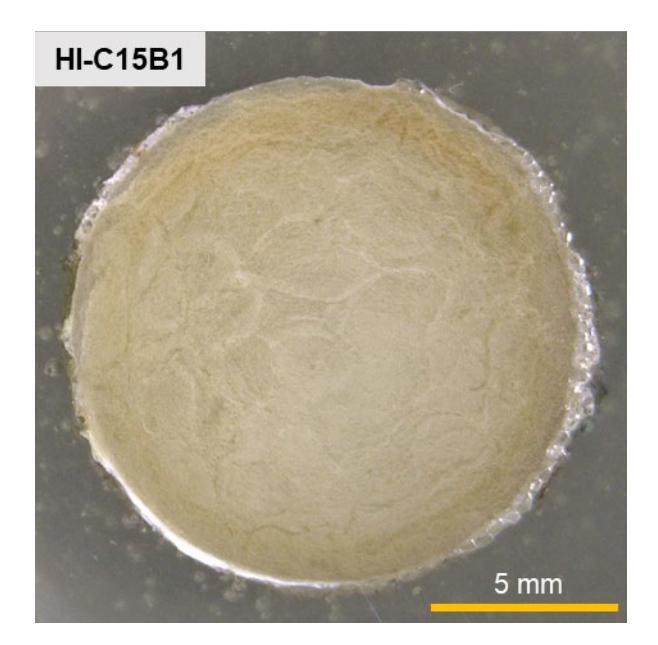
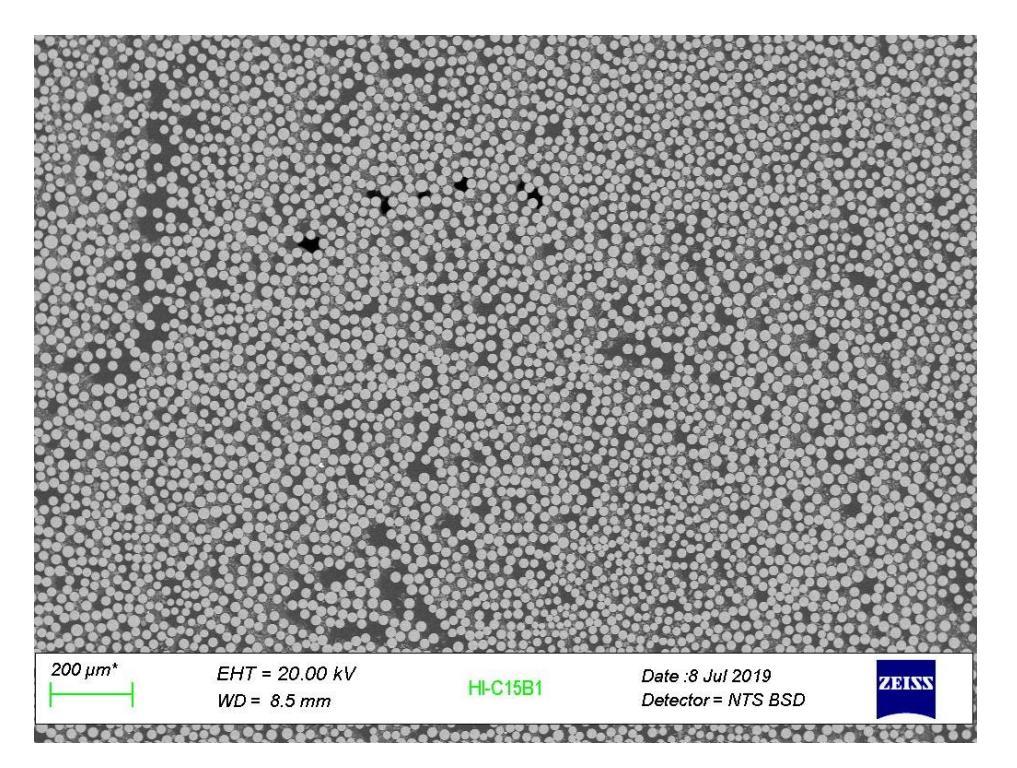
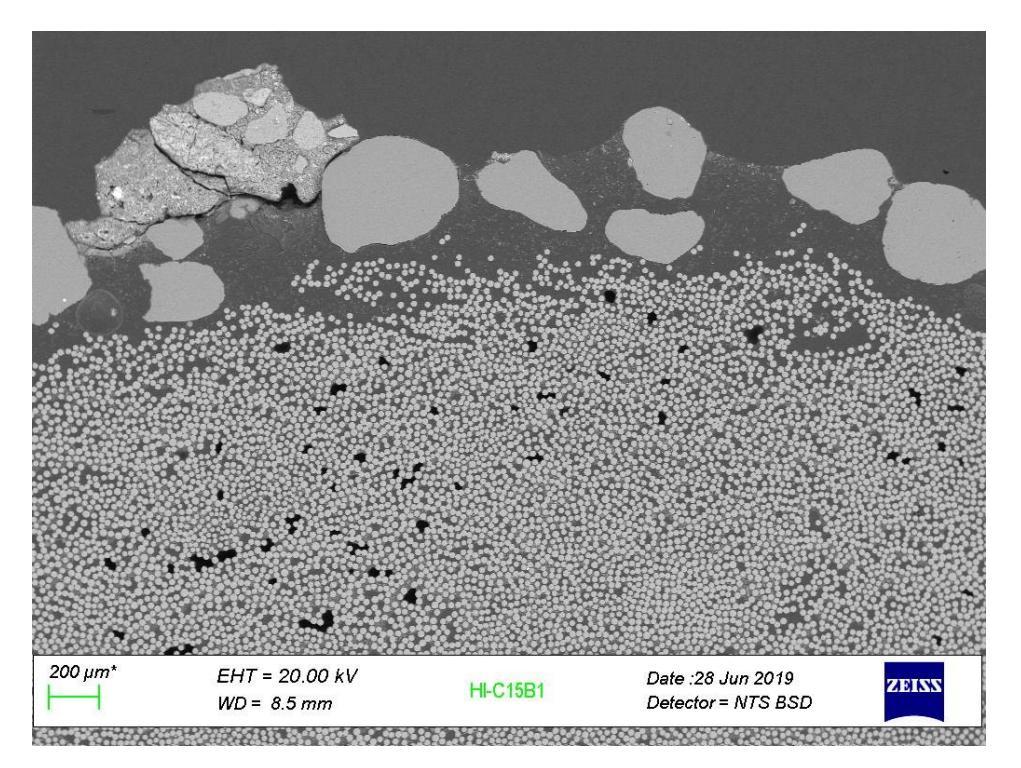
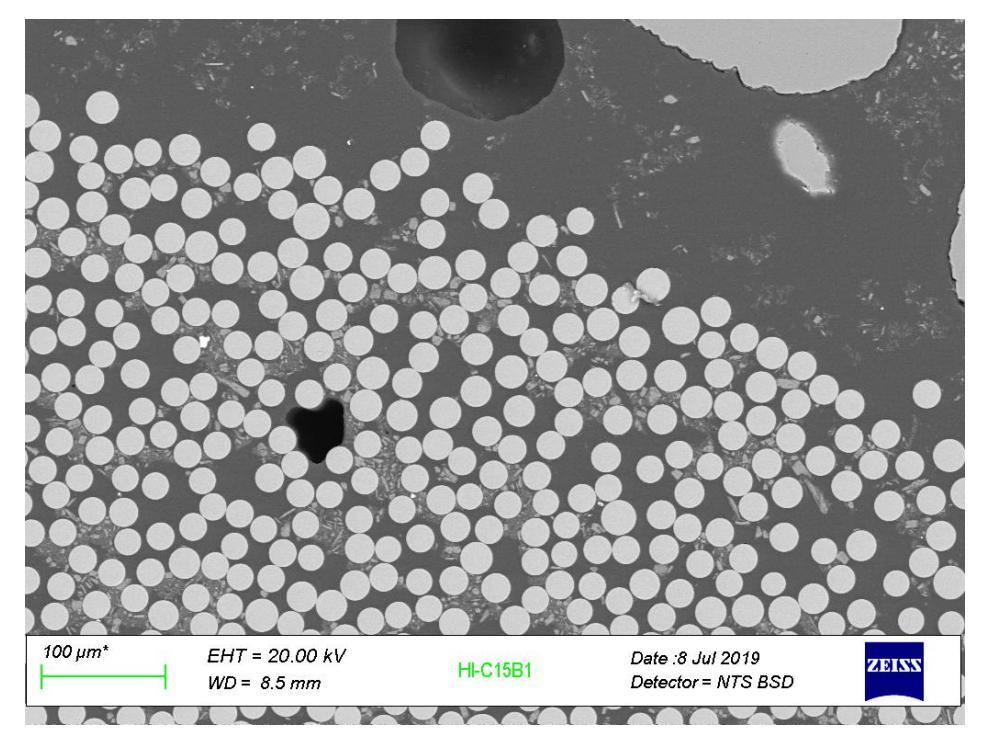
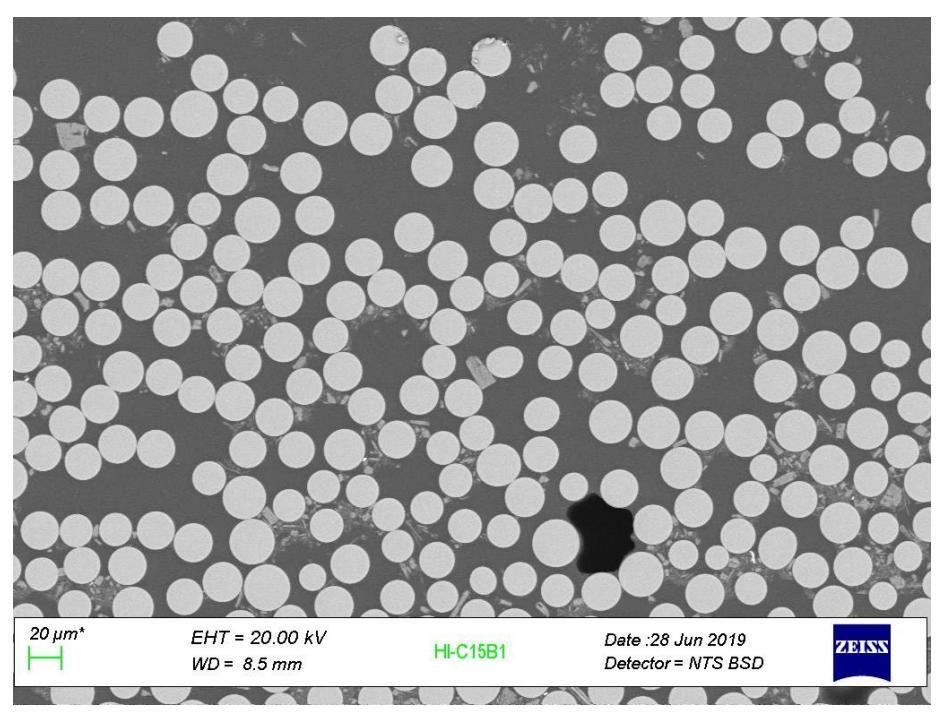
A specimen from bar C2\_B2, as shown in Figure 49, was used for SEM image. As shown in Figures 50 through 54, nearly no negatively affected fibers were observed on the interior or exterior of the bar. Large voids in the resin were observed near the edge of the bar where larger quantities of Na<sub>2</sub>O and Cl where detected during EDS, however, it cannot be determined if the

voids were pre-existing or caused by these elements. Signs of fiber damage were only observed in locations corresponding to voids in the resin. Some voids appeared to be causing debonding among the fibers at different locations of the bar cross section.

Fig. 50 –Core #15 Bar #1 at center

*Fig. 51 –Core #15 Bar #1 at edge.*

Fig. 52 –Core #15 Bar #1 at edge

Fig. 53 –Core #15 Bar #1 at edge
