# **Durability of GFRP Bars Extracted from Bridges with 15 to 20 Years of Service Life** June 1, 2019

# DURABILITY OF GFRP BARS EXTRACTED FROM BRIDGES WITH 15 TO 20 YEARS OF SERVICE LIFE

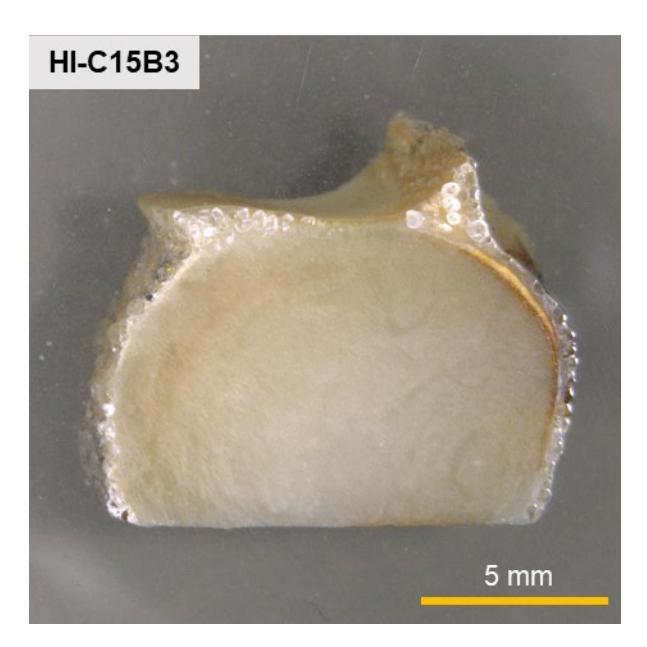
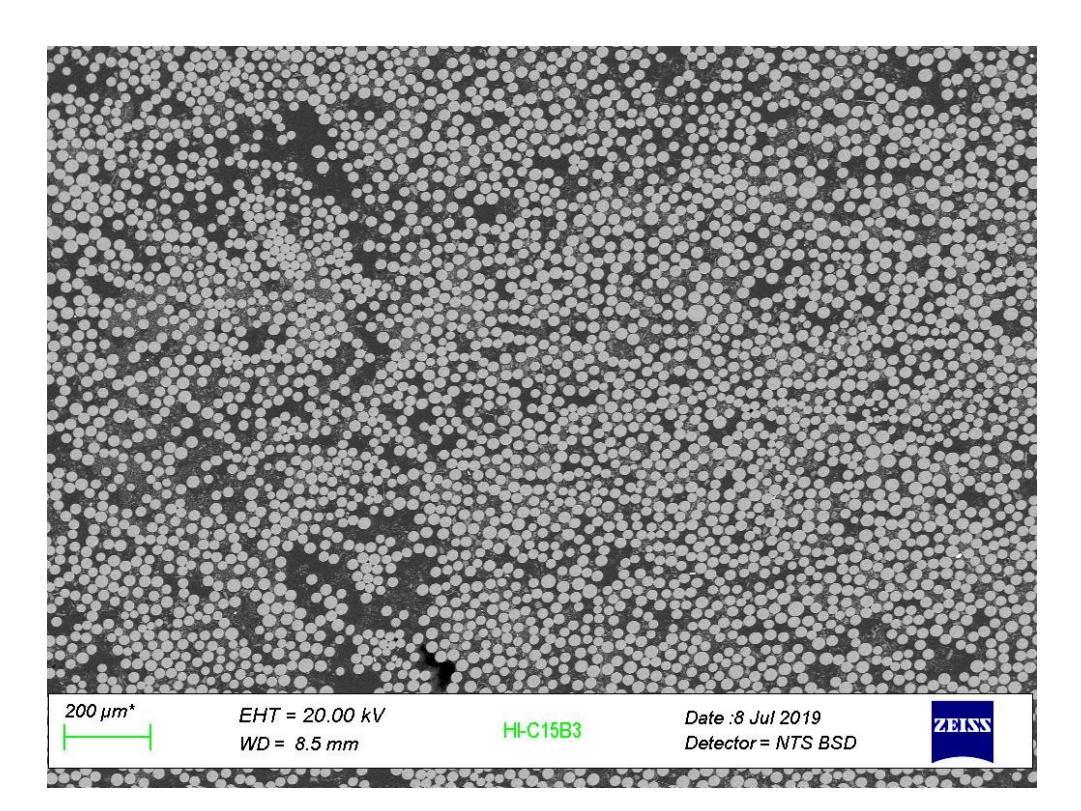
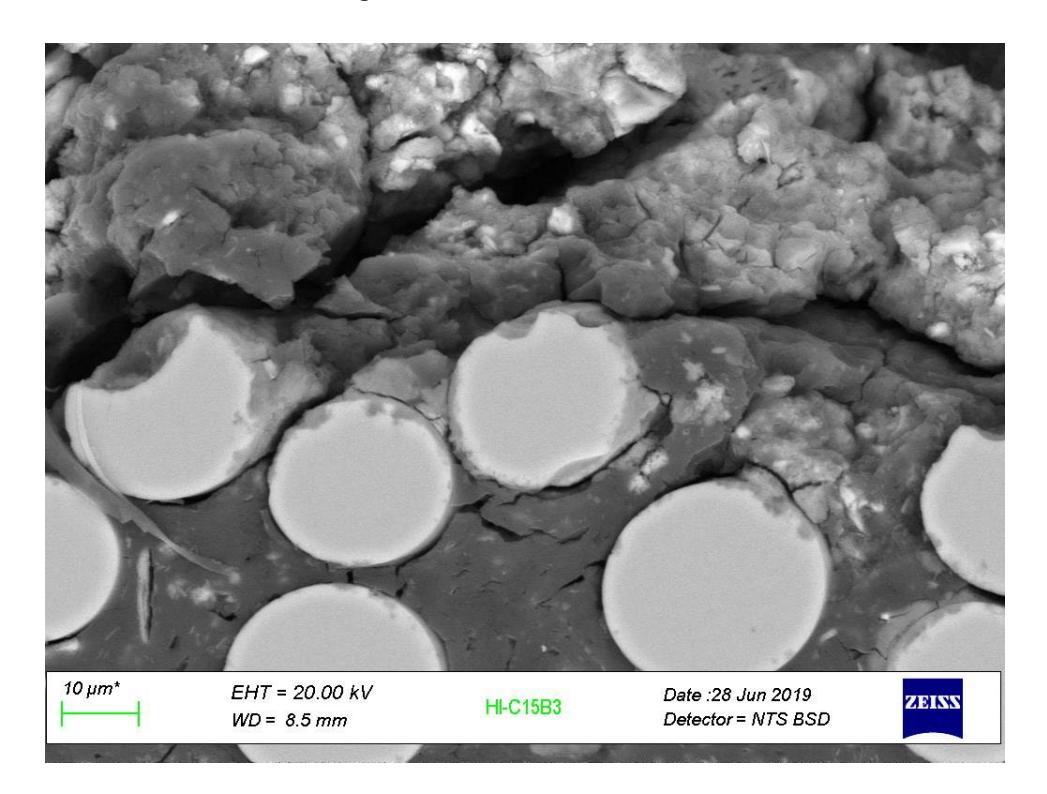
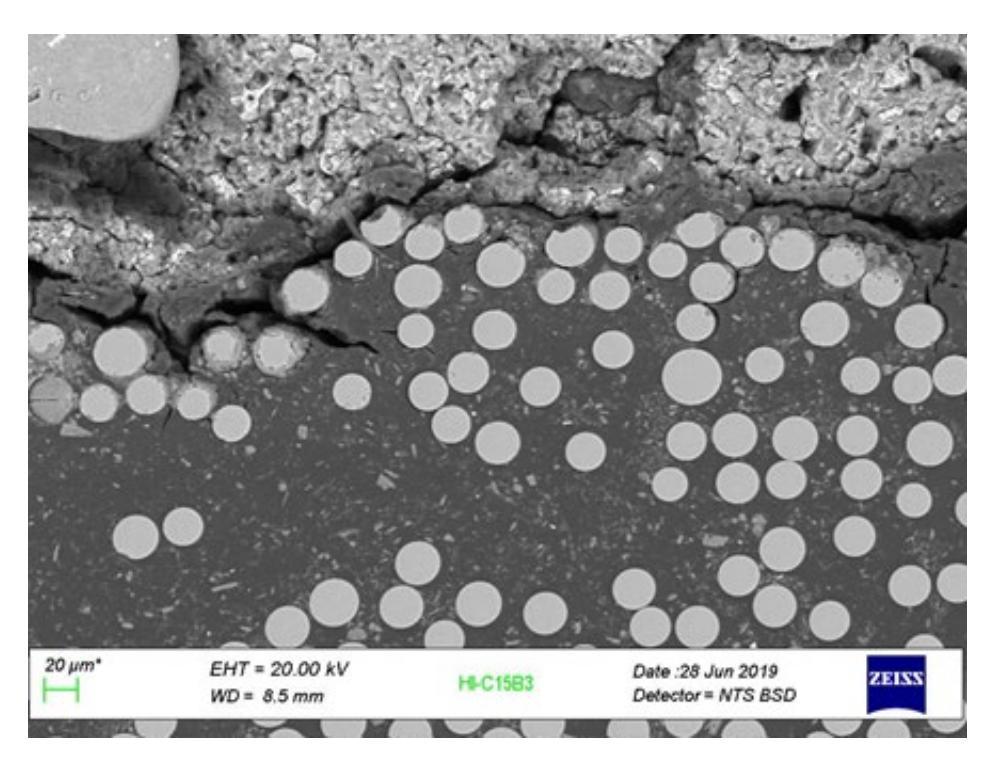
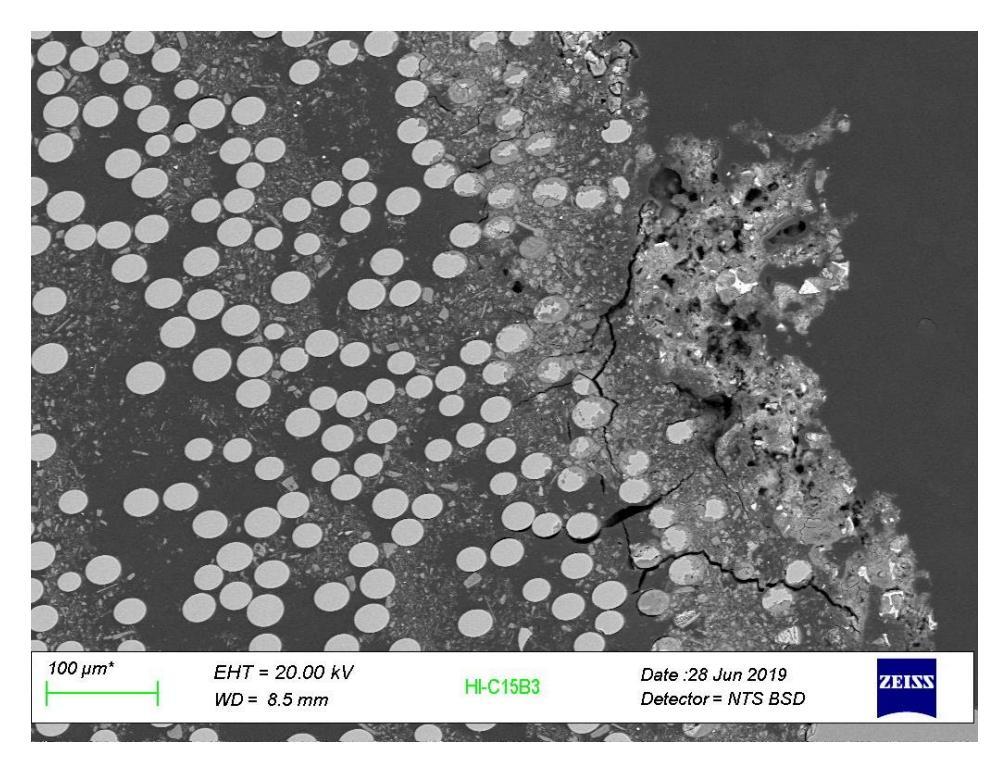
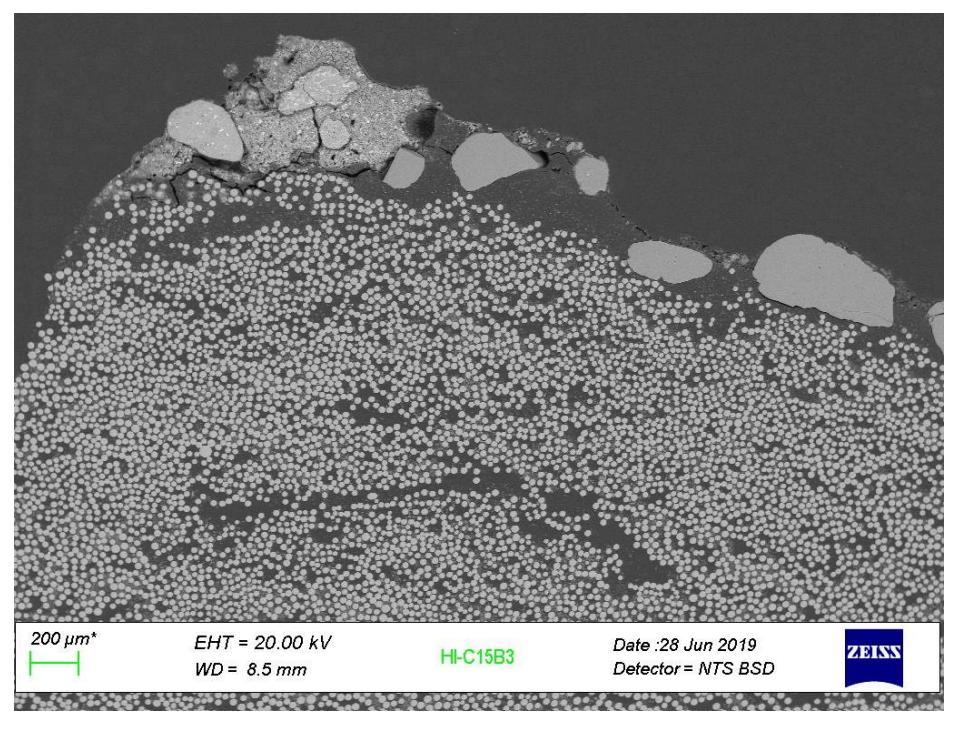
A specimen from bar C2\_B2 was used for SEM image. As shown in Figure 55, the specimen was not a full rebar cross section. As shown in Figures 56 through 60, some negatively affected fibers were observed, but appeared to be isolated on the outer perimeter. The damaged fibers were at locations where the resin is damaged. Some voids in the resin were also observed closer to the center of the bar, suggesting degradation in the interphase between fiber and resin.

*Fig. 56 –Core #15 Bar #3 at center*

Fig. 57 – Core #15 Bar #3 at edge. Fibers negatively affected

Fig. 58 –Core #15 Bar #3 at edge

*Fig. 59 –Core #15 Bar #3 at edge.*

*Fig. 60 – Core #15 Bar #3 at edge.*

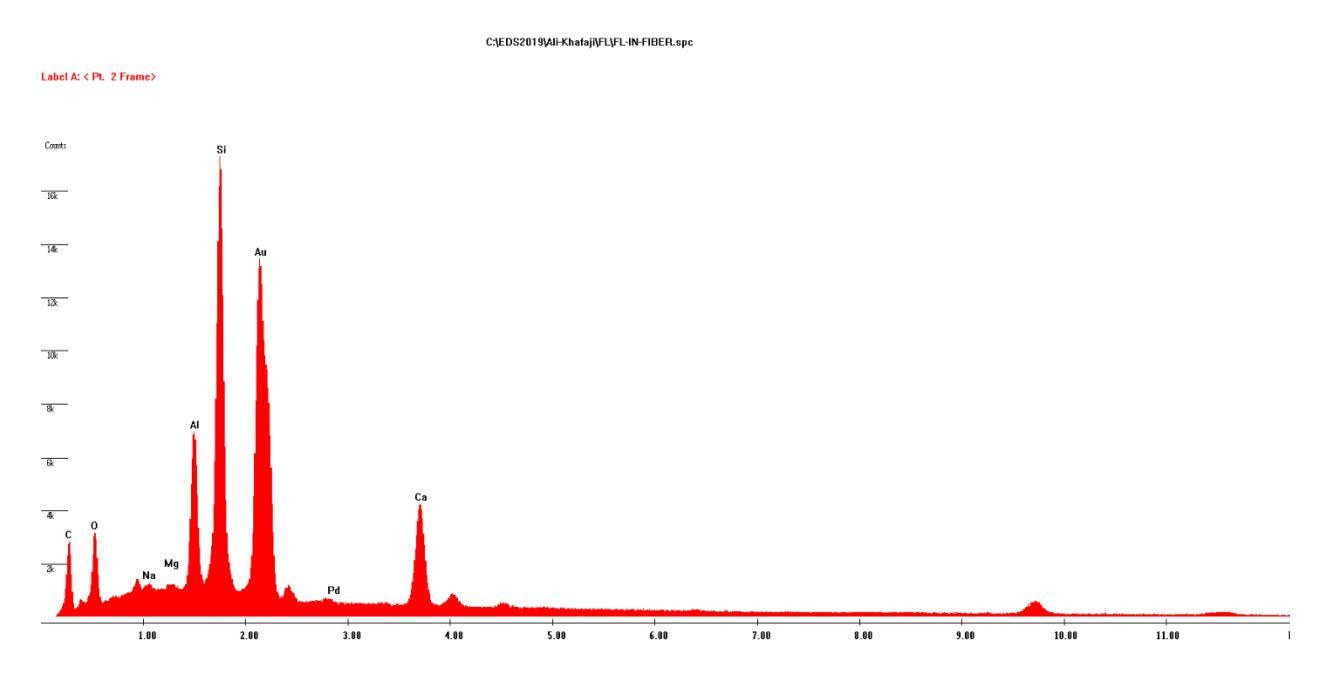
Fig. 61 – Core #2 Bar#2 Si, Al, Ca and small quantities of Na were detected on the center of the fiber

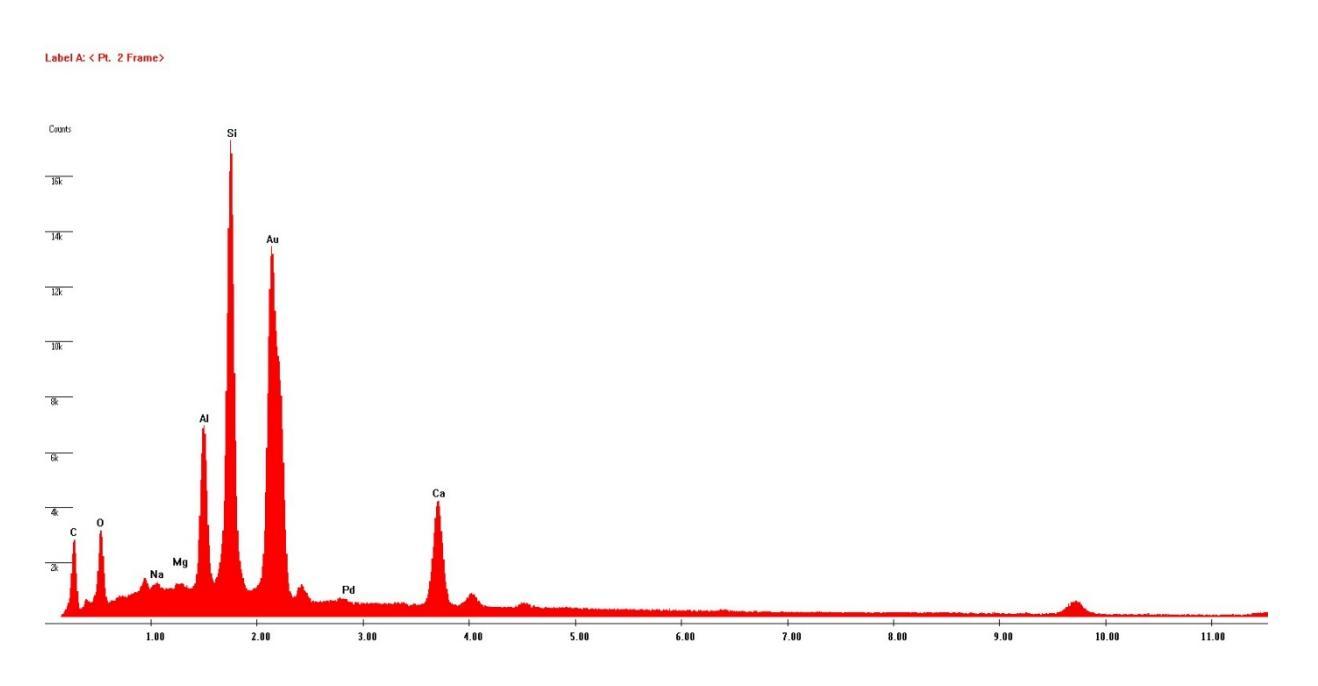
Fig. 62 – Core #3 Bar#2 Si, Al, Ca and small quantities of Na were detected on the center of the fiber

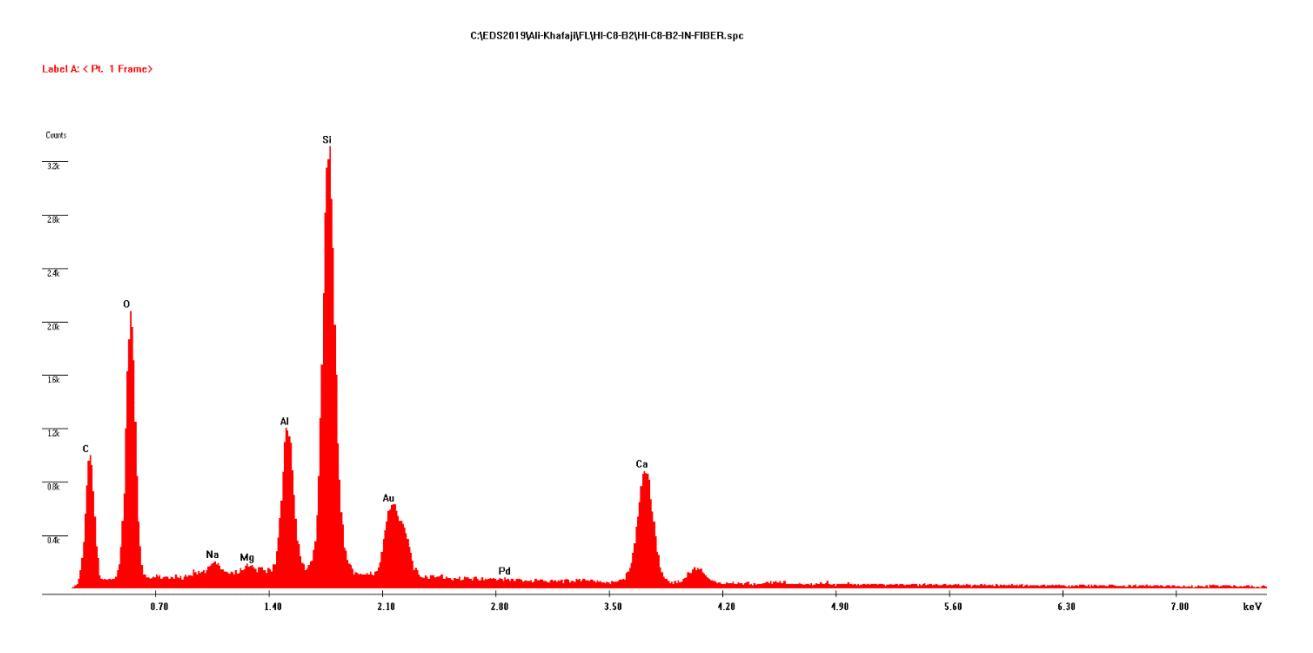
Fig. 63 – Core #8 Bar#2 Si, Al, Ca and small quantities of Na were detected on the center of the fiber

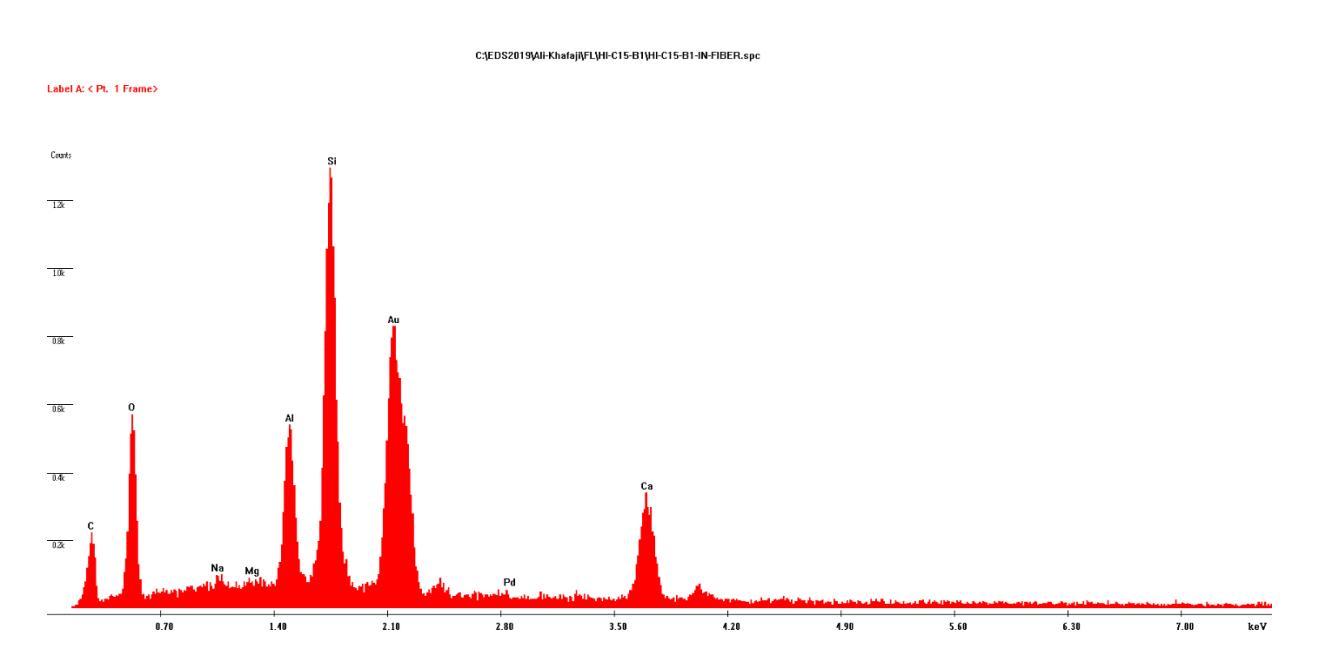
Fig. 64 – Core #15 Bar#1 Si, Al, Ca and small quantities of Na were detected on the center of the fiber

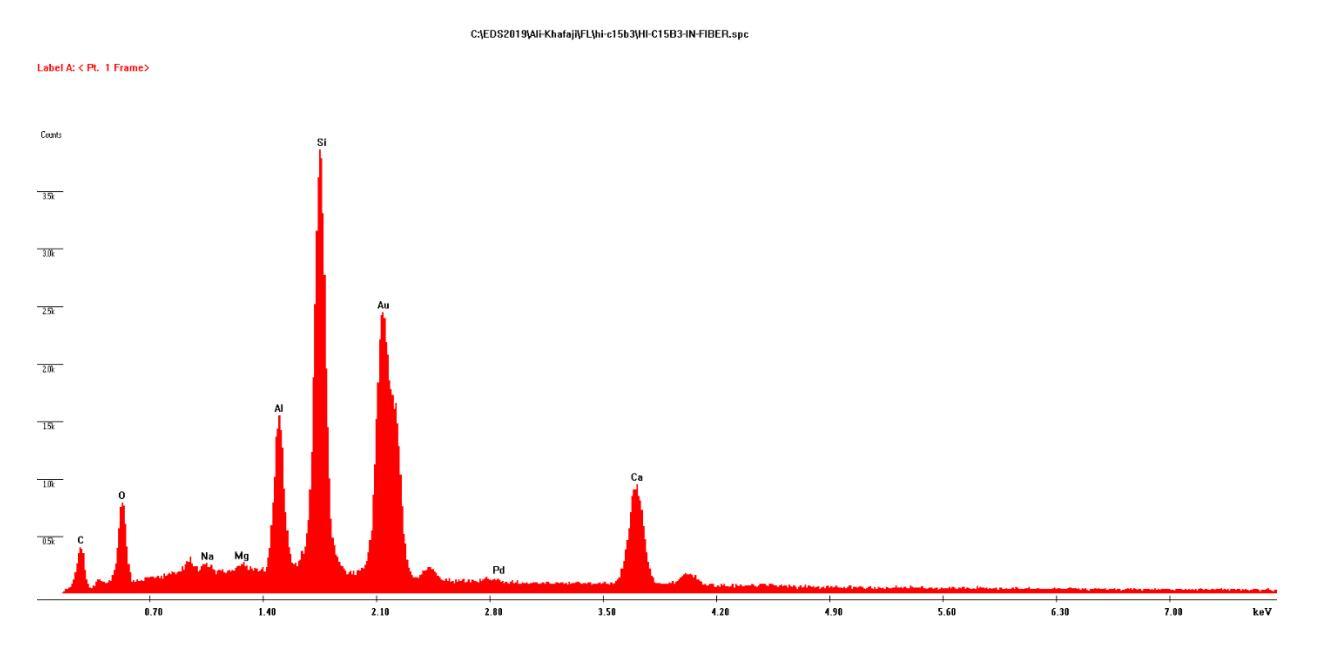
Fig. 65 – Core #15 Bar#3 Si, Al, Ca and small quantities of Na were detected on the center of the fiber
