Durability of GFRP Bars Extracted from Bridges with 15 to 20 Years of Service Life

June 1, 2019

DURABILITY OF GFRP BARS EXTRACTED FROM BRIDGES WITH 15 TO 20 YEARS OF SERVICE LIFE

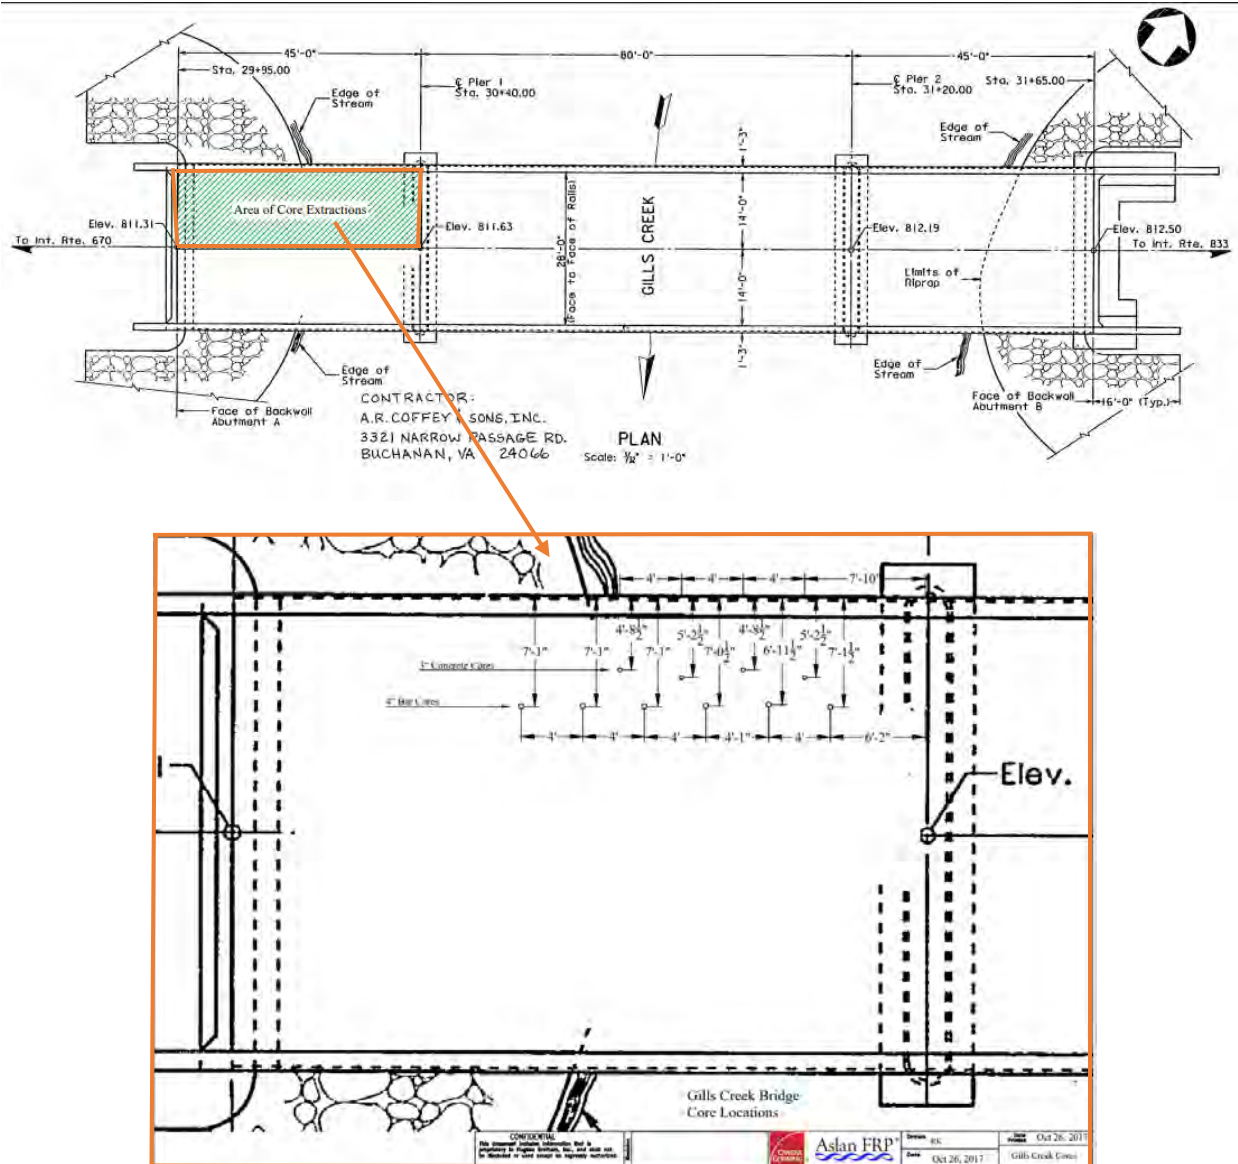
Fig. 3—Gills Creek Bridge location of extracted cores

Ten concrete cores were extracted from Gills Creek Bridge deck to be used for durability testing. The location of the extracted cores is shown in Fig. 3.

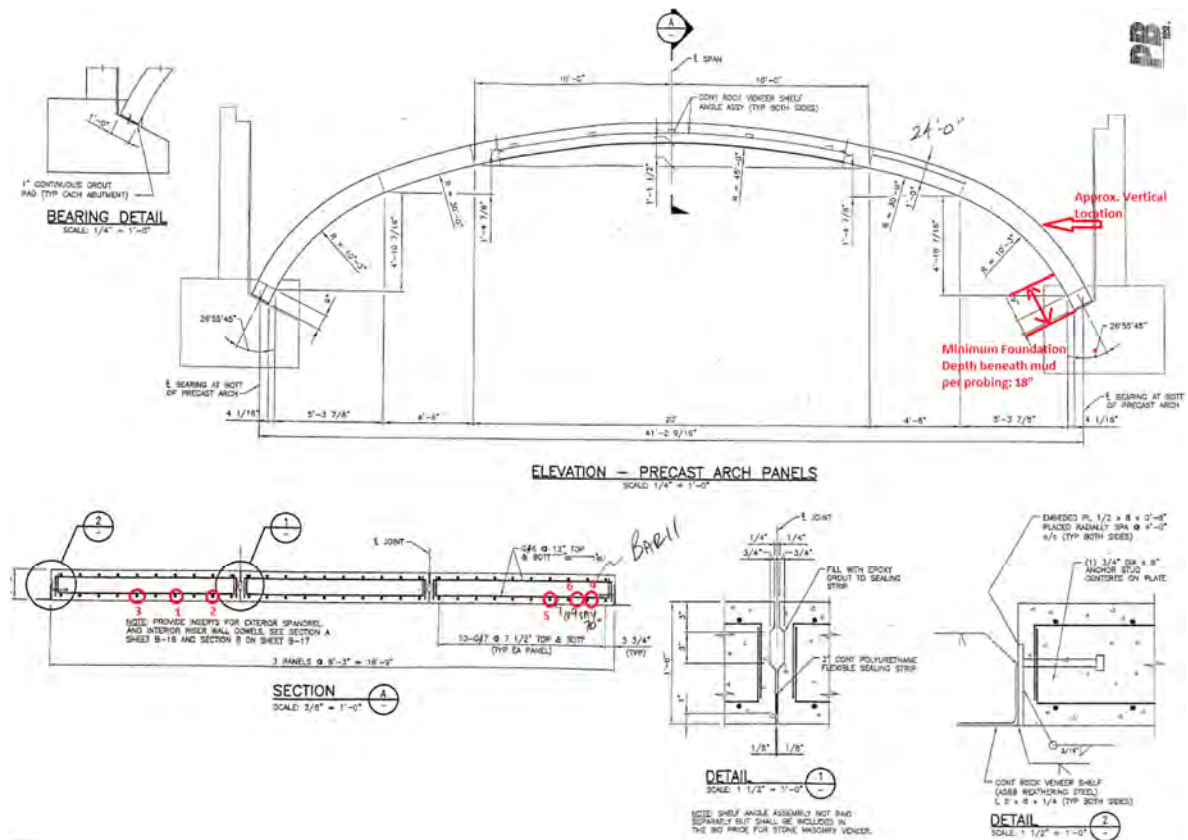
Fig. 6—O'Fallon Bridge location of extracted cores

Ten concrete cores were extracted from underneath the bridge deck of O'Fallon Park Bridge. The location of the extracted cores is shown in Fig. 6 and Fig. 7.

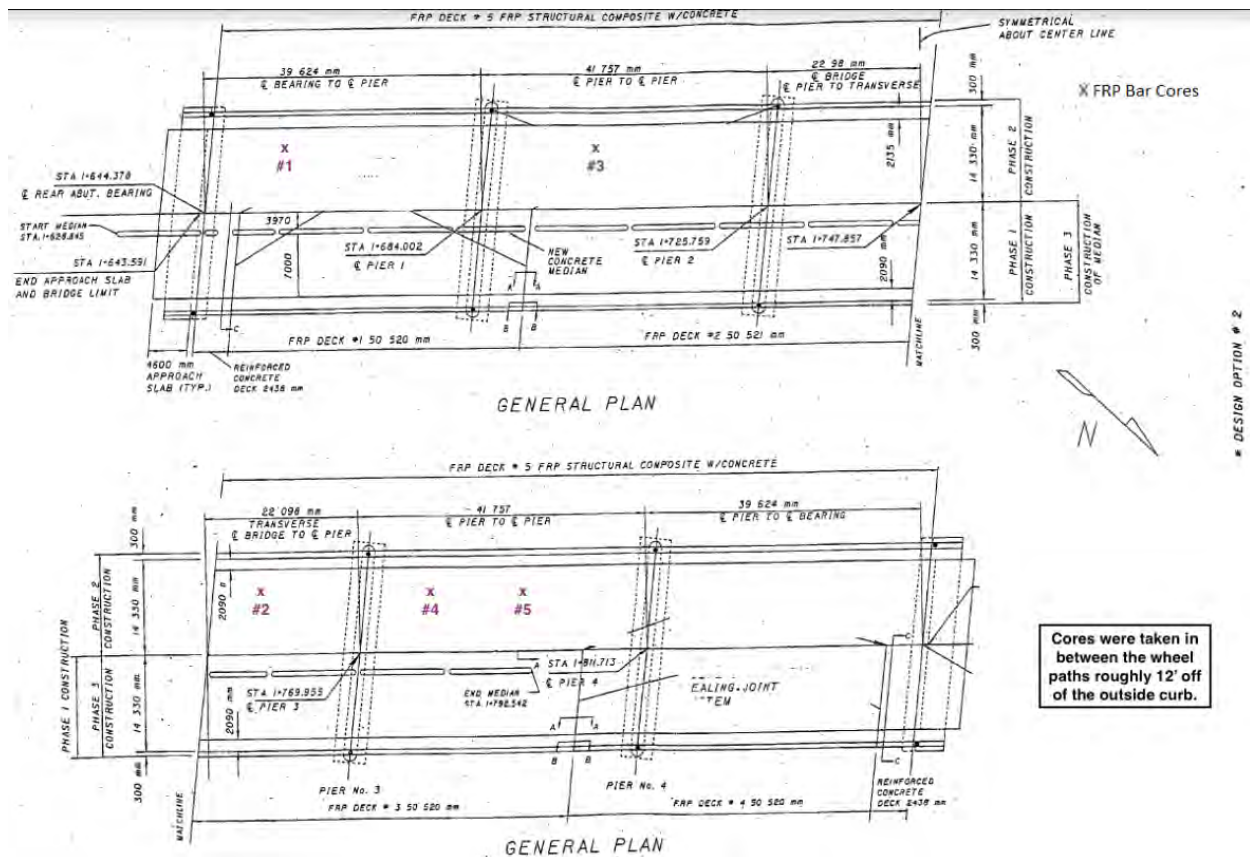
Fig. 10–Salem Bridge location of extracted cores

Five concrete cores were extracted from the Salem Ave. Bridge deck to be used for durability testing. The location of the extracted cores included the four different FRP systems and is shown in Fig. 10.

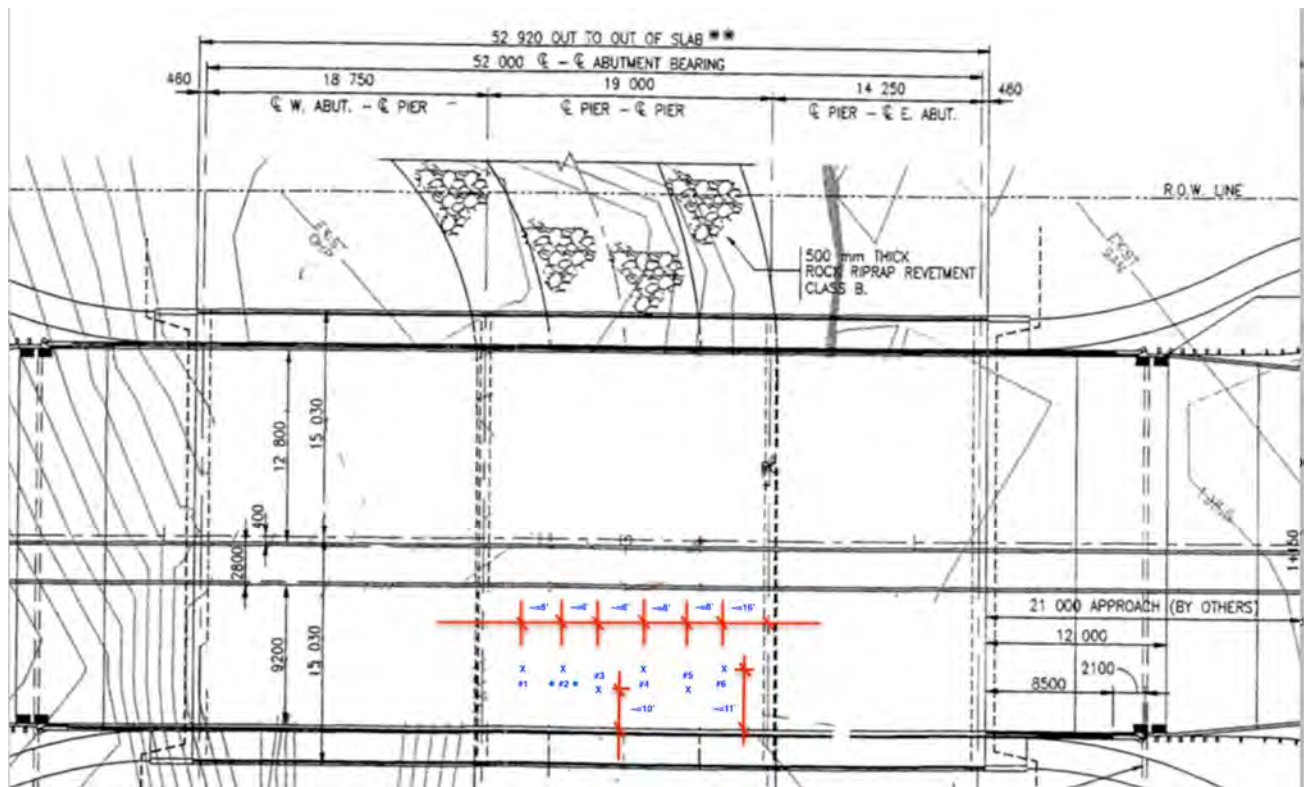
Fig. 13–Bettendorf location of extracted cores

Six concrete cores were extracted from Bettendorf Bridge deck to be used for durability testing. The location of the extracted cores is in *Fig. 13*.

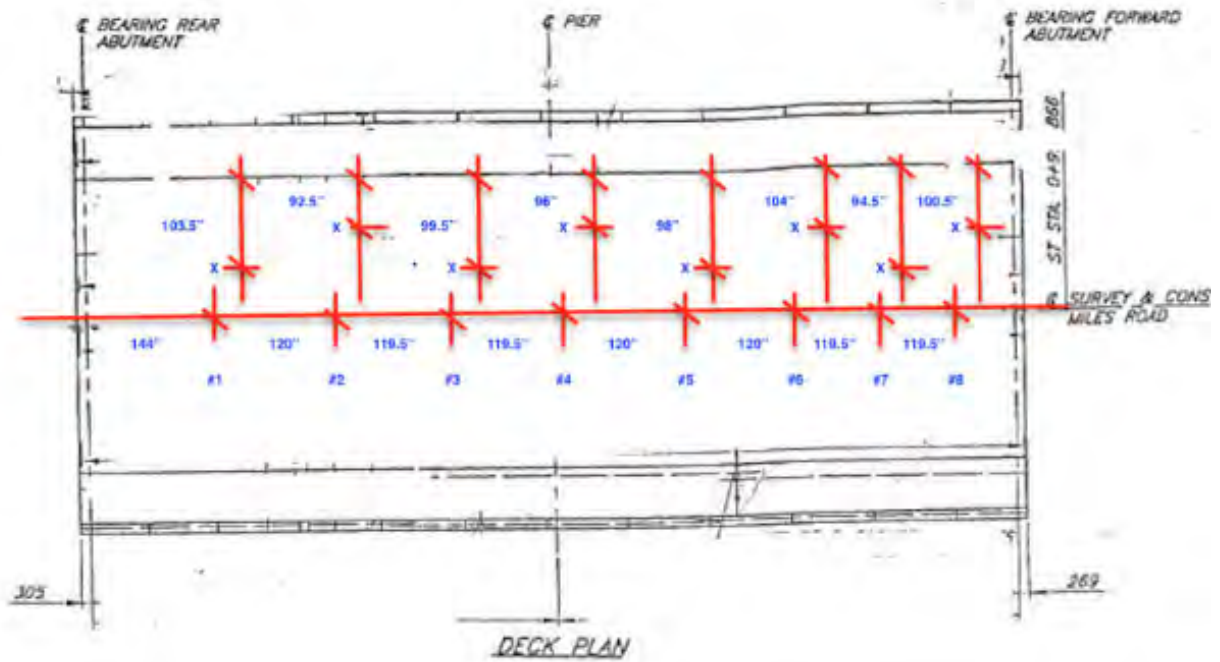
Fig. 16–Cuyahoga Bridge location of extracted cores

Eight concrete cores were extracted from the Cuyahoga County Bridge deck. The locations of the extracted concrete cores are shown in Fig. 16 and Fig. 17.

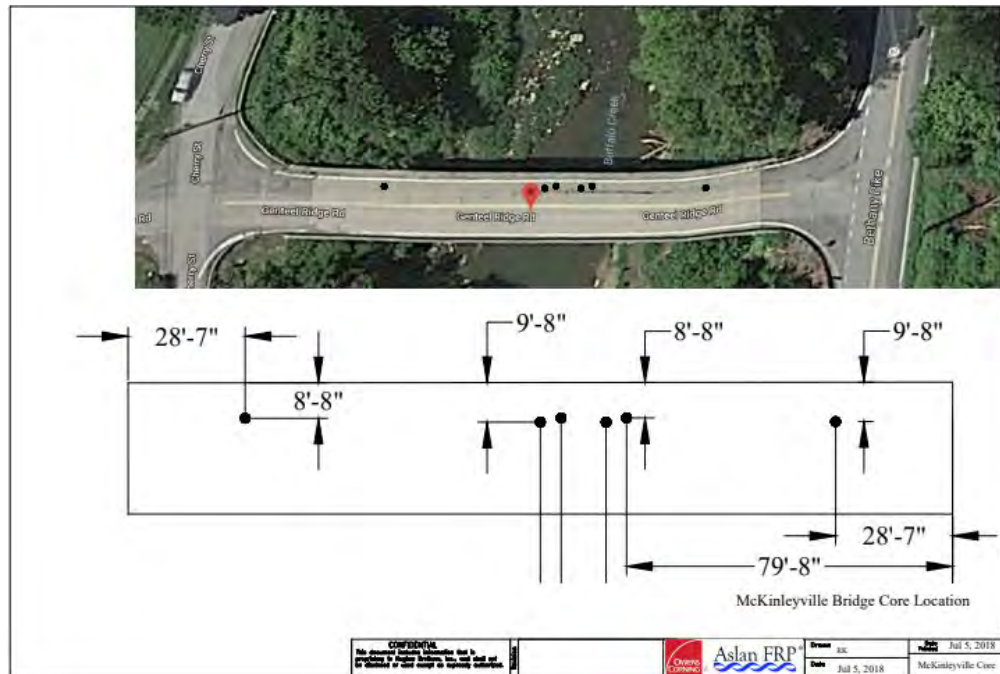
Fig. 19–McKinleyville Bridge location of extracted cores

Five concrete cores were extracted from *McKinleyville Bridge* deck. *Fig. 19* shows the location of six extracted cores; however, only five concrete cores were received.

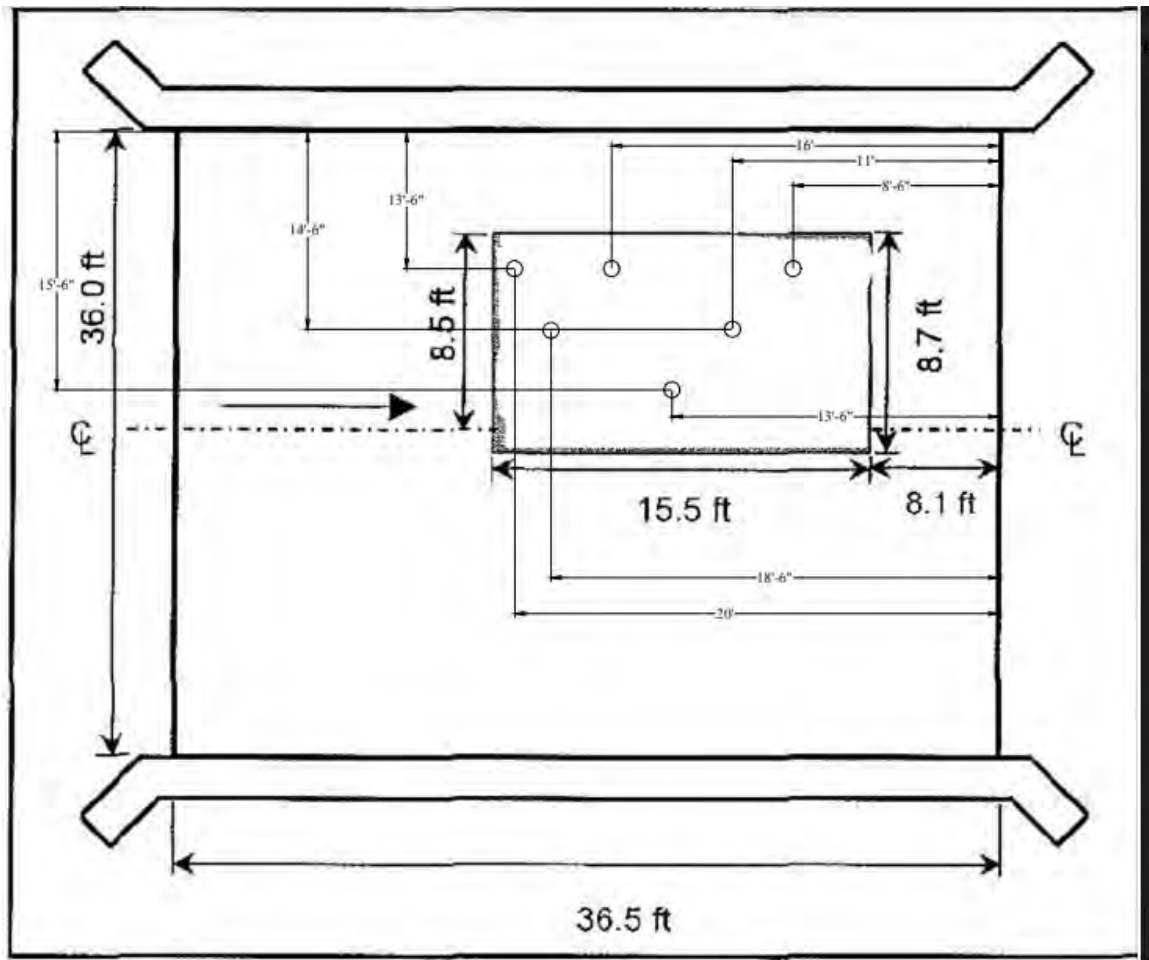
Fig. 22–Roger's Creek Bridge location of extracted cores

Six concrete cores from the Roger's Creek Bridge deck were extracted. The location of the extracted cores is shown in *Fig. 22*.

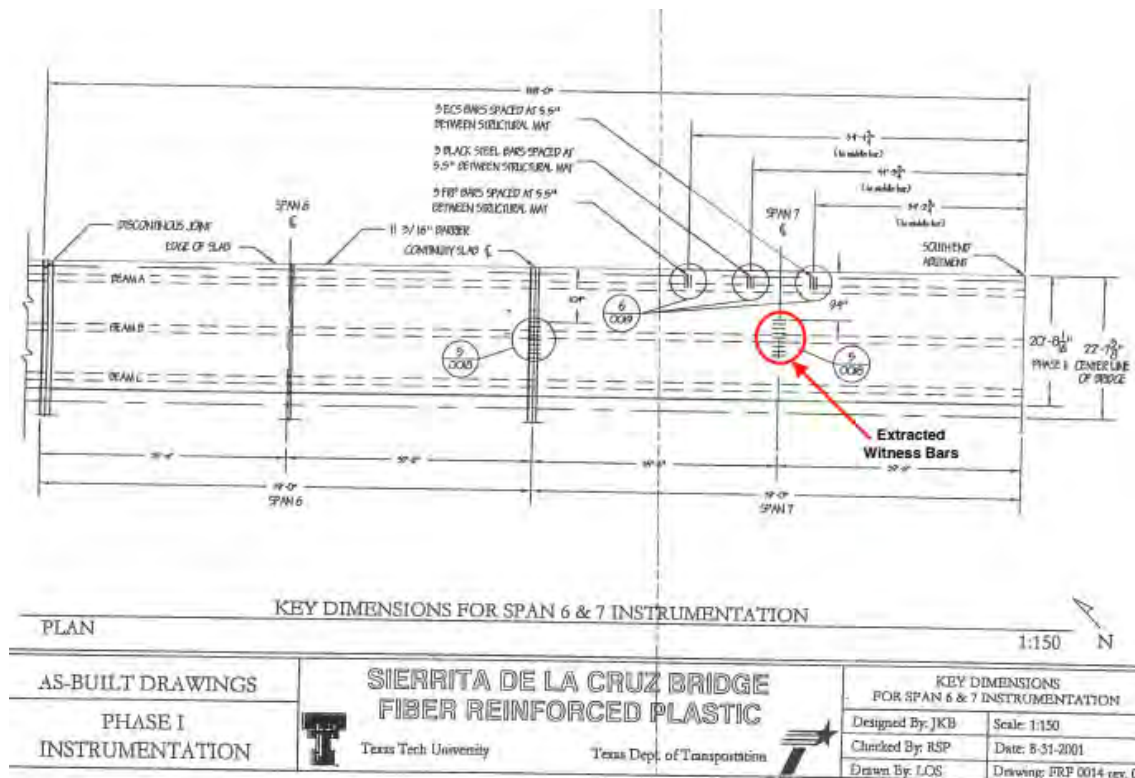
Fig. 29–Sierrita de la Cruz Creek Bridge location of extracted cores

Two concrete cores were extracted from Sierrita de la Cruz Creek Bridge deck and three bars for tensile testing. The location of the extracted cores is shown in Fig. 29.

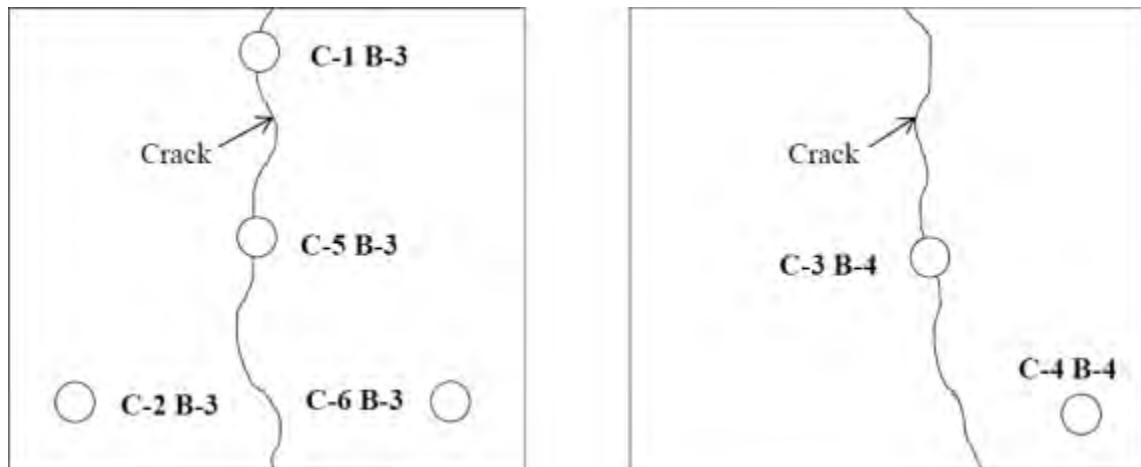
Fig. 31–Walker Box Bridge location of extracted cores. (Wang et al. 2018)

Six concrete cores were extracted from Walker Box Culvert Bridge. The extracted cores were taken near cracked areas, where the concrete is most affected by environmental conditions, as shown in Fig. 31.

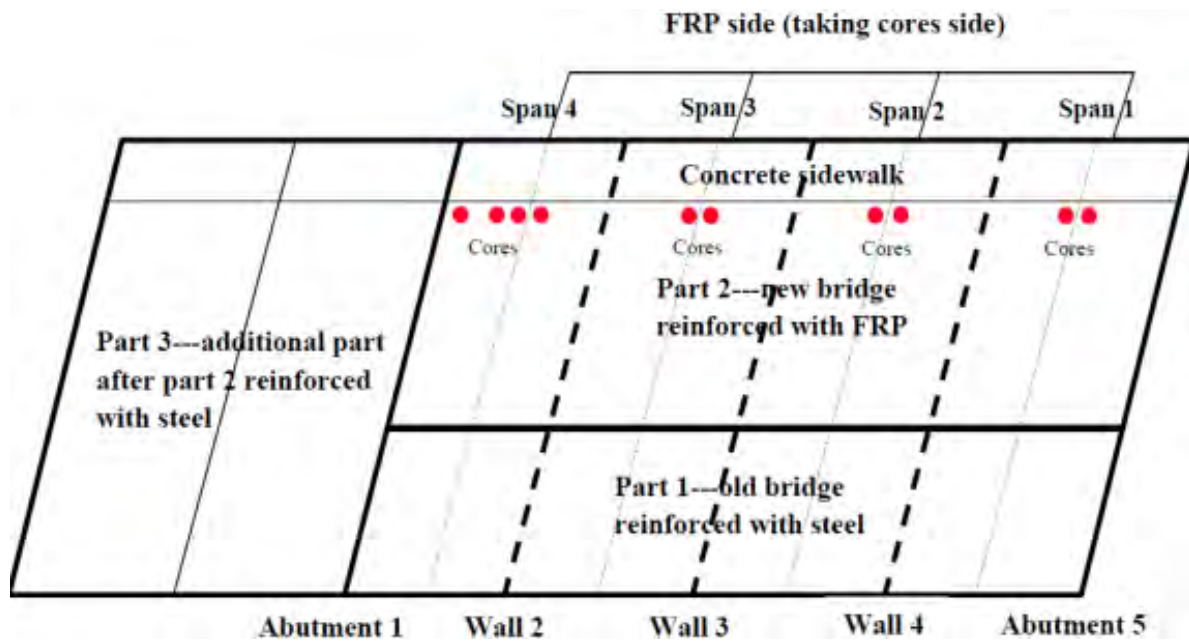
Fig. 34--Southview Bridge location of extracted cores (Wang et al. 2018)

Ten concrete cores were extracted from Southview Bridge. However, only two cores used for durability testing in this study. The location of the extracted cores is shown in *Fig. 34*.

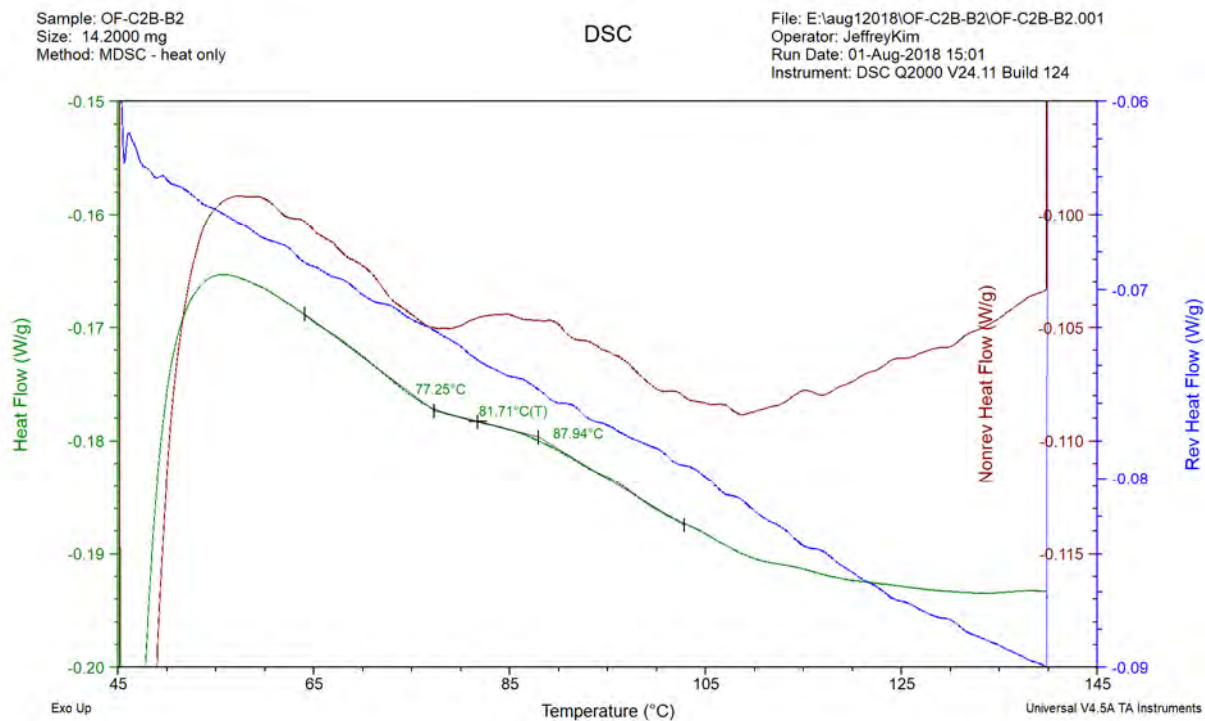
The lowest T_g was 176°F (80°C) for O'Fallon Park Bridge and the highest was 239°F (115°C) for Sierrita de la Cruz Creek. It should be kept in mind that bars from Sierrita de la Cruz Creek were analyzed using DMA rather than DSC. According to the ASTM D7957 GFRP bar specification, the T_g is required to be equal to or greater than 212°F (100°C) as a critical parameter in load transfer capability of the resin.

Fig. 48—Example differential scanning calorimetry curve for determining T_g on a bar from the O’Fallon bridge

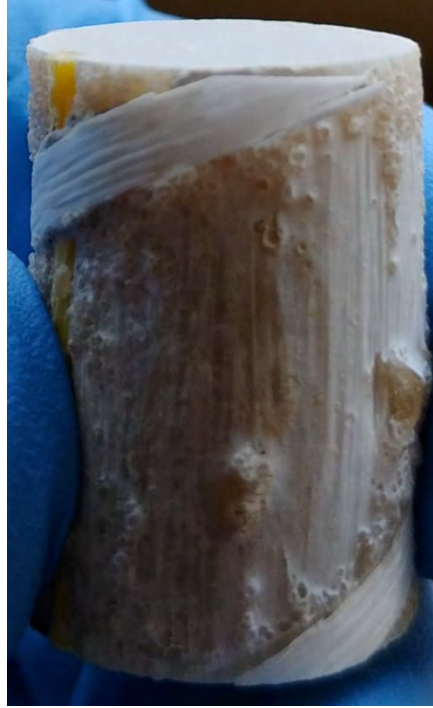
During moisture absorption testing, OH2_C4_B2(2) lost weight between some of the measurements. Between 28 and 35 days into uptake testing, lost a large piece of helical wrap. Fig. 8 displays the cause for this loss in weight.

Fig. 8. Part of the helical wrap fell off of OH2_C4_B2-2

Weight losses as a result of pre-conditioning at 104 °F (40°C) for 48 h in non-circulating oven air are shown in Table 23. The two OH2_C4_B2 specimens had consistently higher pre-conditioning weight loss than any other bar. Such a faster change in percent weight can be expected for the OH2_C4_B2 bar because of its smaller diameter versus the other bars.

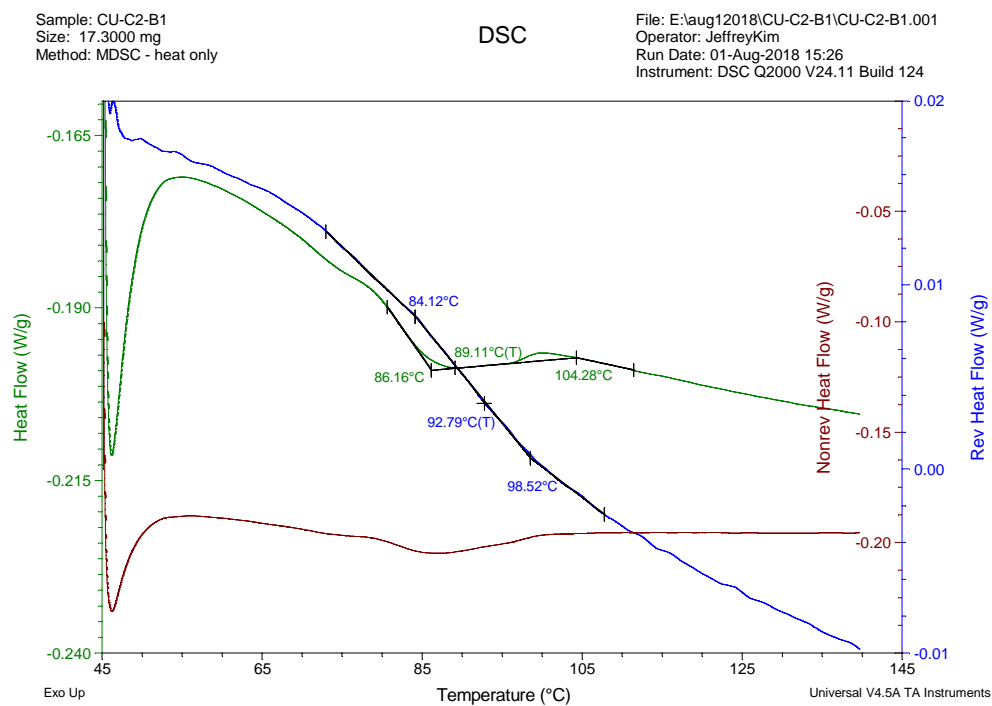
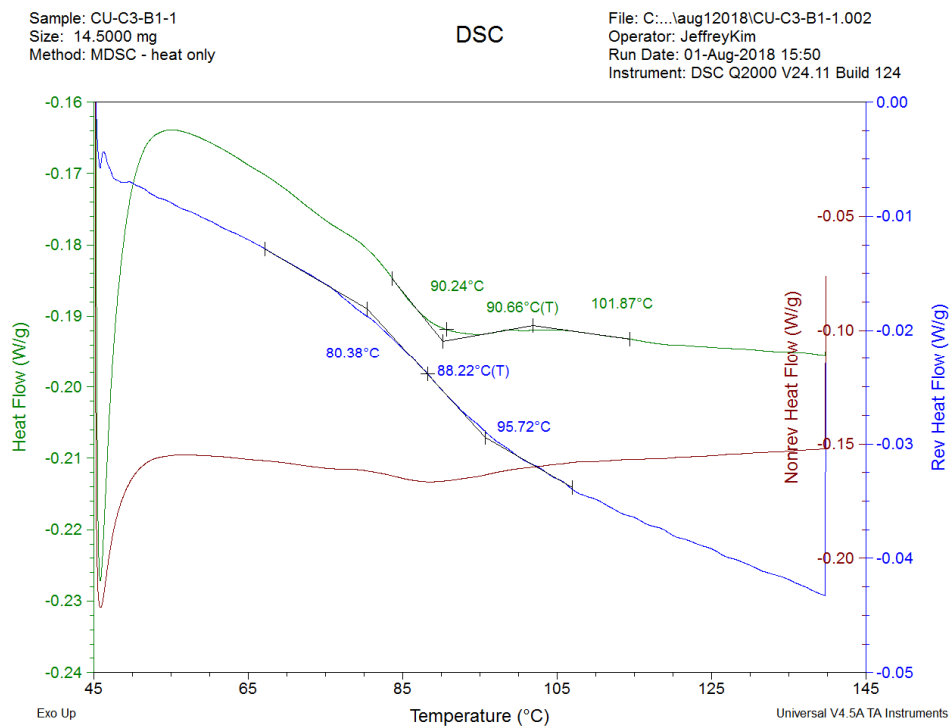
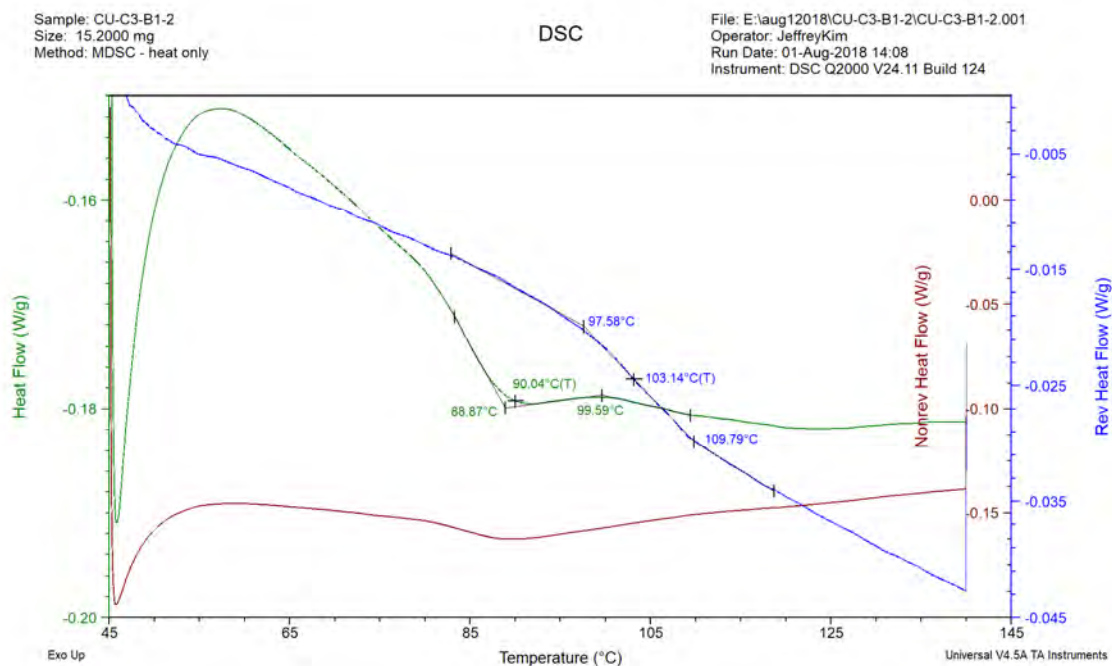
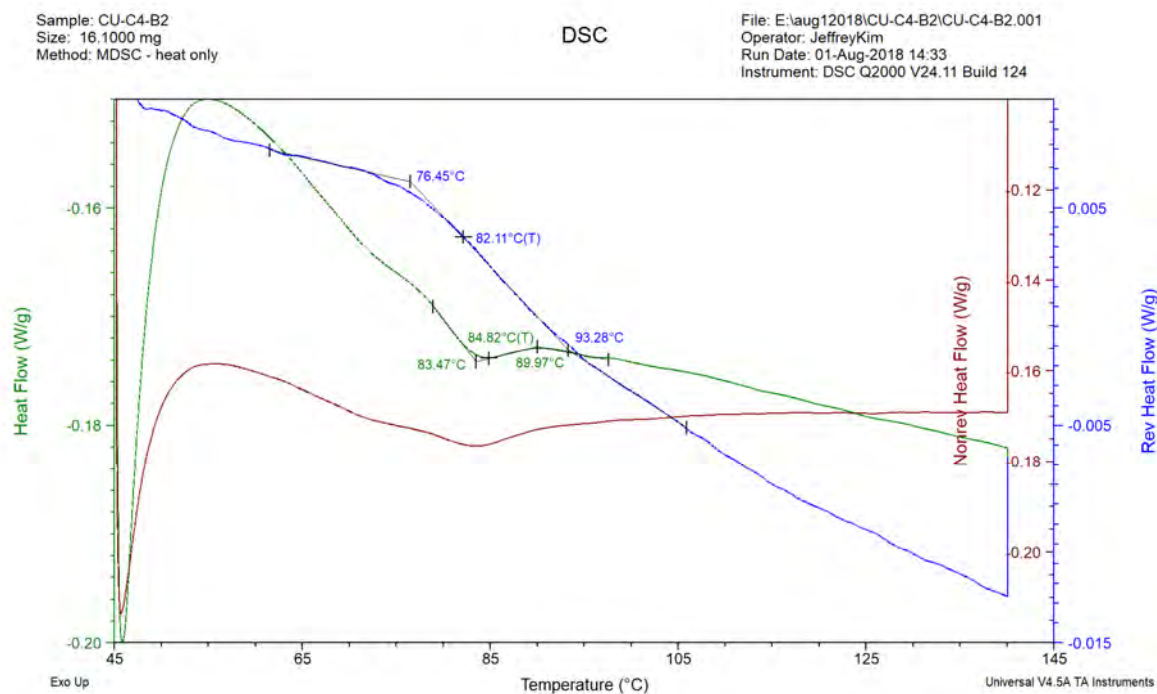
The heat flow curves for MDSC, shown in Fig. 20 to Fig. 23, show generally weak undulations associated with T_g , possibly due to the thermal influence of glass and filler materials mixed in with the matrix material. Evidence of exothermic processes can be seen in the non-reversible heat flow data for all bars. The exotherms appear between 50–70°C and again above 105–110°C. The onset or end of these ranges are believed to be close to the T_g of the materials, which can deviate the total heat flow curve up or down depending on whether the exotherm is starting or ending. Therefore, the influence of exotherms on the total heat flow curves should be considered when attempting to assign a T_g from the total heat flow.

The T_g from the reversible heat flow curves is believed to be a better representation of the T_g of the material in the majority of cases where it could be observed because it was not affected by the onset or end of an exothermic process in the material. For the OH2_C3_B1(1) and CU_C3_B1(2), the T_g results from total heat flow show 1°C variation, which is likely within graphical error, while the T_g results from reversible heat flow show 15°C variation.

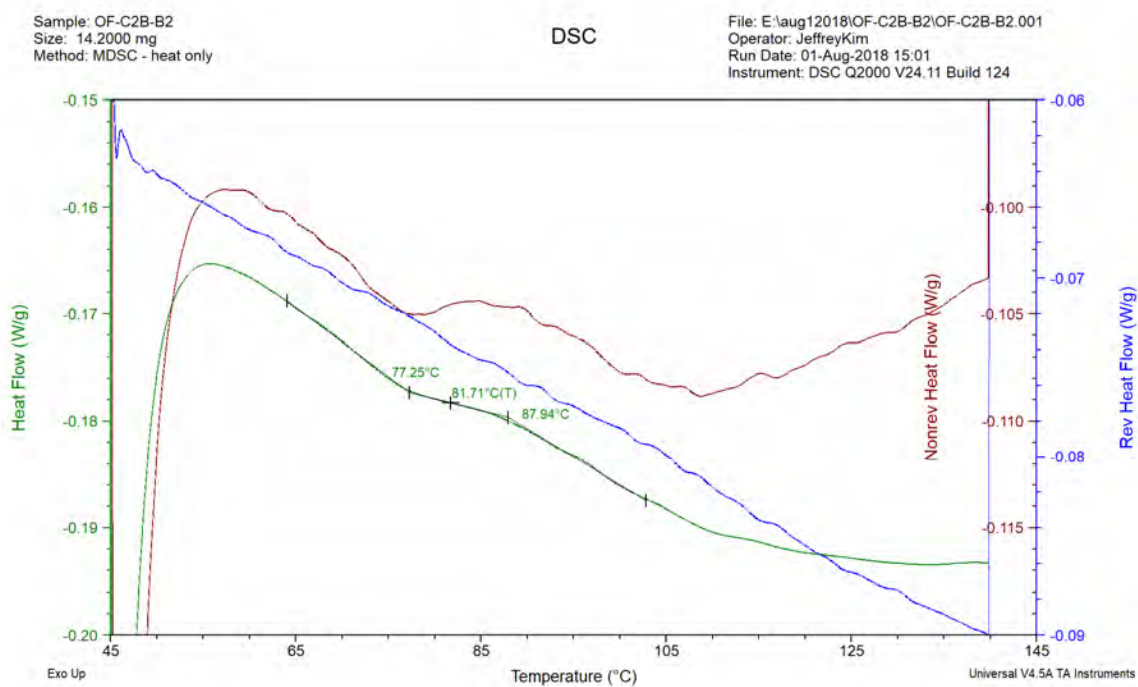
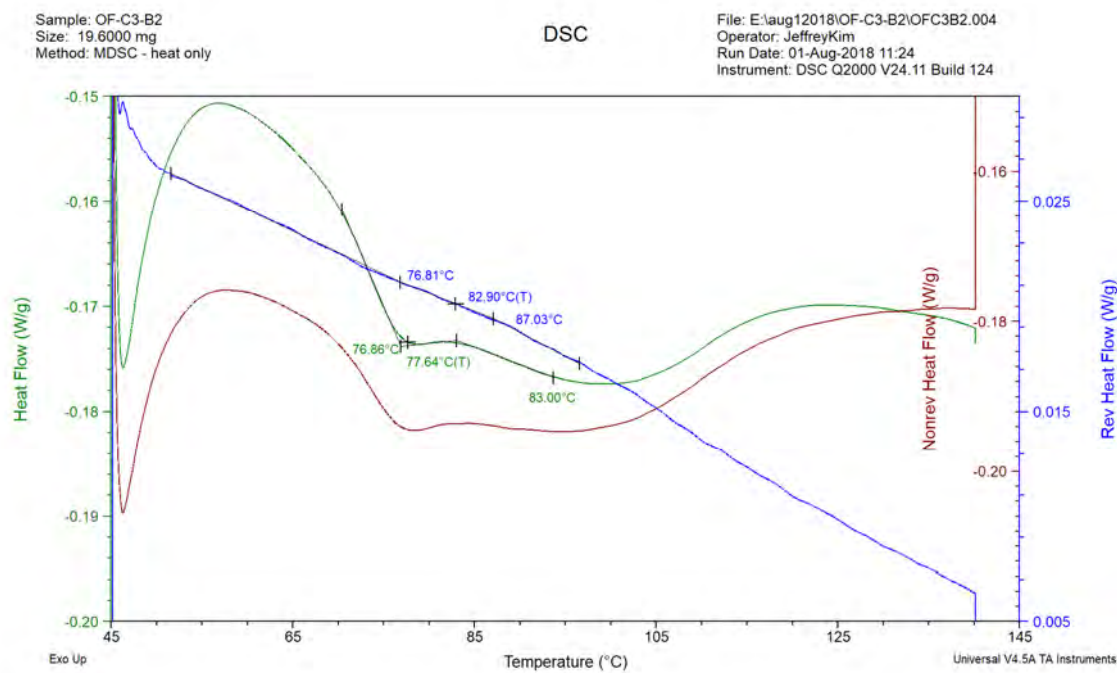
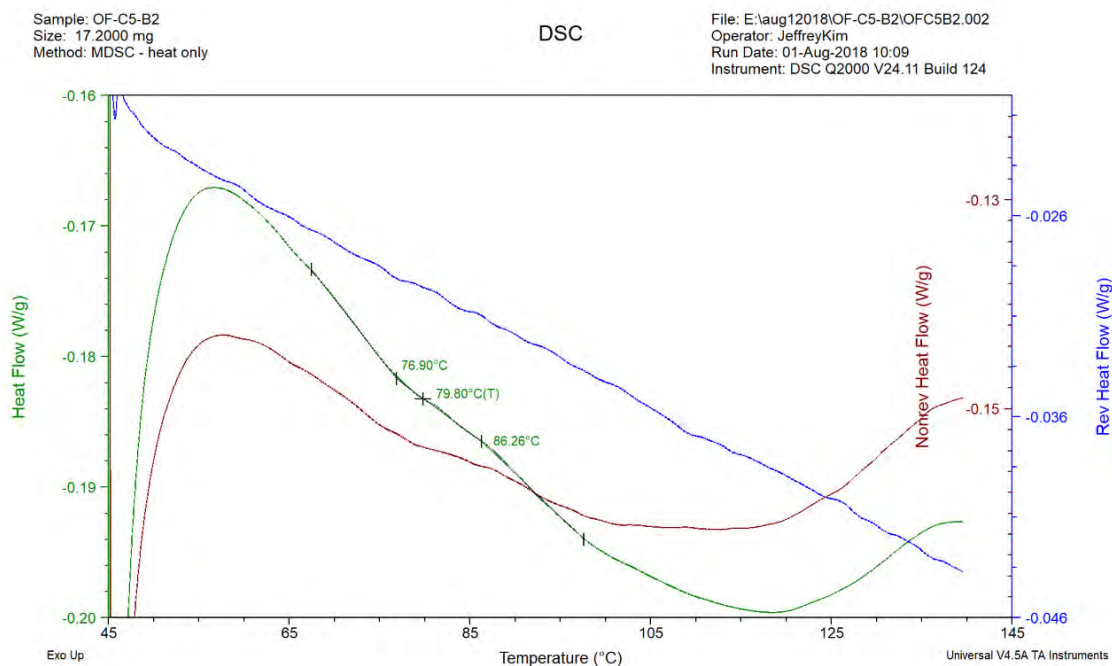
The T_g from the reversible heat flow curves is believed to be a better representation of the T_g of the material in the majority of cases where it could be observed because it was not affected by the onset or end of an exothermic process in the material. For reasons that remain unknown at this time, the T_g from the reversible heat flow was difficult to observe in the *O’Fallon* bars. Thus, no entry is given in the above table for two of the three *O’Fallon* bars and the value given for the third bar is considered questionable.

It appears that the total heat flow provides a clearer and more consistent T_g than the reversible heat flow. However, the total heat flow is believed to be influenced by the proximity of non-reversible heat flow related to exothermic processes. Aside from these concerns, the T_g values measured using the method prescribed in ASTM D7957 (ASTM D7957, 2017) (i.e., ASTM D1356, total heat flow, mid-point T_g) appear to fall in the approximate range of 78°C to 83°C, which is below the mean value of at least 100°C required in ASTM D7957 (ASTM D7957, 2017) for qualification and the minimum value of 100°C required in ASTM D7957 (ASTM D7957, 2017) for quality control and certification.

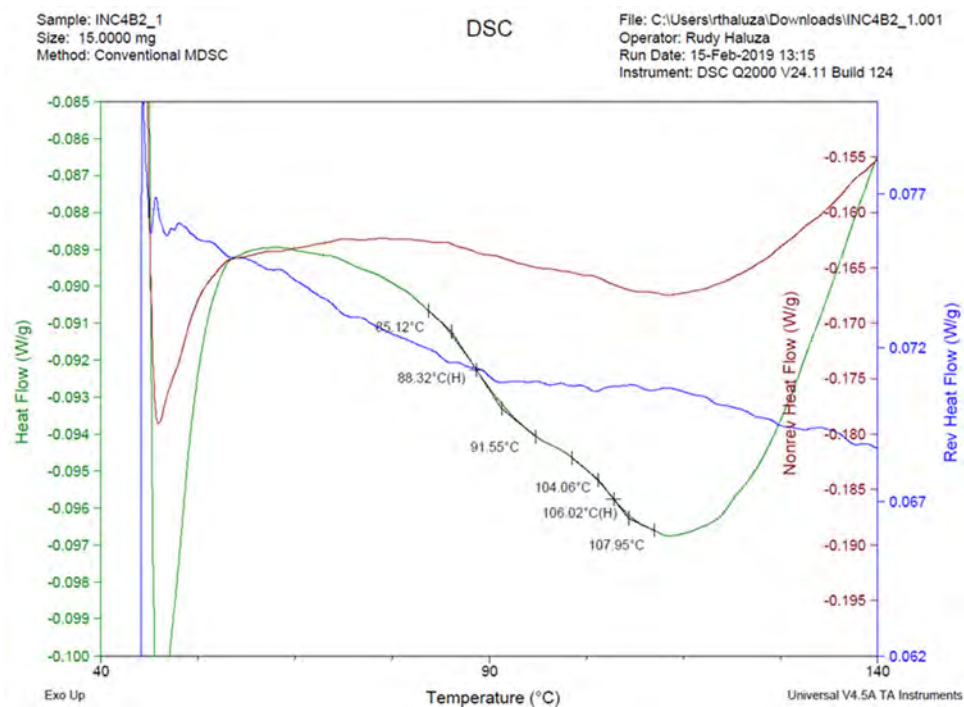
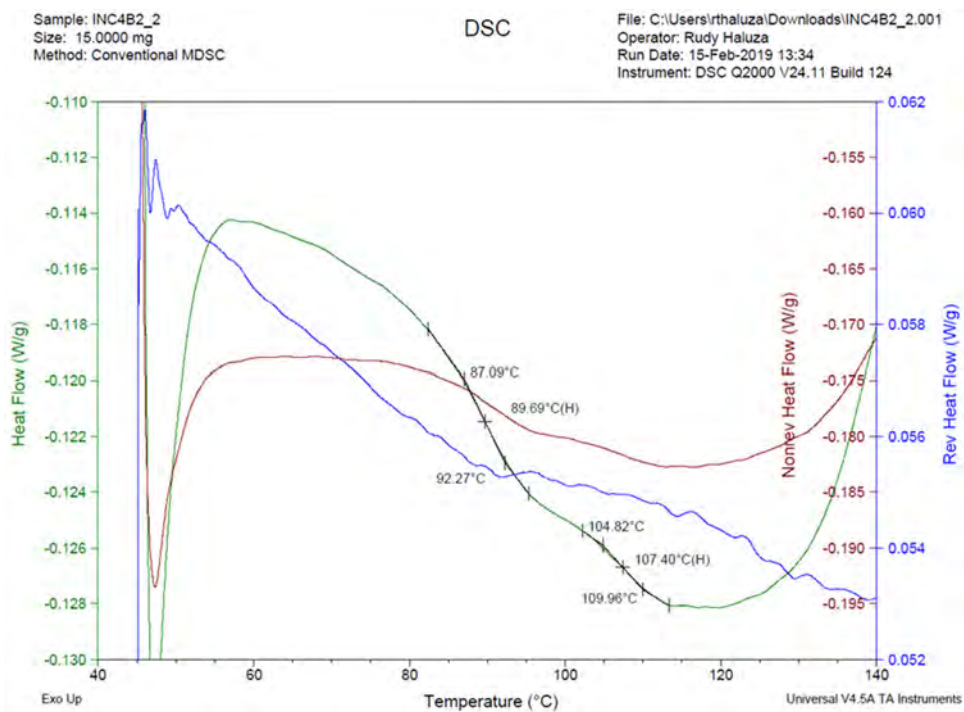
MDSC analysis of bars from the *Thayer Road Bridge* was performed at Penn State University using the procedure described in Section 4.1.4. The results are summarized in Table 51 and the graphical results for each bar are shown in Fig. 47 through Fig. 50. The *Thayer Road* bars displayed no discernable inflection point in the reversible heat flow curves, although all of the total heat flow curves for these bars had two separate T_g values. The lower and upper T_g values are both reported for the bars in Table 51. Only the lower T_g average is reported in the main body of this report, as it is considered the more relevant one for bar performance. The lower T_g values do not satisfy the contemporary GFRP bar specification (ASTM-D7957-17, 2017) of 212°F (100°C), but the upper ones do.

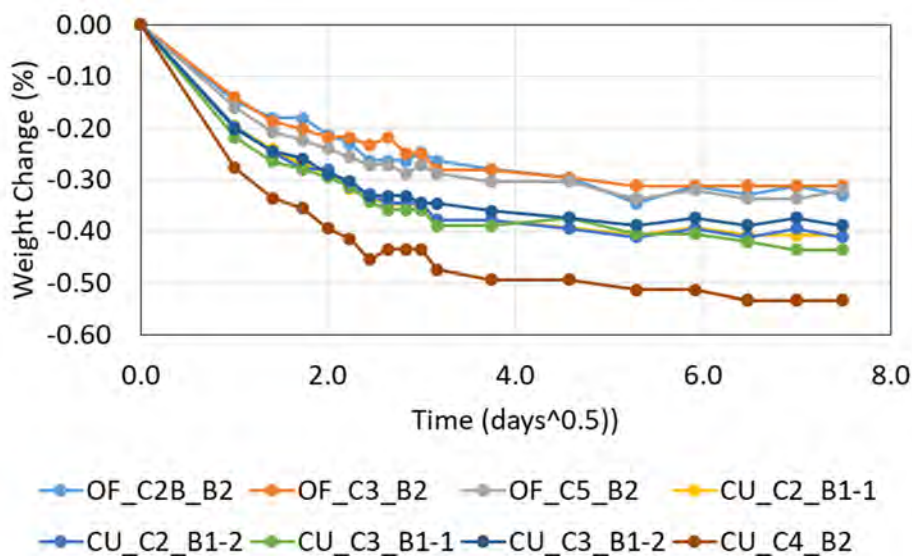
Fig. 52. Cuyahoga weight change versus the square root of drying time, in 176°F (80°C) circulating oven air – PSU

Moisture content for *Cuyahoga Bridge* was performed at Penn State University according to the method described in Section 4.1.6. All dry-out specimens reached equilibrium after 56 days at 176°F (80°C). A plot of percent weight loss versus the square root of time (in days) is shown in Fig. 52. The acronym used for *Cuyahoga Bridge* here is CU instead of OH2. It can be seen that the weight loss is not monotonic. It is suspected that the deviations from monotonic weight loss are due to abnormal humidity conditions in the laboratory, although this possibility cannot be verified.

The weight changes at equilibrium, as a percent of weight before the drying procedure, are listed in Table 53. Overall, the weight losses from the dry-out procedure ranged from 0.38% to 0.53%. Upon conversion of these results to weight gains from a substantially dry initial state, the as-received moisture content of these bars due to field exposure likewise ranged from 0.38% to 0.53%. It should be kept in mind that the moisture content of the bars between the several months' time between when the bars were extracted from the bridges and when they were tested could be affected by the environment in which they were stored.

It is noteworthy that the OH2_C4_B2 bar with the highest as-received moisture content of all tested bars is also the only smaller diameter (5/8 in. [16 mm]) bar of all bars tested. The other bars have a larger (3/4 in. [19 mm]) diameter, which according to theory leads to less weight gain/loss for a given immersion/dry-out time because of a larger moisture permeation path in the material.

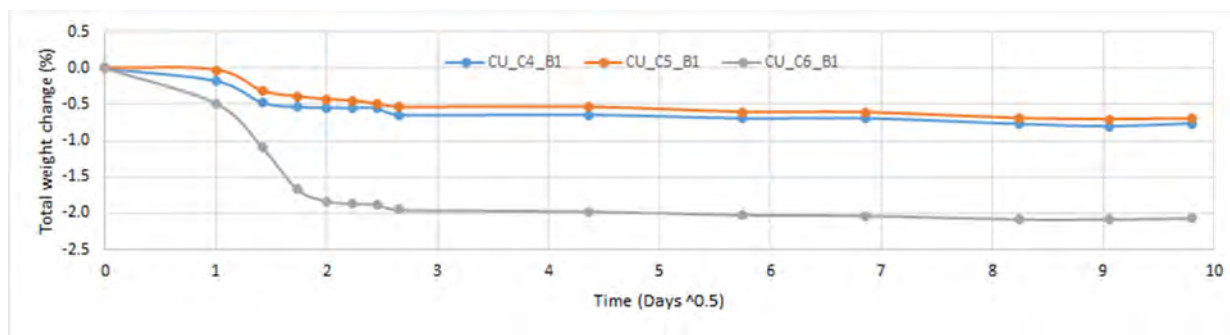
Cuyahoga Bridge was also tested at Missouri S&T. Three bars were used in this test. Results from the moisture content test are shown in Fig. 53. The graph was drawn according to ASTM D5229 requirements, which were to draw the results in term of weight change and days^{0.5}. All specimens reached equilibrium after 68 days at 176° F (80° C). However, the test was continued for a total of 96 days to monitor any abnormal changes in weights. It may be noted in Fig. 53. Cuyahoga weight change versus the square root of drying time, in in 176°F (80°C) circulating oven air that there was no significant change in weight after 68 days (X-axis – at point 8.2), as the curve trend levels off pass that point. However, a slight change in weight can be noticed from core 4 (CU_C4_B1), and it could be due to balance instability. The final weight change percentages respectively were 0.8% for CU_C4_B1, 0.7% for CU_C5_B1 and 2.1% for CU_C6_B1. The higher percentage of moisture content for the larger diameter bar could be related to larger surface area. Moisture content test was not conducted on control bars to benchmark these results. Additional tests are required to improve the dataset and validate these results. In addition, if test methods exist to measure moisture levels throughout the cross section on thin slices (i.e. relative to distance from the core to the outer surface of the bar) for different bar diameters, this may be examined to better understand moisture content relative to bar surface area and depth.

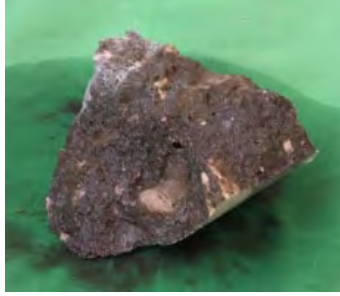
Fig. 8. Roger's Creek chloride penetration sample

No evidence of chloride diffusion was observed in the tested specimens of *Roger's Creek Bridge*. The results are shown in the Fig. 8.

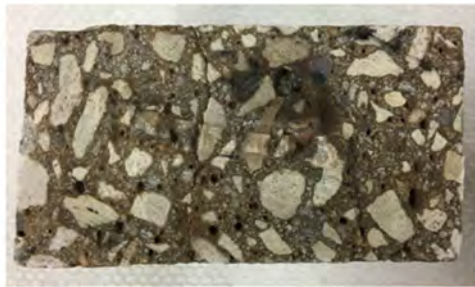
Fig. 9. Walker Box Culvert chloride penetration sample

No clear evidence of chloride diffusion was observed in all the tested specimens using this method. It was noticed that the surface became darker, to a color similar to brown, while there was no visible gray area (*Fig. 9*).

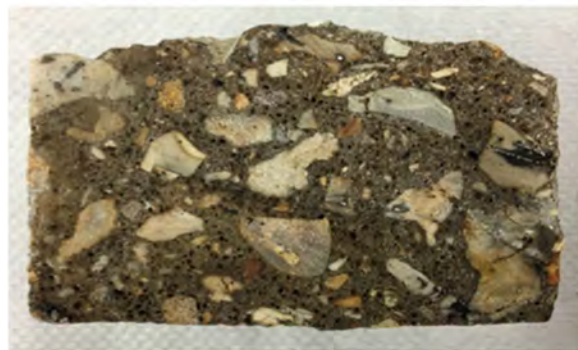
Fig. 10. Southview chloride penetration sample

No clear evidence of chloride diffusion was observed in all the tested specimens of both bridges using this method. It was noticed that the surface became darker, to a color similar to brown, while there was no visible gray area (*Fig. 10*).

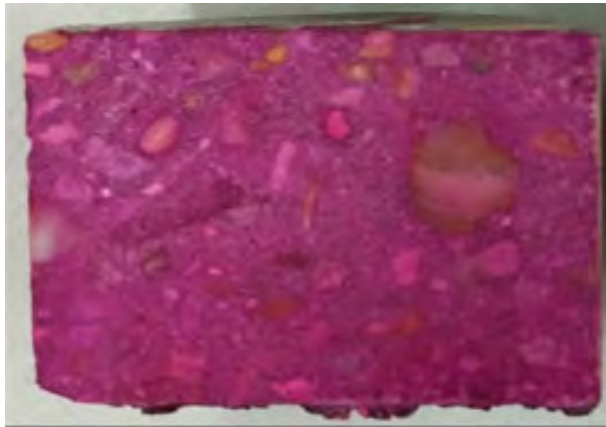
Fig. 18. Southview carbonation depth results

No indication of concrete carbonation was observed in samples extracted from Southview Bridge (*Fig. 18*). While no carbonation of concrete can be considered beneficial to steel rebars because the pH remains at high values, the opposite is true for GFRP reinforcement that is more sensitive to high alkalinity. Thus, the GFRP bars extracted from these cores were subject to an alkaline environment over the 11 years of service.

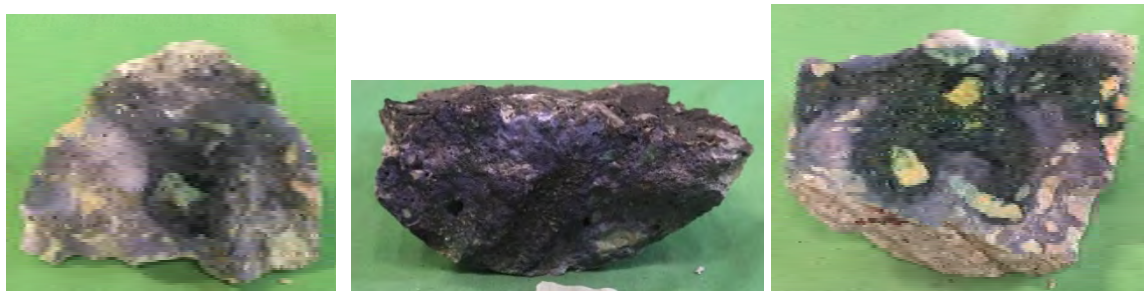
Fig. 31. Thayer Road pH test

The pH obtained for *Thayer Road Bridge* concrete samples only varied between 11 and 13, as shown in Fig. 31.
