Durability of GFRP Bars Extracted from Bridges with 15 to 20 Years of Service Life

June 1, 2019

DURABILITY OF GFRP BARS EXTRACTED FROM BRIDGES WITH 15 TO 20 YEARS OF SERVICE LIFE

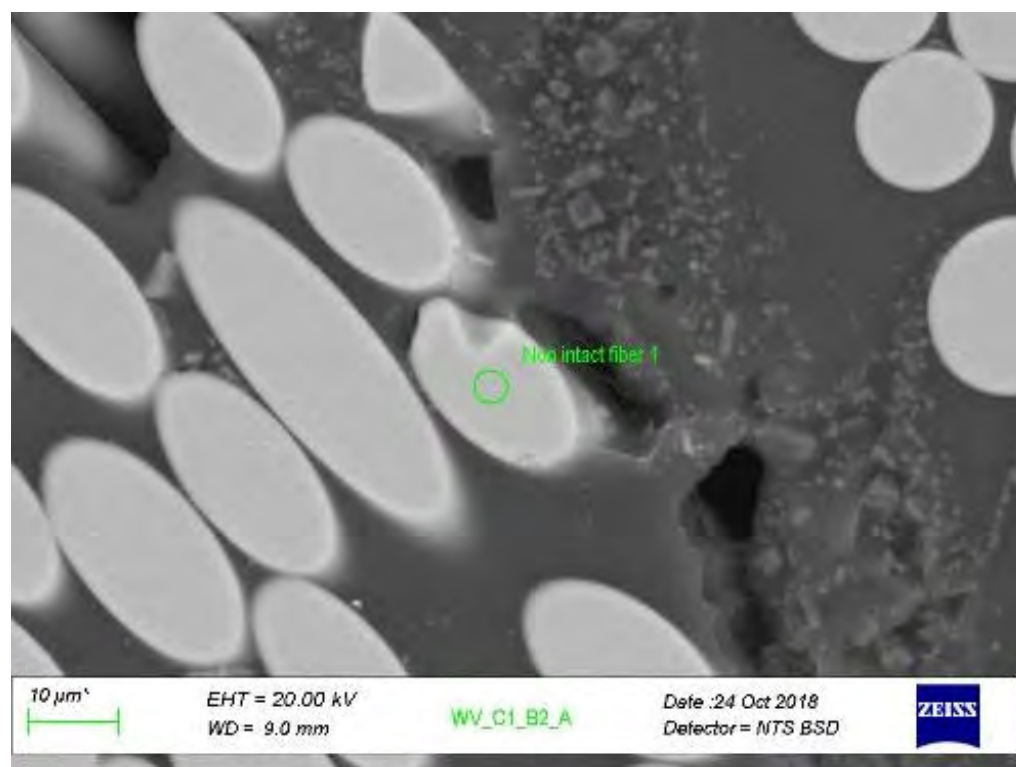
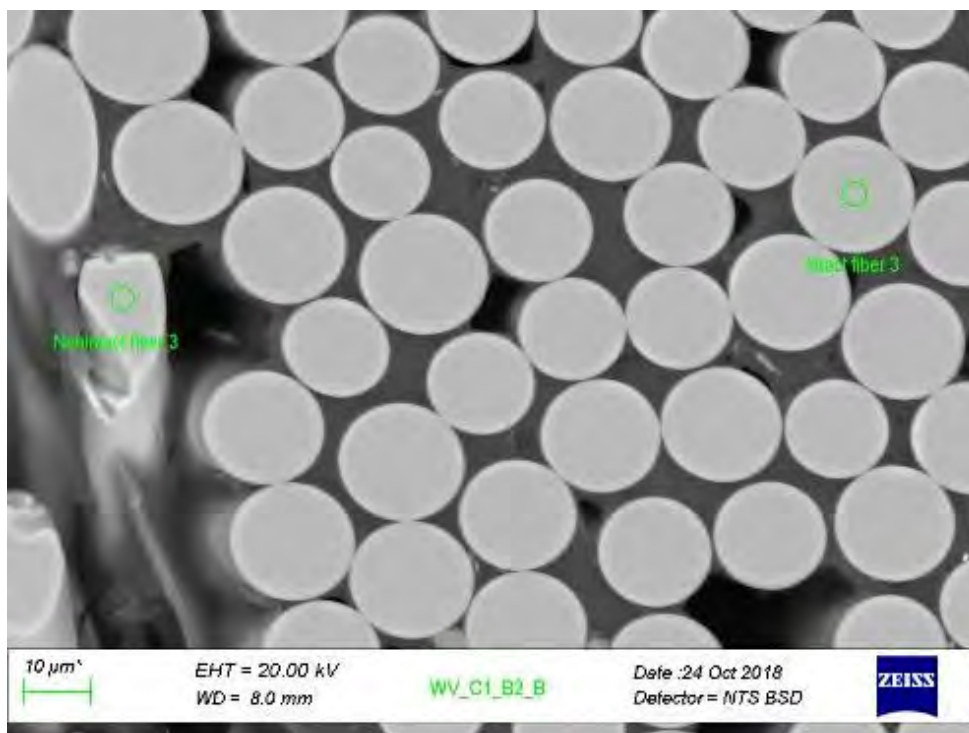
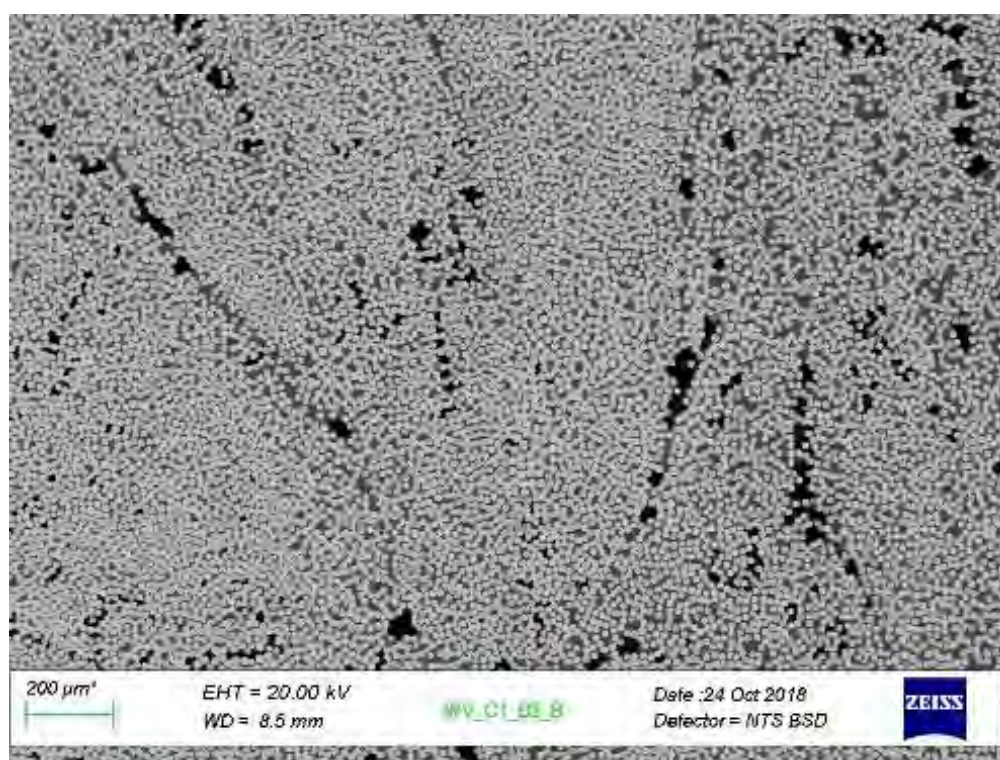
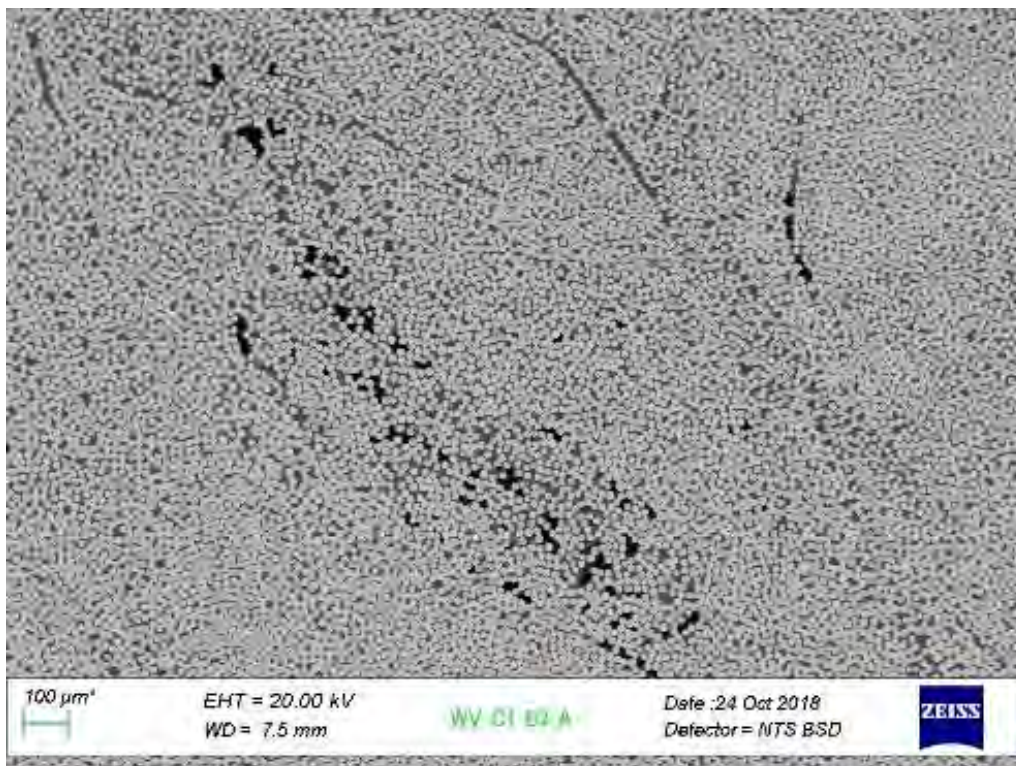
SEM imaging for *McKinleyville Bridge* was performed at Owens Corning. Nearly no negatively affected fibers were observed on the interior or exterior of in-service rebar. The few negatively affected fibers appear to have physical damage from specimen preparation as they are near resin voids. The SEM images of each bar is shown in Fig. 36 through Fig. 80.

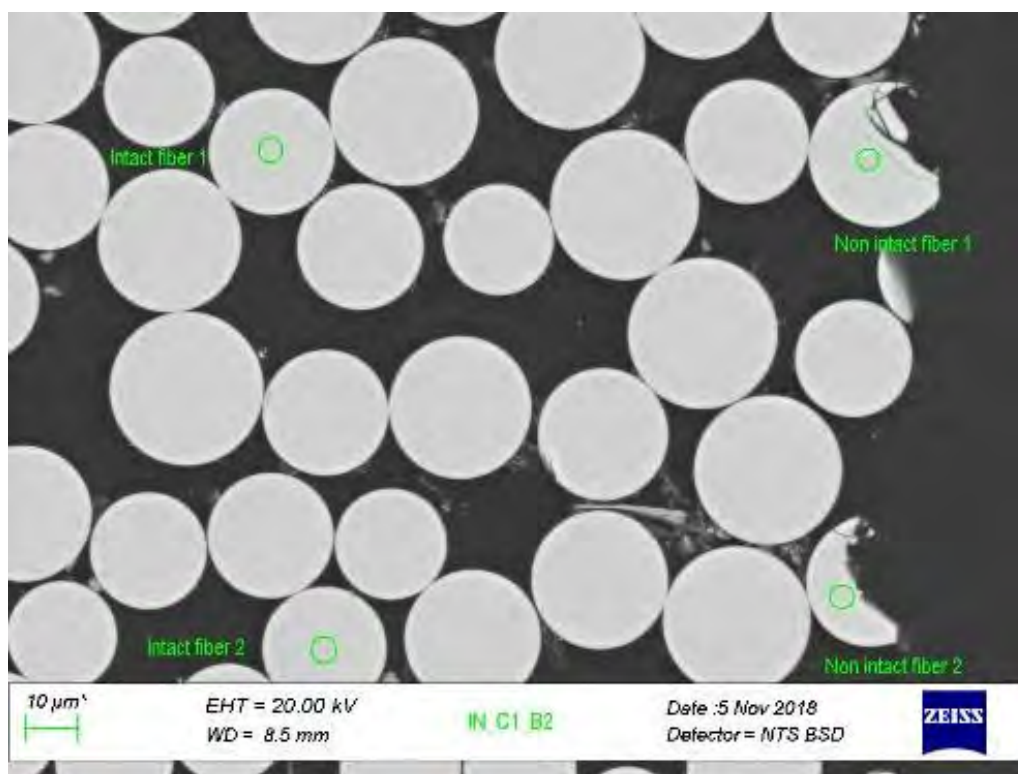
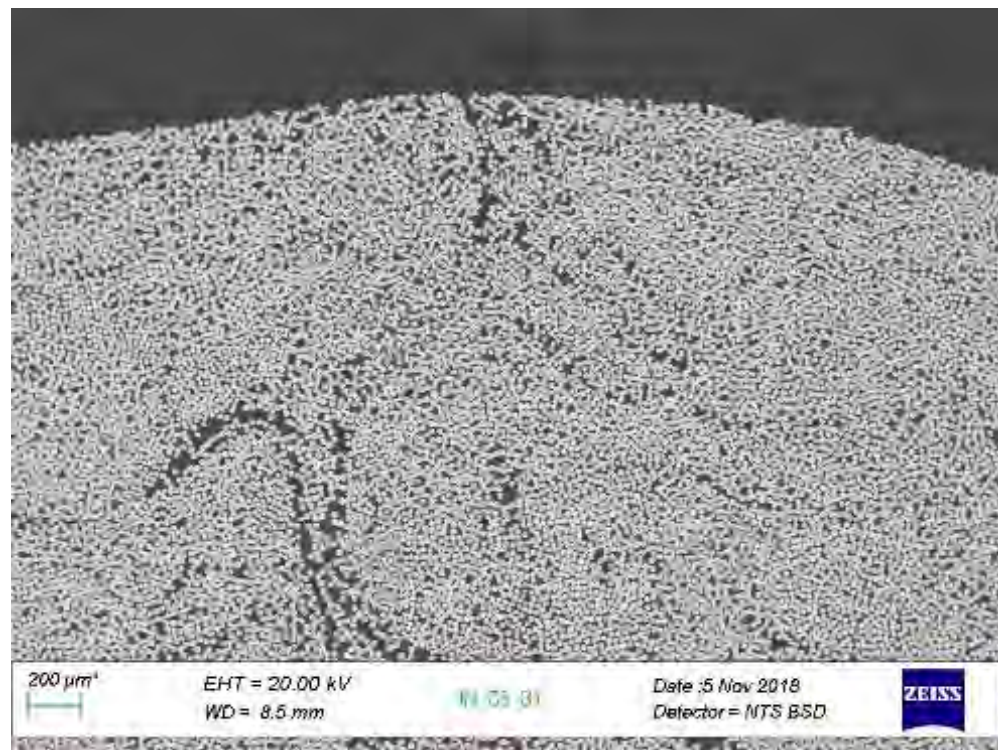
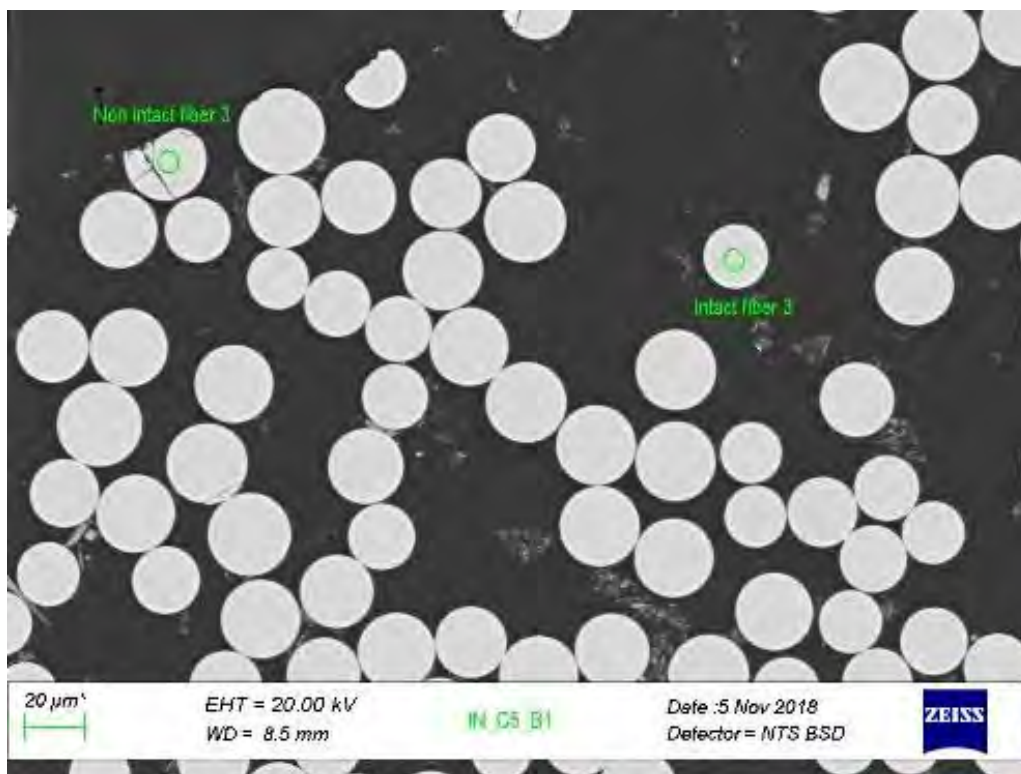
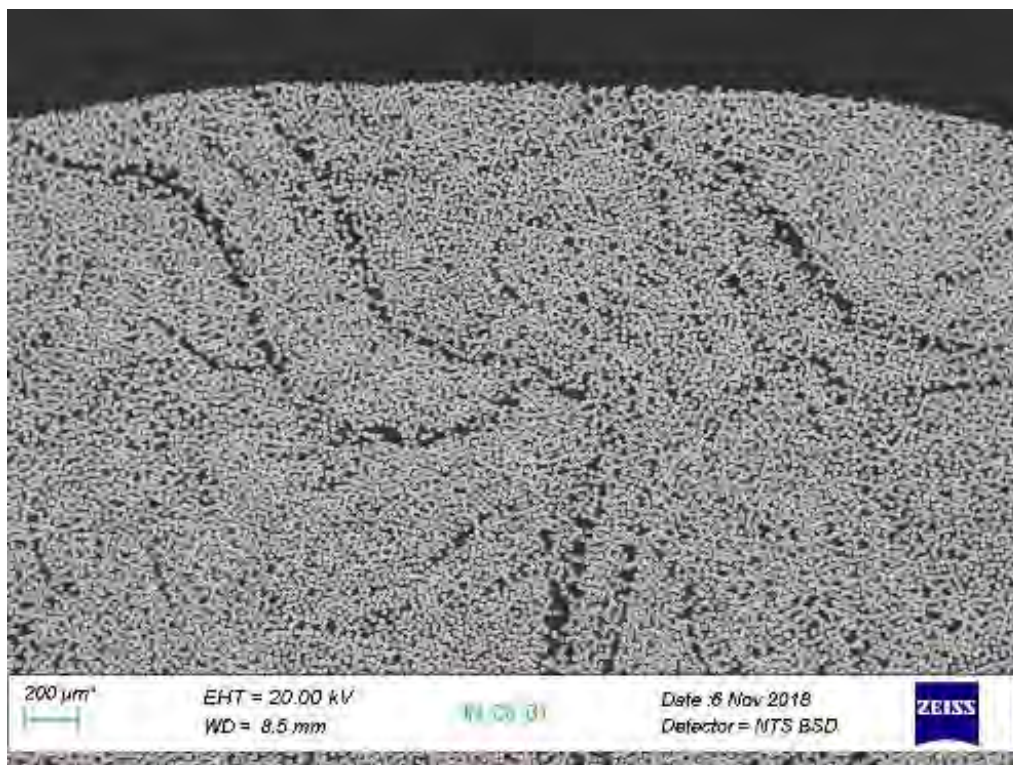
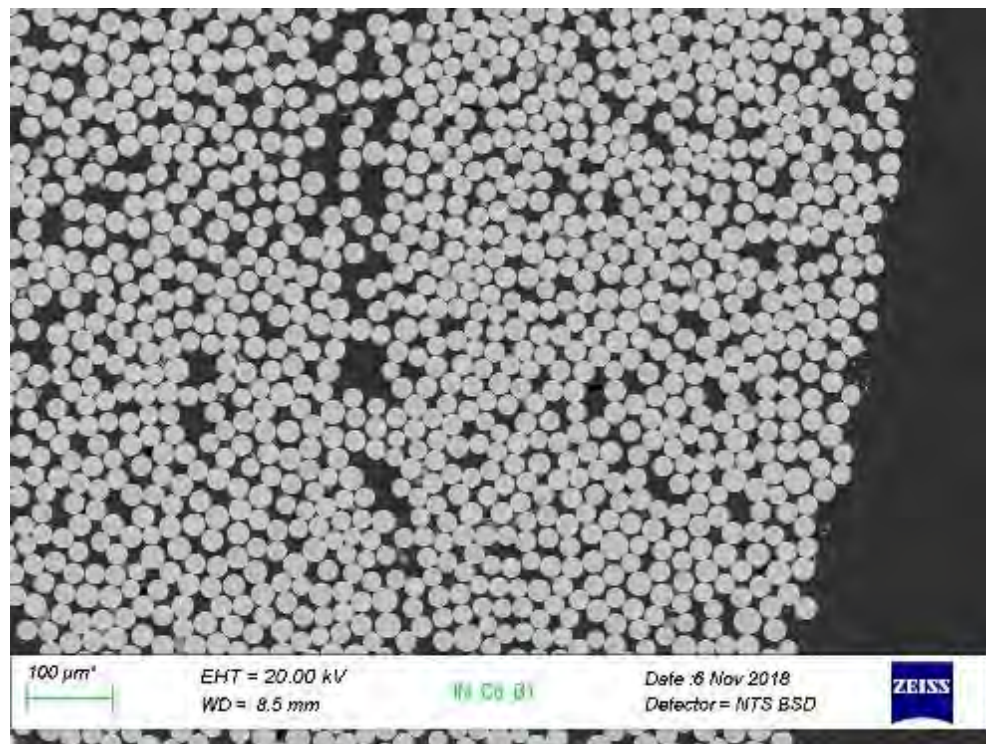
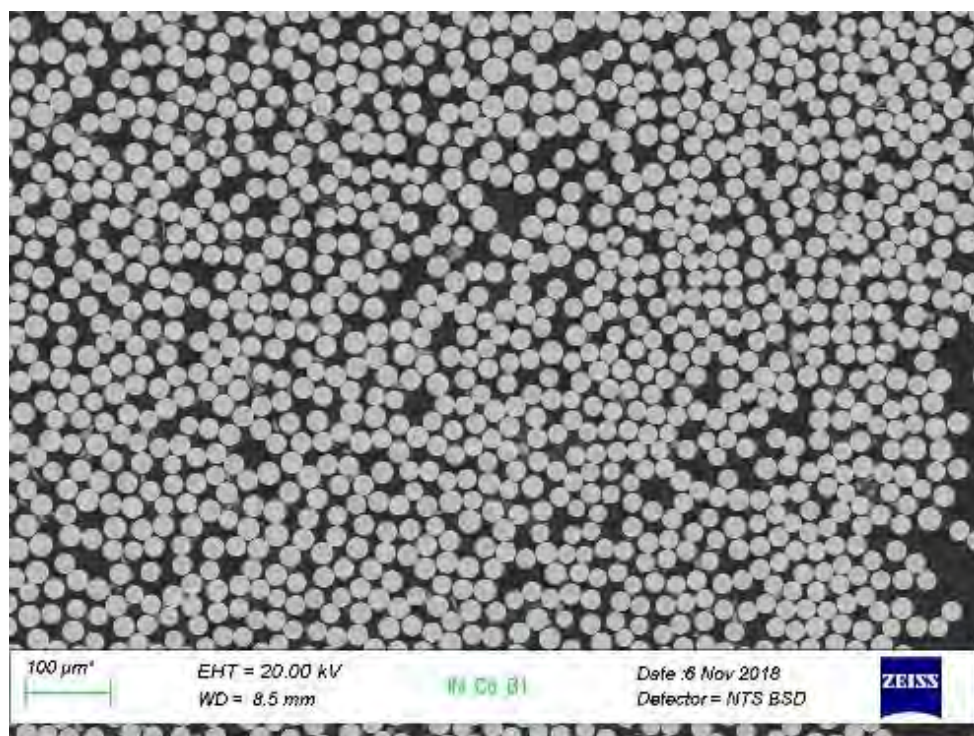
SEM imaging for *Thayer Road Bridge* was performed at Owens Corning. A few negatively affected fibers were observed but appeared to be isolated on the outer perimeter of in-service rebar. The affected fibers only indicated physical damage, likely from manufacturing process. Extrapolated damage was not visible in this sample. Swirls observed in optical microscopy can be seen in low magnification images and are related to resin rich areas. The SEM imaging of each bar is shown in Fig. 81 through Fig. 98.

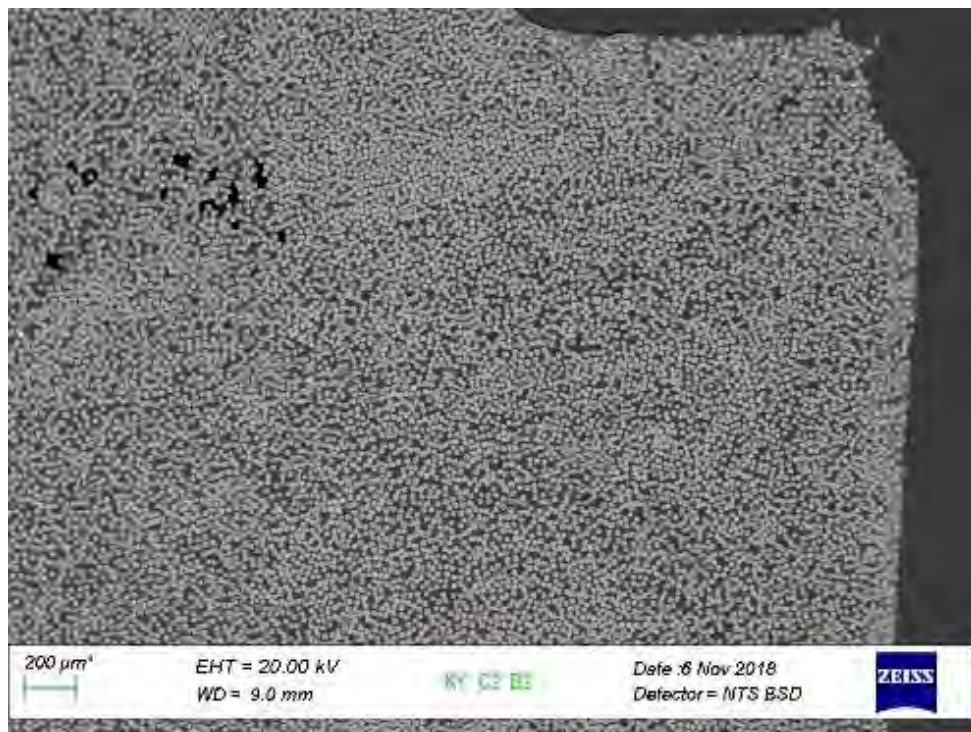
SEM imaging for *Roger's Creek Bridge* was performed at Owens Corning. The fibers from *Roger's Creek Bridge* showed some evidence of being negatively affected by concrete exposure. Of the few negatively affected, they were located on the exterior or near large cracks. The number of affected fibers is expected to be similar or less than the Cuyahoga or Gills Creek samples. The SEM imaging of each bar is shown in Fig. 99 through Fig. 109.

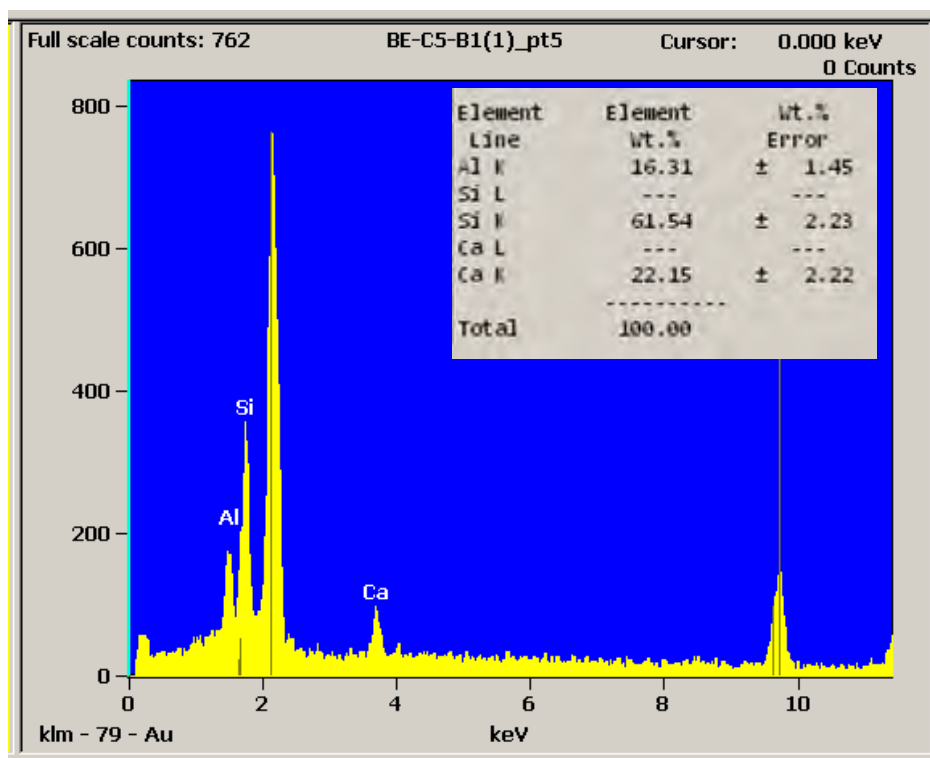
Fig. 121. BE_C5_C1-1 pt 5 no gold included. Yielded less Al, Si and Ca.

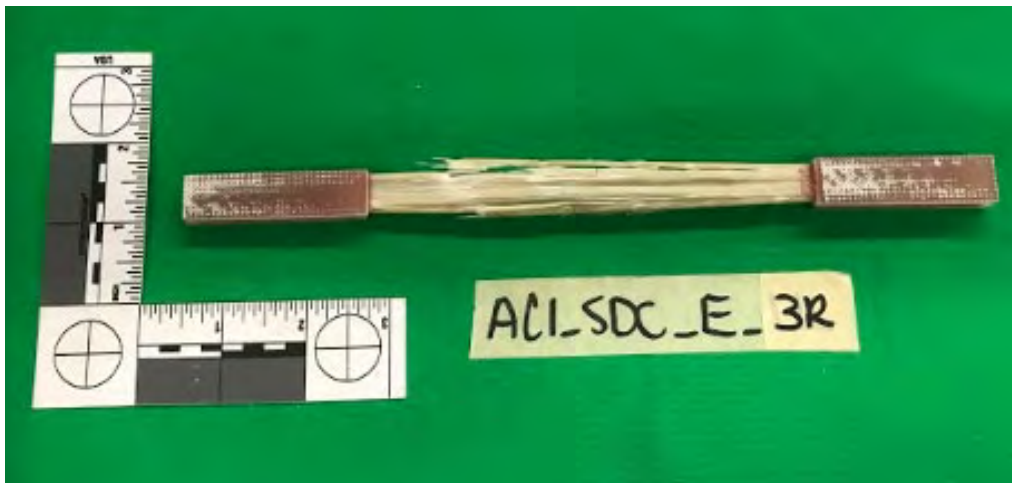
Sierrita de la Cruz Creek coupon 3 from the right side of the rebar failed with the splitting of gage at various points at a peak load of 4,330 lbs. (19 kN) and a peak strain of $13,112 \times 10^{-6}$. The coupon before testing and after failure are shown in Fig. 27 and Fig. 28, respectively. The strain values were recorded with both strain gauges and extensometer; however, the extensometer was removed at 3,500 lbs. Therefore, the stress strain curve uses the values obtained from the strain gauge. The stress strain curve for this bar is shown in Fig. 29. A summary of the tensile test results is shown in Table 9.

Fig. 28. Coupon E_3R after failure

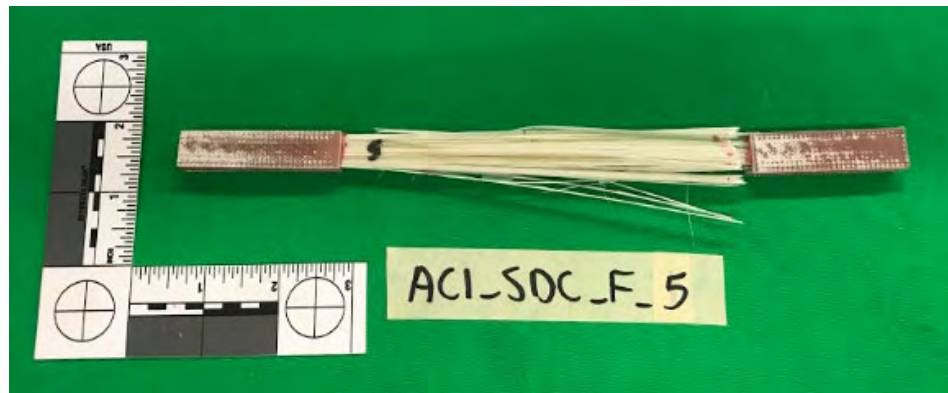
Fig. 39. Coupon F_5 after failure

Pristine coupon 5 failed with the splitting of gage at various points at a peak load of 5,321 lbs. (24 kN) and a maximum strain of $19,400 \times 10^{-6}$. The coupon after failure is shown in Fig. 39. The strain values were recorded with both strain gauges and extensometer; however, the extensometer was removed at 4,000 lbs. Therefore, the stress strain curve uses the values obtained from the strain gauge. The stress strain curve for this bar is shown in Fig. 40. A summary of the tensile test results is shown in Table 14.

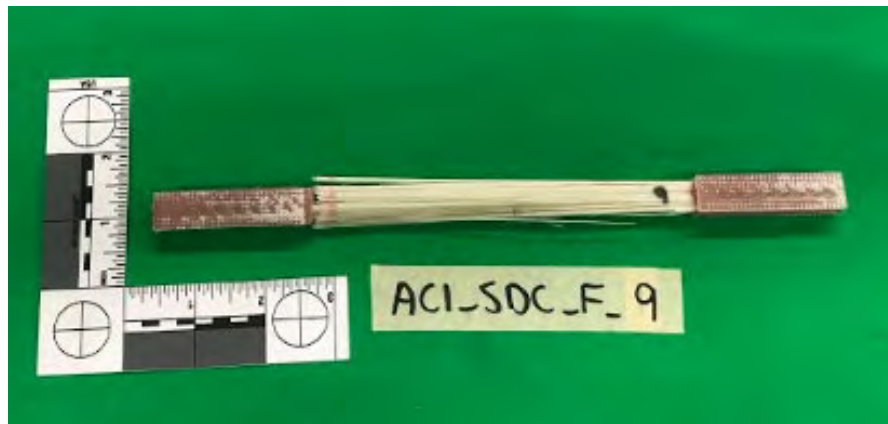
Fig. 47. Coupon F_9 after failure

Pristine coupon 9 failed with the splitting of gage at various points at a peak load of 5,207 lbs. (23 kN) and a maximum strain of $15,600 \times 10^{-6}$. The coupon after failure is shown in Fig. 47. The stress strain curve for this bar is shown in Fig. 48. The coupon before testing and test set up are shown in Fig. 2 and Fig. 3, respectively. The failed coupon and the stress strain curve shown in Fig. 4 and Fig. 5, respectively. The strain values were recorded with both strain gauges and extensometer; however, the extensometer was removed at 4,000 lbs. Therefore, the stress strain curve uses the values obtained from the strain gauge. A summary of the tensile test results is shown in Table 18.

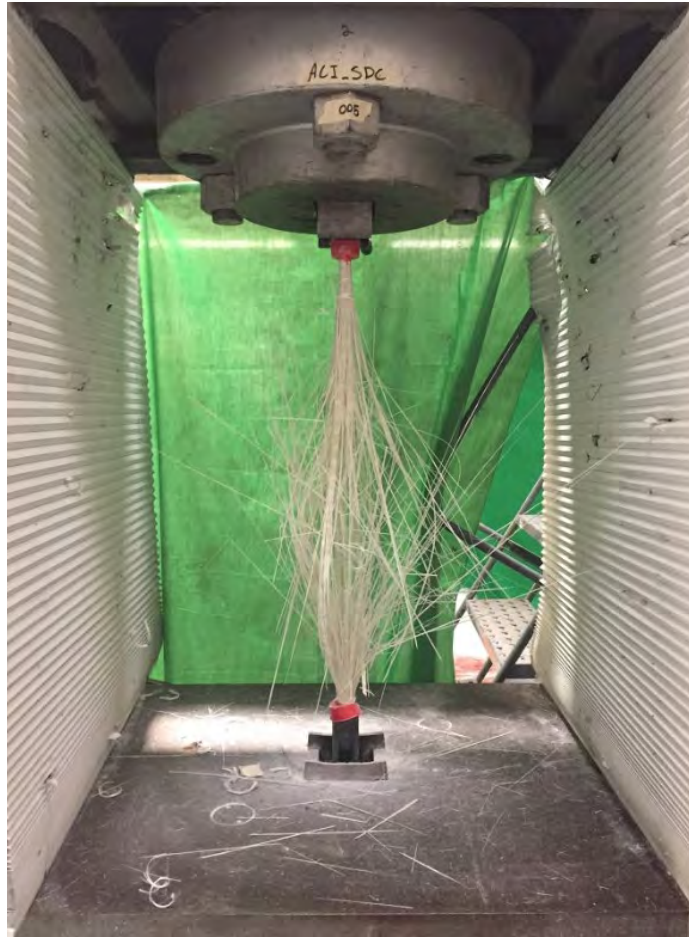
Fig. 58. Bar 005 after failure

Pristine bar 005 failed at a peak load of 38,186 lbs. (170 kN). A photograph of the bar after failure is shown in Fig. 58. The extensometer was removed at a load of 12,150 lbs., and therefore, the maximum strain could not be determined. The stress strain curve for this bar is shown in Fig. 59. A summary of the tensile test results is shown in Table 25.

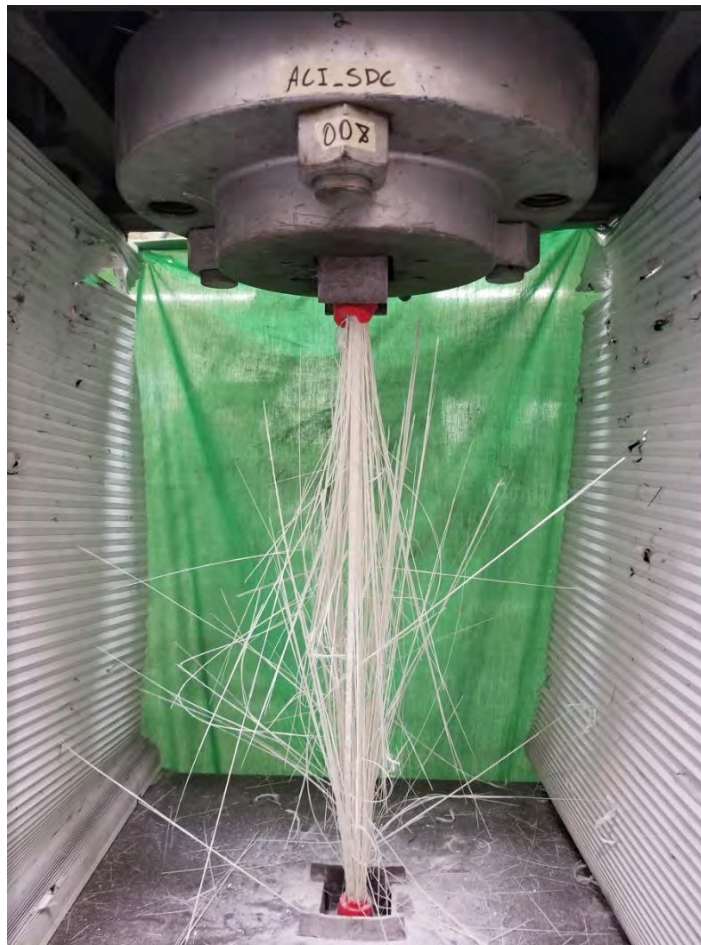
Fig. 63. Bar 008 after failure

Pristine bar 008 failed at a peak load of 37,212 lbs. (166 kN). The extensometer was removed at a load of 11,880 lbs., and therefore, the maximum strain could not be determined. The bar after failure is shown in Fig. 63 and the stress strain curve for this bar is shown in Fig. 64. A summary of the tensile test results is shown in Table 28.
